# REVITALIZATION OF THE 1970S WITHIN THE 'OLD TOWN' IN KRAKÓW

Paweł ŻWIREK<sup>1</sup>, Jakub FISZER<sup>2</sup> <sup>1</sup>Cracow University of Technology Tadeusz Kościuszko Faculty of Civil Ingineering, Kraków, Poland <sup>2</sup>AKE Studio Spółka z o.o., Kraków, Poland

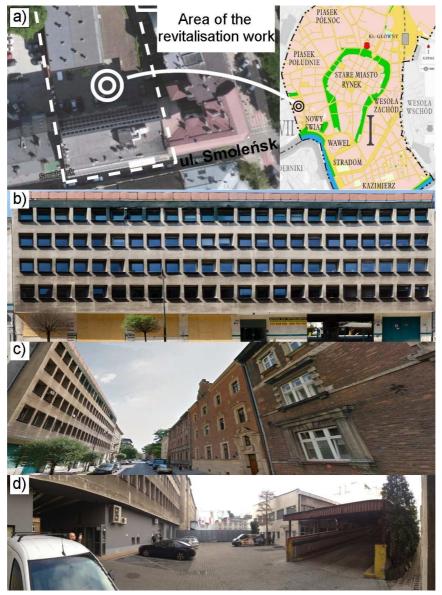
Fig. 1. a) Area of the revitalization work, b), c) The façade of the office building from Smoleńsk street, d) View of the courtyard, with a two-storey garage and ramped driveway

floors, where damage to the flat roof's waterproofing had resulted in significant deterioration of the walls. Parts of the inter-window pillars were in such bad condition that they required complete reconstruction.

The specific architecture of the existing façade has very deep window cavities (Fig. 1b, c), resulting in the use of thick walls (tens of centimetres), which were made of cellular concrete that is characterized by low thermal conductivity. As a result, there was no need to perform additional thermal modernisation of the from the Smoleńsk street wall to adjust its parameters to modern regulations on thermal insulation baffles [5].

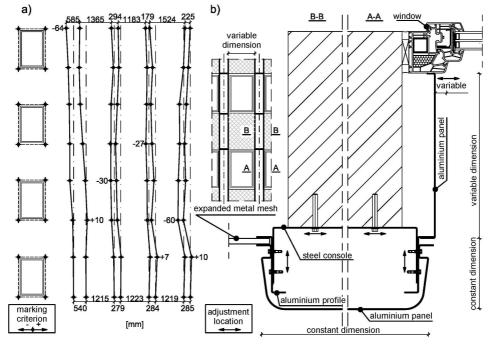
Fig. 2. a) Inventory of window positions in the parallel plane to Smoleńsk street (for the first three rows of windows on the left side) b) Wall detail

Before execution of the regeneration project, a preliminary inventory of the façade's existing geometric wall was carried out. Fig. 2a shows examples of horizontal measurements on the parallel plane to Smoleńsk street, and displacement of the corners of the window cavities from the lower corners of the first floor. Fig. 2a shows the inventory results for a portion of the wall on which the largest displacement values were present. The inventory results indicated very low precision of workmanship, with deviations considerably exceeding the tolerances specified by the standards of that time [4]. The widths of the window cavities varied from 1,215mm to 1,524mm; the width of the inter-window pillars from 179mm to 285mm, and the deviation from the vertical position of the inter-window pillars located at successive levels was up to 60mm. Similar displacement values from the vertical were also obtained for measurements along the perpendicular plane to Smoleńsk street.

The windows had been replaced before the project, and so their location was matched to the position of the window cavities (Fig. 2a). For the project, nearly 1,500 window cavity geometry measurements were carried out. Due to the large number of inaccuracies in the existing façade, the vast majority of cladding elements required individual workshop documentation. Based on the inventory results, it was established that it would be possible to select the dimensions and position of the pilasters in such a way that they would run vertically along the entire height of the façade, and at the same time would not building the light of the window frames.

The window cavities panels were mounted perpendicular to the plane of the façade, which resulted in different window frame widths visible from the window cavity panel. Fig. 2b shows the solutions which were used to achieve the designed position of the individual elements of the new wall's housing – even with the significant inaccuracies of the existing walls. Fig. 3 shows a view of the office building's façade after renovation.

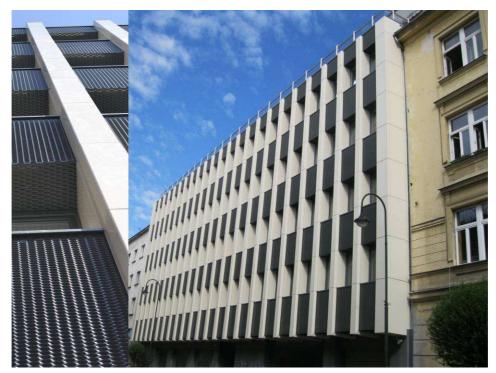
Fig. 3. Façade of the office building after revitalization

The concept for the revitalization took in the use of full, bright pilasters made of smooth powder-coated aluminium sheets. Dark, perforated strips of expanded metal mesh were placed between the pilasters (Fig. 3). The breaking up of the façade's plane with the introduction of strong vertical accents and materials of varying texture meant that the window cavities no longer dominated the façade. In addition, the elevation changes, depending on the angle at which an observer looks at the façade. When entering Smoleńsk street we can initially only see the bright pilasters, and as we move toward the building, the dark bands of expanded metal mesh begin to gradually emerge from behind them.

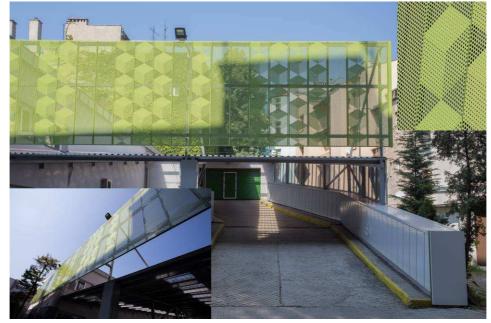
Fig. 4. Garage and ramp façade after revitalization

The off-street access road to the office building (Fig. 1b, d) leads to a courtyard behind the building, where training rooms are now located (originally, these were home to a car mechanic), along with a two-level garage with access ramps (Fig. 1d). The revitalization concept assumed, for example, optical masking of the existing offset between the building's structure and the ramp's roof (Fig.1c). This effect was achieved by making a false wall measuring about 3.5x12.5m, enclosed by perforated aluminium panels. The perforations were made using numerically controlled turret punches, allowing for diversity in the perforation pattern and creating a spatial effect in the flat panels. The use of aluminium also reduced the weight of the housing. The perforations also allowed for mitigation of more wind load compared to a full wall, which was also of utmost importance from the point of view of the load capacity of the existing structure of the ramp. At the same time, the housing of the false wall overlaps the wall of the existing building and masks the window openings of the

garage. In this case, the aim of the perforations was to allow natural light into the interior of the building. The completed garage and ramp revitalization can be seen in Fig. 4 (compare to Fig. 1d).
