EFFECTIVENESS OF ASSESSING FLOOD HAZARDSALONG THE LUBUSKI SECTION OF THE ODER

Urszula KOŁODZIEJCZYK University of Zielona Góra

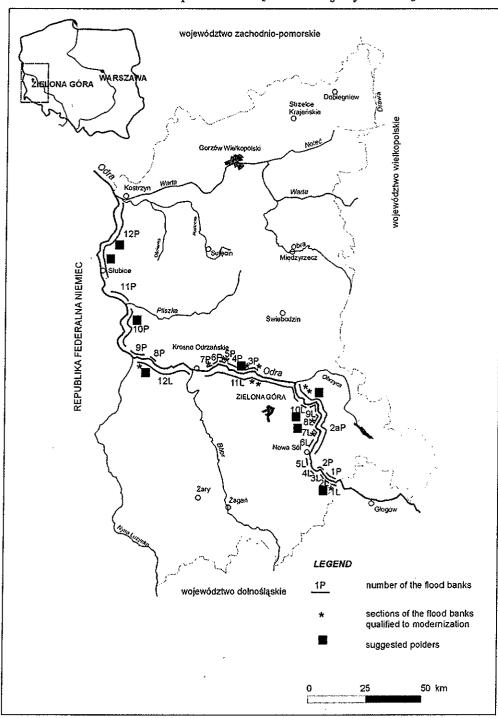
Fig. 2. The Lubuski section of the Oder river

Over Lubuski section of the Oder the following sections of the flood banks were qualified to urgent modernization (Fig. 2):

- part of the section 2P protecting Głuchów Village and Kargowa Valley,
- part of the section 3P protecting Pomorsko Village and Brody Village,
- part of the section 5P protecting Nietkowice Village and Railway Track
 Zielona Góra Czerwieńsk,
- part of the section 7P protecting Będów Village,
- section 1L of the flood banks protecting Drogomil Village,
- part of the section 7L (where water overflew in the direction to Otyń),
- part of the section 8L protecting Tarnawa Village,
- part of the section 11L protecting arable land and surroundings of Czerwieńsk Town,
- part of the section 12L protecting Kosarzyn Village.
