HYDROMORPHOLOGICAL RIVER ASSESSMENT OF DEGRADED LAND IN THE REGION OF OPEN CAST MINES

Mariusz ADYNKIEWICZ-PIRAGAS, Iwona LEJCUŚ
Institute of Meteorology and Water Management Wrocław Branch
Regional Research Department
ul. Parkowa 30, 51-616 Wrocław, Poland
Mariusz.Adynkiewicz@imgw.pl, Badania.Regionalne@imgw.pl

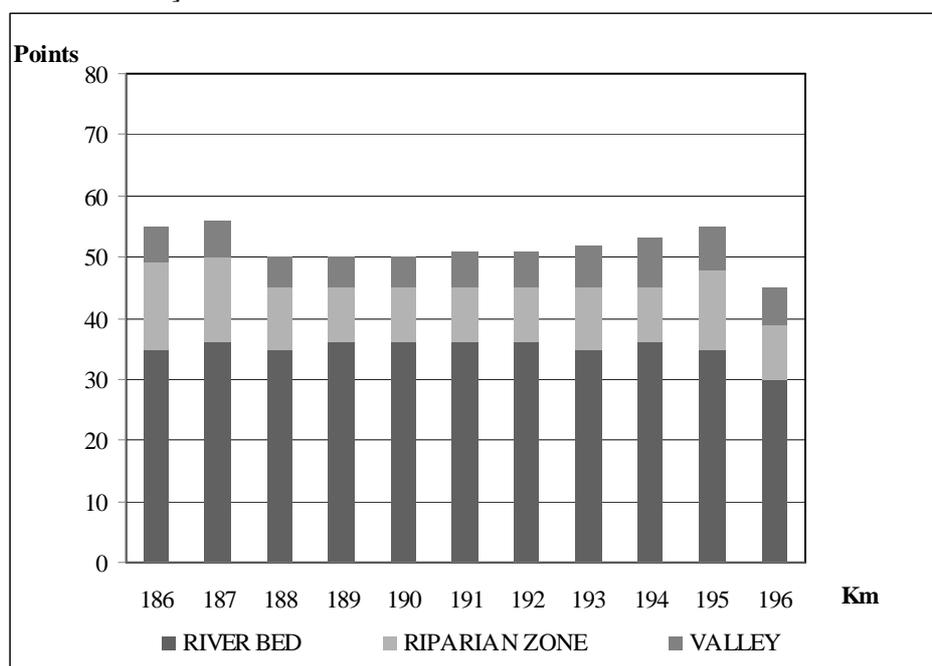
Figure 2. Changeability of hydrological quality assessment in individual zones of the Lusatian Neisse River from 186th km to 196th km

The analysis of results obtained for each zone indicates that the Lusatian Neisse river, on the evaluated river course in the zone of river bed area, gained an average rating for 35 points (max. assessment 70 points). The lowest value obtained the river course on the 196th kilometer that is 30 points whereas the highest score that is 36 points on the river course of 187, 189, 190, 191, 192, 194th kilometer. Among the six assessed attributes in the zone of river bed, vegetation of the watercourse was assessed as the poorest (average 9 points / max 25 points) while the highest score was given to the structure of the slope (average 7 points/ max 10 points). In the riparian zone, river gained an average score of 11 points (max score 20 points). Among the three evaluated attributes in

the riparian zone, the lowest score was given to vegetation (average 4,1 points/ max 10 points) whereas the highest was given to use the riparian zone (average 3,9 points/max 5 points). However, the Lusatian Neisse river, in the valley zone, got an average value of 6 points at the maximum value of 15 points. The parameter which was ranked as the lowest was the use of the valley (average 3 points/ max 10 points) while the highest one were the anthropogenic transformations (average 3,4 points/ max 5 points) [Andykiewicz-Piragas, Błachuta 2009].

In the case of the discussed river course of the Lusatian Neisse river, 6 parameters out of 11 obtained more than a half of possible points to get within use of valley and scarp structure which got the value exceeding 74 %. The lowest score was obtained by two parameters namely use of valley (27%) and vegetation of the river bed (36%). The river gained an average total score of 51.3 points which indicates that it can be classified as a river belonging to class IV. It means that the river is in a poor state and a variety of action should be taken in order to improve its morphological state to the year 2015.

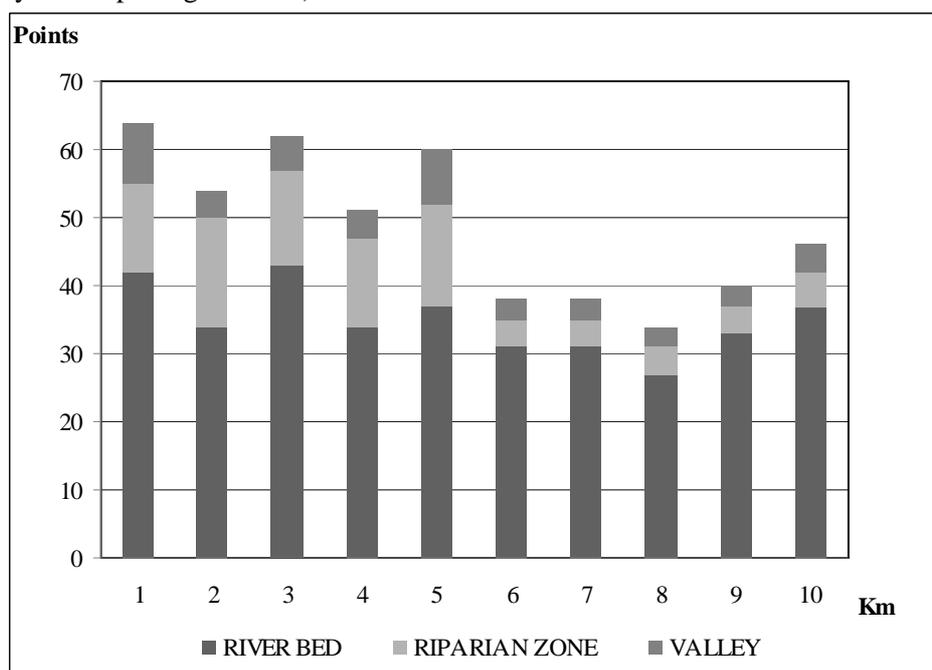
Figure 3. Changeability of hydrological quality assessment in individual zones of the Miedzianka River from 0th km to 10th km

The analysis of the results obtained for individual zone indicates that the Miedzianka river in the river bed zone gained an average assessment of 35 points (max assessment 70 points). The lowest value was attributed to the river course in 8th kilometer which was 27 points whereas the highest one was noted in 3rd kilometer and 1st one. Among six assessed attributes in the zone of river bed, the river continuity was rated as the lowest one (average 1,9 points/max 25 points) while vegetation of the river bed was noted as the highest one (average 13 points/ max 25 poits).

In the riparian river zone, the river scored 9,1 points (max assessment: 20 points). Among the three attributes in the evaluated riparian zone, geometry got the lowest score (average 1,4 points/ max 5 points) whereas vegetation the highest one (average 5,5 points / max 5 points). However, the Miedzianka river in the valley zone noted an average value of 4,6 points at the maximum value of 15 points. Both the anthropogenic transformations (average 1,3 points/ max 5 points) and the use of the valley (average 3 points/ max 10 points) did not exceed 30 % of the maximum value [Adynkiewicz-Piragas, Błachuta 2009].

In the case of discussed watercourse, none of the parameters exceeded 55 % of the points possible to score. Only three parameters (geometry of the river

bed, riverbed substrate and vegetation of river bed) exceeded values of 50 %. These results implicate that in case of the river, many elements must be improved by taking action of renaturalisation so that the watercourse will have gained a good hydromorphological assessment by 2015. The river received an average total score of 48,3 points which classifies the river to class IV (poor hydromorphological state).

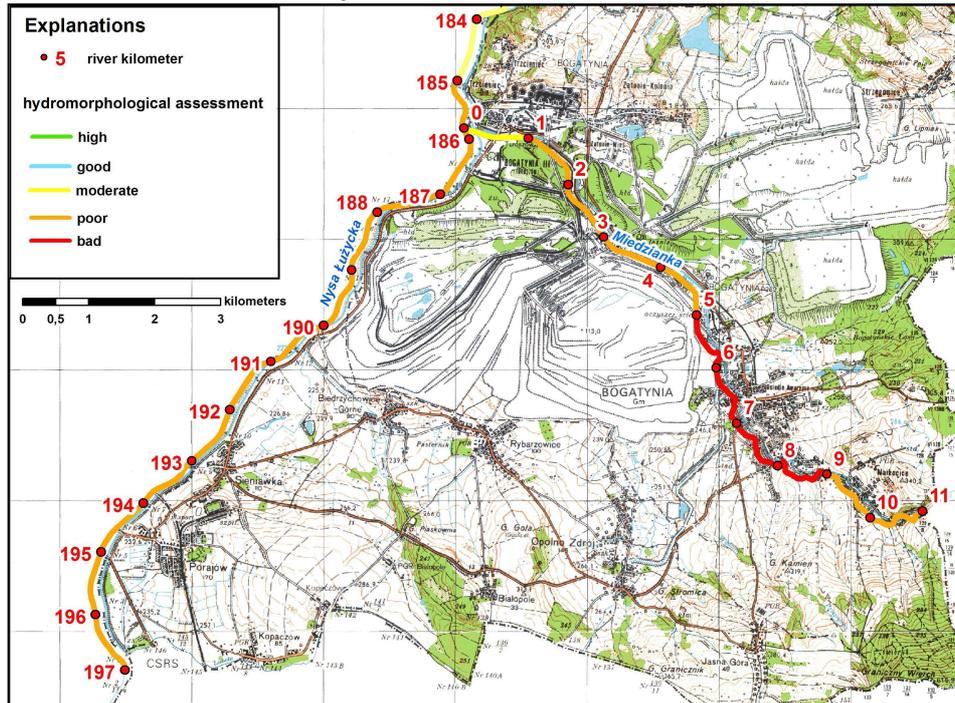
Figure 4. Visualization of the outcomes of hydrological assessment of the Lusatian Neisse River and Miedzianka River

The results of visualisation of hydromorphological assessment of both of assessed rivers are illustrated in Figure 4. As it has already been mentioned, the Lusatian Neisse river scored the total average evaluation of 51,3 points which categorizes the river to class IV. What is more, all river courses received low number of points. Thus, they are in poor condition. Such a low assessment of watercourse derives both from the nature of the watercourse as well as the specific localization of the discussed river course. It is a border river between Poland and Germany. Therefore, it is a sort of water course which is regulated in a way which prevents the river from 'moving' (e.g. through the creation of meanders among riparian forests which would be the characteristic of the water course if it had not been regulated by man in the past). Additionally, the

The Miedzianka river received an average total score namely 48,3 points which classifies the river to class IV. This means that the river is in a poor state and all possible measures should be taken in order to improve its hydromorphological state by 2015. The highest number of points was given to the river course in the 1st kilometer in the mouth. It is a class III which consequently can be categorized as a moderate state. Other river courses from 2nd km to 5th km and 10th km were labeled as class IV- poor state as well as four river courses from 6th km to 9th km where the river flows through the region of Bogatynia. The changes of classes of the researched river course are given in Figure 4. Such a low assessment is due to the fact that the river course is subject to significant anthropogenic impact. What is more, the whole river course is at urban-rural area on Polish territory or areas afflicted by mine activity which implies a low assessment of the river course. It is essential that in a river bed zone, the river bed was previously concreted and it has improved as a result

of a deposition of a sandy and rocky material from the upper watercourse. Therefore, it is possible to develop aquatic, waterside and bank side vegetation at the bottom of the watercourse. A much worse situation was observed in the case of the other two zones. The fact that the Miedzianka river is closed in retraining walls and lacks of riparian zone (houses, gardens, pavements or streets are near the watercourse) has a direct impact on its poor assessment in the urban-rural area of Bogatynia and Markosice.

discussed river course is adjacent to the brown coal open mine at Turoszów and the way extending through the entire length of the discussed river course. It also forces taking up action such as: building an anti-filtration screen in the valley of the river course or flood embankments along the right bank of the Lusatian Neisse river located in a very short distance from the river course.
