CONCEPT AND ITS IMPLEMENTATION DURING THE RECONSTRUCTION OF THE CHURCH OF BLESSED VIRGIN MARY IN CHOJNA

Maciej PŁOTKOWIAK¹

West Pomeranian University of Technology,
Construction and Architecture Department, Szczecin, Poland

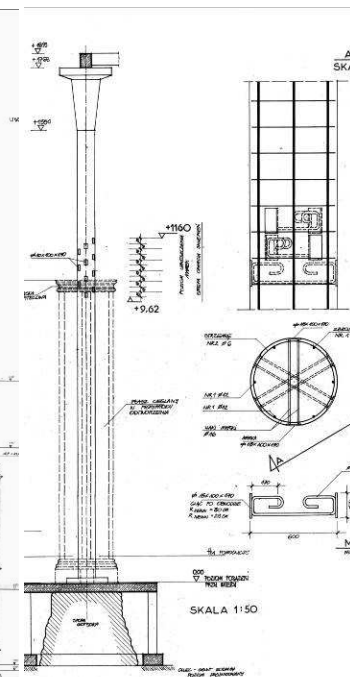
Fig. 4. The draft of the first stage from 1994; new between-nave pillar

¹³ supports height $h = 17.65\text{m}$ at shaft diameter of $\phi=0.60\text{m}$

The construction of the foundation of the new between-nave pillars was designed incorporating terms of preserving medieval footings. On footings, made of wall, one supported base plate of the new pillar resting on the ground

via 4 pillars resting on a new wall footing. Installation of foundation and new foundation pillars were designed using reinforced concrete structure.

Further was built a new, cylindrical between-nave supports and layout of collars on the walls crown.

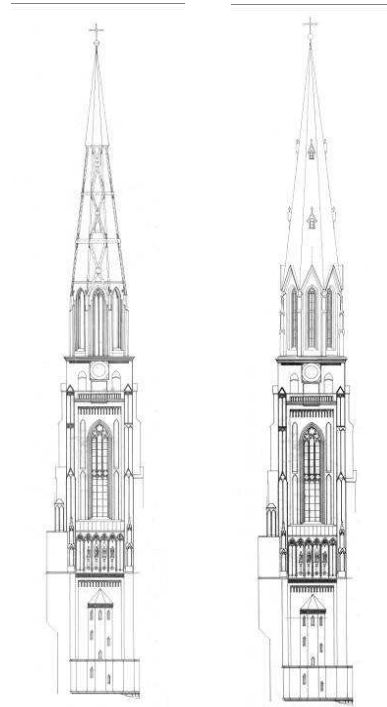
Fig. 8. Project of 1999 and 2001 of stage II of reconstruction; north elevation tower

Following an inspection of scaffolding and laboratory studies of samples of building materials technical condition of rectangular lower part of the tower was considered good. However, the state of the upper octagonal section was defined as an emergency with the imminent hazard of the building catastrophe. Its wall construction remained flawed by nature, furthermore weakened as a result of demolition, heavily cracked, and mortar exhibited a low endurance. In the initial phase of developing the concept of ruins security of the tower, one seriously took into account the need to demolish the whole upper part of the tower¹⁷.

- stage IIa: was to safeguard endangered parts by using the system in a form of the outer shell of the rod construction in reinforced concrete structure,
- stage IIb: was to hide security system under a layer of the copula cover.

The task of the new protection structure was the consolidation of cracked walls, taking the spire bending forces under the influence of horizontal forces and preventing resonance phenomena. Its support was provided on the lower, rectangular part of its body using the reinforced concrete slabs resting on the ceiling placed above the floor clock during protecting works in the years 1932-1933.

On them, one planned anchoring a wooden structure and surface shuttering. The tower received a total height of 98.0m and a spectacular appearance of sheet metal coping installed on a structure with tight-fitting security system of upper octagonal part of the block.

In 2001 one prepared the documentation for the execution of the stage IIb¹⁹. The scope of the proposed treatments included: introduction in the interior of the tower-roofs systems and stairs connecting them and making coverage of copper sheet on forms with the introduction of design elements referring to the original artistic detail of neo-Gothic tower.
