Case study

# CONSERVATION OF THE 'PIAST' CINEMA IN SŁUBICE: AN ARCHITECTURAL, URBAN OR MORAL PROBLEM?

Wojciech ECKERT<sup>1</sup>
University of Zielona Gora, Zielona Góra, Poland

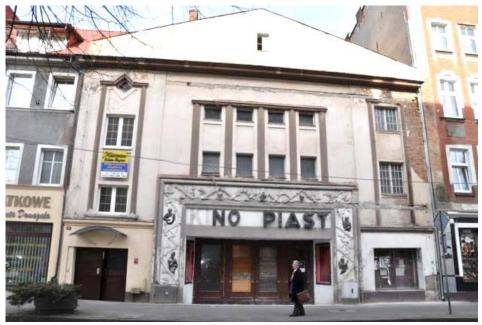
Fig. 3. Słubice, Nos. 9-10 Jedności Robotniczej street. Façade of the 'Piast' Cinema.

The façade of the former cinema building is distinguished by rich architectural and sculptural decoration in the art deco style. It is symmetrical and consists of three parts, with the main entrance located in the central part, recessed from the plane of the side parts and consisting of four glass doors. The entrance is bordered by a broad concrete frame embellished with a stylized floral relief, including four masked figures seen from the waist-up, all of which creates a rhythmic composition. '1924' is also inscribed in the upper part of the border. Above the main entrance are four small windows in two rows, separated by vertically-profiled frames and finished at the top with a simple beam. In the extreme axes, at ground level, there are doors on the south side and a glass 'cage' on the north side. Above these, on the second floor, are individual windows. These were installed in common frames with profiled columns closed at the top with a triangular beam, the shape of which accommodates a diamond-shaped window

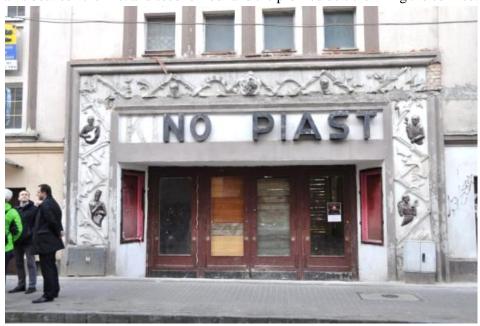
Fig. 4. Słubice, No. 10 Jedności Robotniczej street, main entrance.

During visual inspections conducted on the 6th of March 2013, it was found that fragments of this historic façade had been damaged during the works. As agreed with the Provincial Office for Monuments Conservation, grooves had been forged in the wall under the windows of the first and second floors, to accommodate clamps for propping up with braces. Part of the decorative entry frame and pieces of the frontage had been destroyed. While drilling holes, the upper north corner of the front wall had been damaged, and the unsealed gutters and flashing there had led to a loosening of the plaster and partial destruction of the exposed brickwork. The main entrance from the street had been boarded up, preventing access from the front, while access to the higher floors was still possible via a door at the back of the building. The building was run down inside, due not only
