## **SOBIESKI PALACE IN LUBLIN AFTER THE ASSESSMENT OF THE EXISTING CONDITION. RESTORATION AND MODERNIZATION PROJECT**

The Palace, situated in Bernardyńska Street in Lublin, has a checkered history – it was, among others, mentioned in the vetting in 1661; then it was the Sobieski family's property for about 100 years. In the subsequent periods, its owners changed several times, and the object itself was repeatedly rebuilt. Since 1959, it has been used by the Technical University of Lublin. Because of the alarming state of the palace buildings – after carrying out the necessary research and expertise - a multi-disciplinary restoration and modernisation project has been elaborated, together with the proposition for the EU financed grant from the Operational Program “Development of Eastern Poland”. The paper presents the analysis of the existing state of the palace, and also the modernisation project. The new EU programme “Town Restoration Programme 2014-2020” opens the opportunity to implement this project after the functional correction.

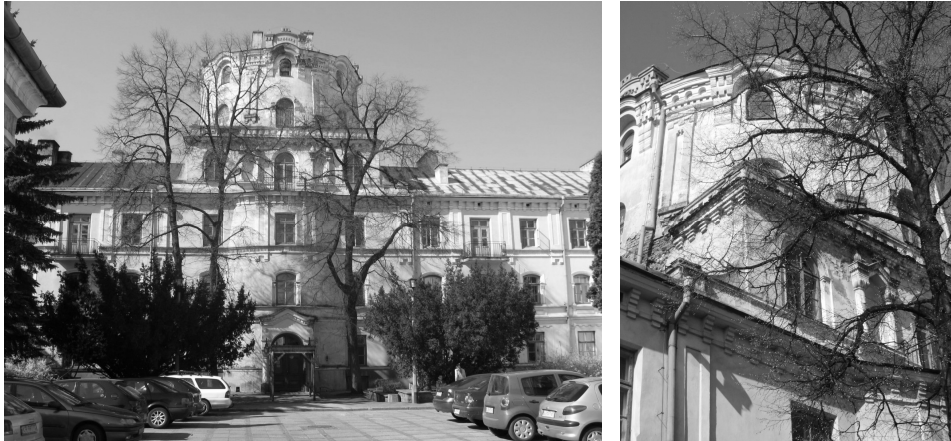
After the restoration works, in 1884, the palace gained its eclectic appearance which preserved till today. The recent elevation works were performed in 1986, since than no repairs have been carried out, hence the condition of the elevation is critical – numerous cracks are visible as well as plaster losses (or its complete lack, as in the case of north elevation), moisture, stains from leaking flashings. The elevation also poses a threat to users due to the fragments of the plaster which break away. Thus, it was necessary to build a

provisional canopy over the entrance protecting against a possible threat. Also, window frames (box windows) and the doors are in bad shape - clear distortions and leakage are visible.

Fig. 1. A general view of the Palace – the current condition (2008). Photo by J. Wrana.

Fig. 2. Close-up of the tower (2008). Photo by J. Wrana.
