## RENOVATION OF LARGE-PANEL BUILDINGS IN CONTEXT OF URBAN RENEWAL

Wiesław LIGEŻA<sup>1</sup>

The Bronisław Markiewicz State Higher School of Technology  
and Economics in Jarosław, Technical Engineering Institute, Poland

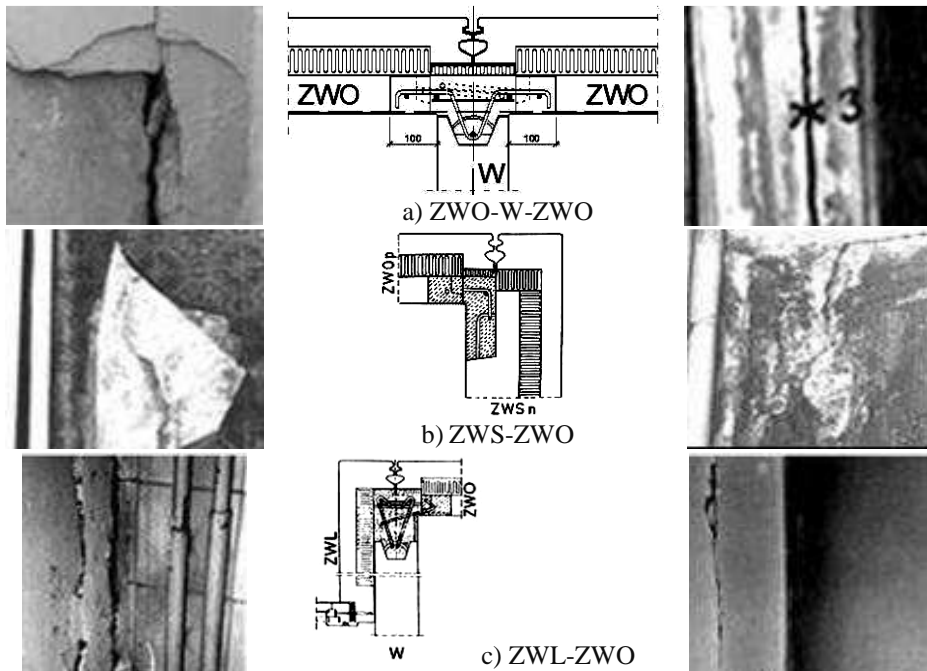
Fig. 5. Examples of cracking due to construction defects in the vertical joint

Cracks in the vertical joints (Fig. 5), as shown in the work [16], do very little to reduce the planned carrying capacity of the load-bearing structure, as curtain walls were not accounted for in structural design calculations. Therefore, if cracks in the joints are of a stable nature and the load bearing construction of the building is intact, adapting the building to construction safety requirements comes down to standard renovation, returning the rooms to their full service potential. This most often involves filling the cracks with mortar or resin and covering them with plaster on a synthetic fiber mesh [8].

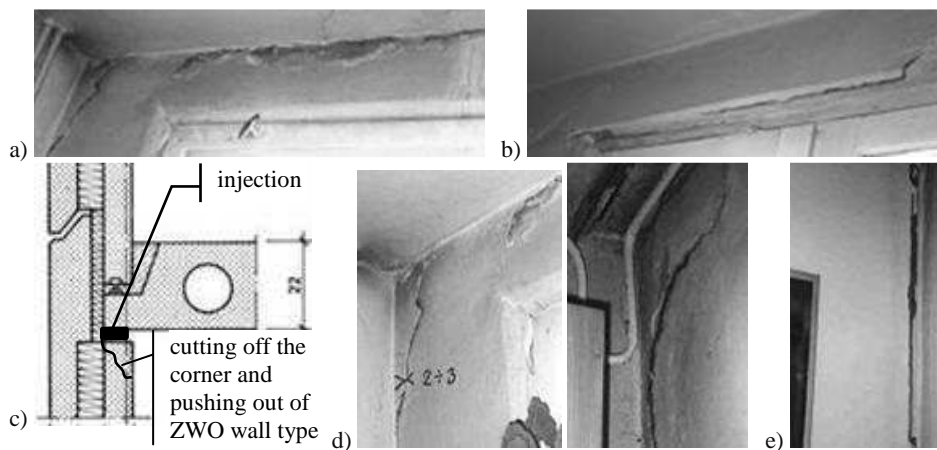
Fig. 6. Examples of damage in horizontal ZWO-S-ZWO wall type joints due to an in-service defect (injection of the gap beneath the floor): a), b), c) cutting off the upper corner of the load-bearing layer of wall and pushing out of ZWO type wall, d) inclination of wall and associated cracking in joints, e) gap with thickness of 5-8 mm between the ZWO type wall and partition wall

When cracks in vertical joints are structural or reveal a tendency to progress (active cracks), or when inclination of the curtain wall has taken place as a result of injecting the expansion gap underneath the ceiling (Fig. 6), it is necessary to remove the source of the cracking and then apply reinforcement in order for the building to meet safety requirements [10, 18]. Reinforcements should be made from the outside (from scaffolding) and should not infringe on

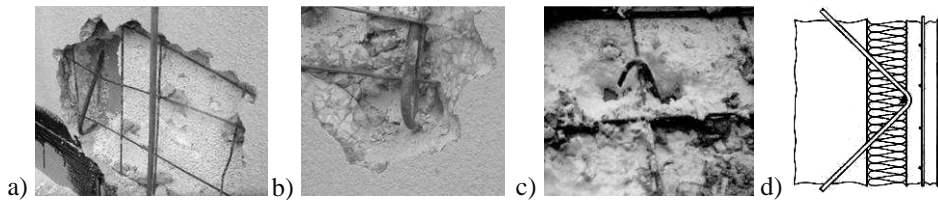
Fig. 7. Examples of faulty assembly of triangular hangers: a) photo by [26], b) photo by [In-westbud], c) photo by [J. Dębowski], d) lack of hanger within the texture layer

Defects in connecting (hooks, pins) the vapor-control layer with the load-bearing layer of prefabricated ZWS and ZWO wall panels (Fig. 7, Fig. 8) and cracks in the vapor-control layer (Fig. 9) are not connected with damage (cracking) in the joints and do not pose a safety threat to the load-bearing construction of the building. However, they do pose a potential safety threat to its use as a result of the possibility of destruction occurring in the vapor-control layer and, in extreme cases, its separation (Fig. 12). The safety threat to the

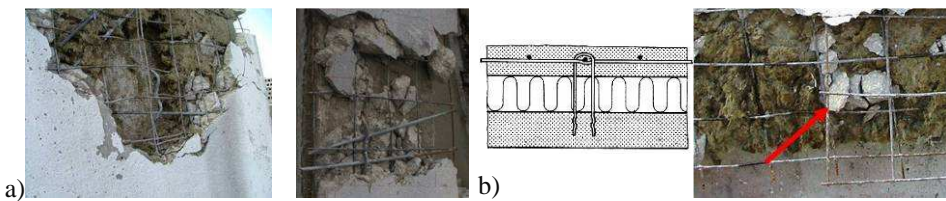
Fig. 8. Examples of faulty assembly of: a) two-humped hangers [photo by Inwestbud], b) pins in concrete slab with texture layer facing down [photo by Inwestbud]

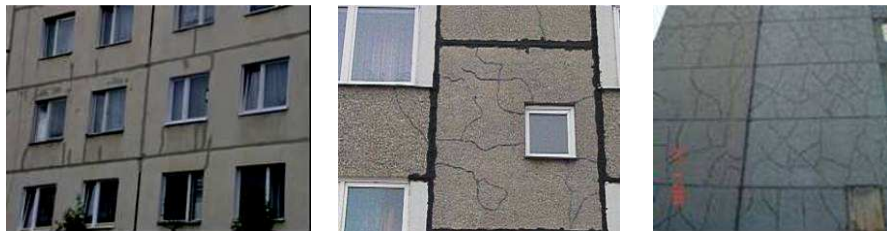
Fig. 9. Examples of characteristic crack patterns in texture layer

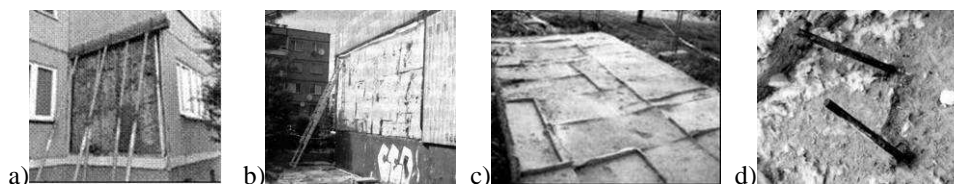
Fig. 12. Effects of the "hidden" construction defects in the joining of the layers: a), b) view of ZWS type walls after separation of texture layer [21, 26], c) view of inside surface of separated texture layer following the removal of mineral wool insulation [21], d) broken bars of hanger anchored within the texture layer [21]

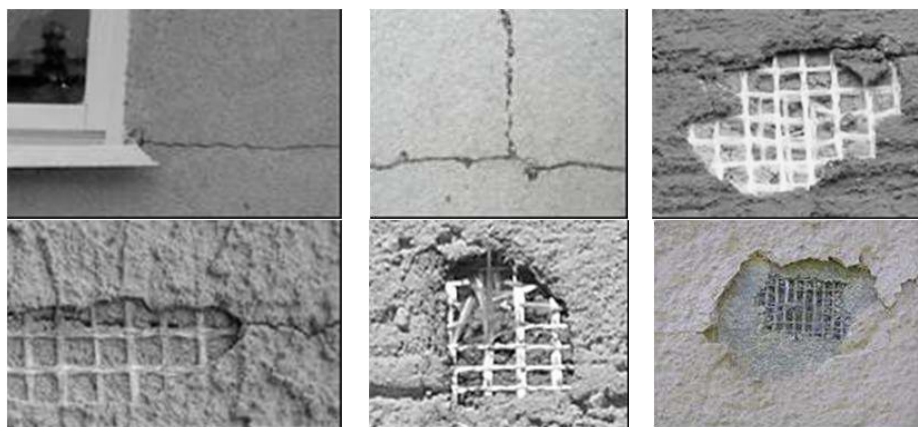
The author's own studies as well as findings reported in literature unfortunately indicate there to be numerous cases of the quick destruction of heating insulation caused by not adhering to the technical and technological conditions of carrying out insulation work. The result of construction defects, described among others in chapter 6 of this the work [15], is damage to the elevation of the building which occurs as soon as after a few years: cracking and destruction of the plaster coating and reinforced adhesive layer (Fig. 14), progression of biological corrosion and sporadically occurring separation of entire heat insulation (Fig. 15).

Fig. 14. Cracks and destruction of plaster and glue reinforced layer

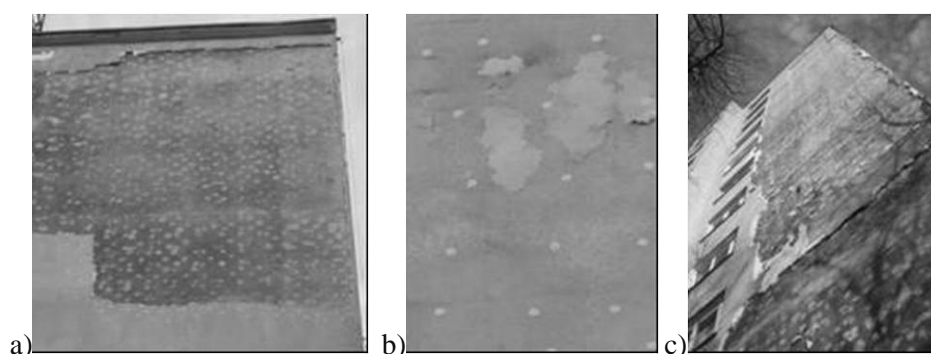
Fig. 15. Effects of faulty insulation of two 11-storey buildings - view following the separation of the insulation layer: a) at the level of the top three floors, b) secondary dowelling of the remaining insulation, c) along the entire height of the building
