ANALYSIS OF THE IMPACT OF MOISTURE AND BIODETERIORATION ON THE ASSESSMENT OF THE TECHNICAL CONDITION OF HISTORICAL BUILDINGS

This paper deals with issues related to the diagnosis of dampness and mycological tests in historic buildings. The selection of appropriate diagnostic procedures in the case of historic buildings undergoing modernisation, revitalisation or renovation is an important element of properly conducted works aimed at the preservation of cultural heritage. The article presents the issues of biodeterioration, and the scope of procedures for carrying out expert assessments of historic buildings, with emphasis on the issue of mycological testing. In conclusion, the article states that due to dynamic degradation processes caused by biological corrosion, mycological examinations of buildings containing wooden structures should be obligatory in the building law. It was pointed out that economics repeatedly determines the depth of research and thus the reliability of the analysis results obtained.

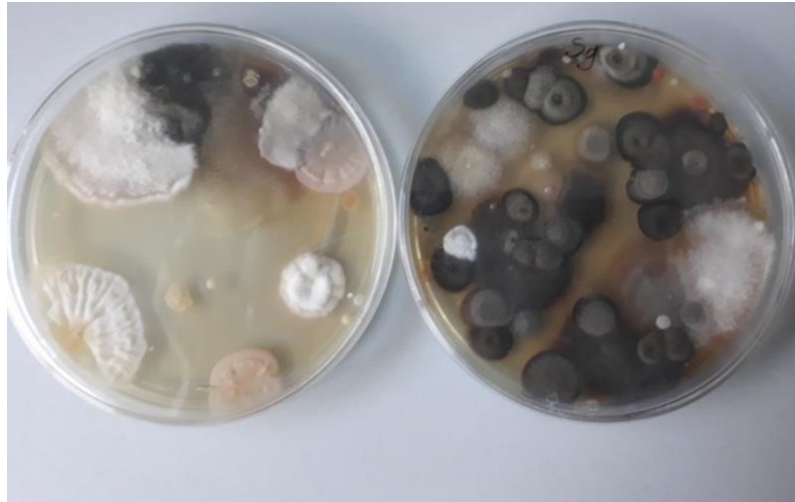
Fig. 3. View of moulds grown from swab samples author archive

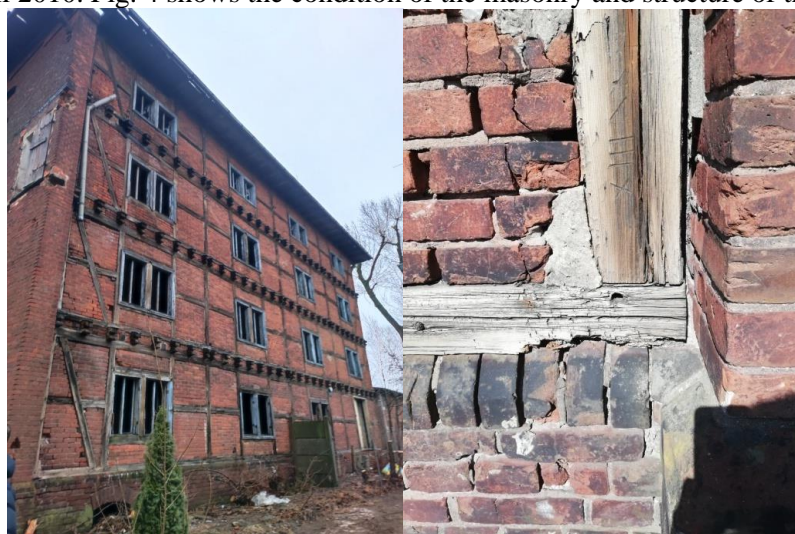
Fig. 4. Elevation of the retrofitted building, condition of the masonry samples author archive

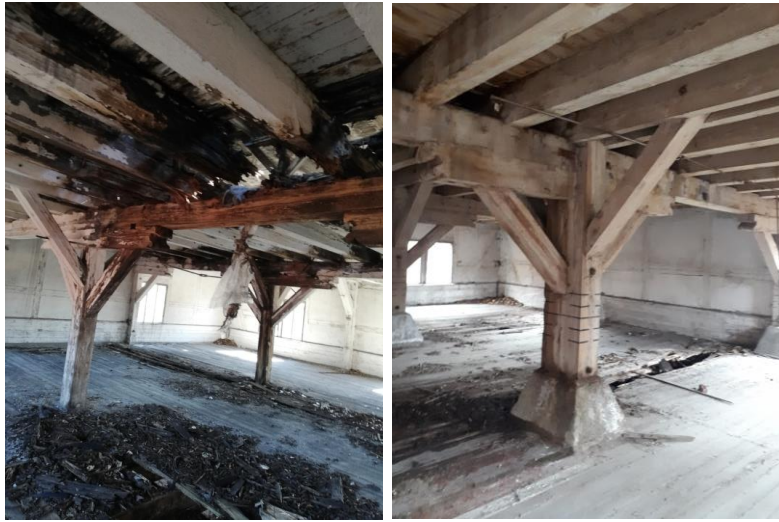
Dampness was observed over a long period of exposure, there are clear degraded elements on the roof truss elements in the roof slope section in the nave and on the lower floors of the building in the nave and along the slope line. Traces of fire are visible in the outer nave on the third storey (fig. 5).

Fig. 5. Structural elements damaged by fire, uncontaminated section of building structure author archive

In samples 2,5,7,10 *Serpula lacrymans* was found and in samples 1,3,5,6,8,9 spores of the fungus *Gloeophyllum sepiarium* were present. In the literature, the authors of this work show that regardless of the level of colonisation achieved with the fungal species found, the wood is vulnerable to decay. The fungus *Serpula lacrymans* is included in the first group of construction fungi - the most damaging, causing strong and rapid wood decay. The dry weight loss of wood after 6 months can be 50% and the compressive strength decreases to 3% of that of healthy wood during this time. The level of risk of wood degradation depends mainly on its moisture content. In wood with a moisture content below 18%, the listed fungi will be in a state of anabiosis. At higher moisture contents, the lacewood structures present in the wood will form mycelium with a high capacity to destroy this material. The survey allows us to conclude that the building is in an unsatisfactory technical condition from the point of view of building mycology and currently requires repair work. It is recommended to dismantle the half-timbered structure

and get rid of contaminated elements (foundations, damaged pillars), as it is not possible to maintain the moisture regime in the case of elements exposed to environmental loads. In addition, macroscopic examination of the roof truss revealed damage to the structure of the element and thus a marked decrease in the strength of the element, and thus the roof truss with numerous elements in a state of degradation should be reconstructed with new material. No destructive fungi were found in the ceiling and column samples taken from the third floor.

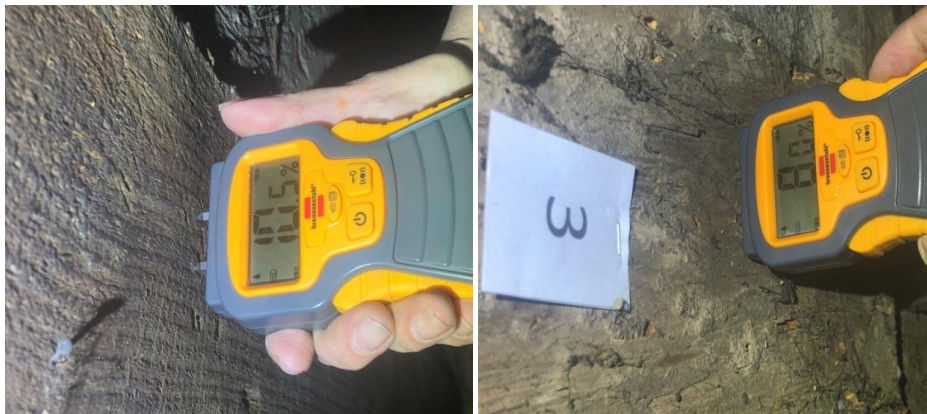
Fig.6. Measurements of moisture content of construction elements selected for mycological tests author archive

The location of the measurement points is marked on the floor drawings of each storey. The moisture content of the selected elements (visually selected representative locations for the analysis) was as follows: 8-10,5%.

According to the given criteria, the tested elements in the most sensitive places showed a condition bordering on dry/humid. The internal temperature was not measured during the site visit, as this would

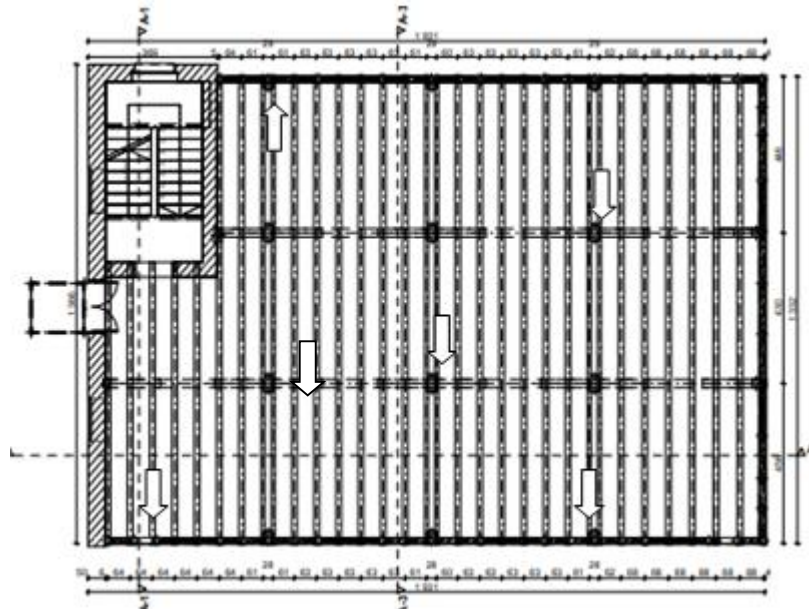
Fig.8. Example of mapping of selected areas of mycological analysis and moisture surveys carried out, ground floor plan

The wood from the ceiling and columns of the lower storeys may be safely used provided that a moisture regime is maintained during the renovation of the building, i.e. the wooden elements, especially those in which the most destructive fungi have been found, must be protected against additional moisture during the renovation and continuously monitored, and during use against the occurrence of additional condensation
