RENOVATION AND MODERNISATION OF A POSTINDUSTRIAL FACILITY IN POZNAŃ

Tomasz BŁASZCZYŃSKI*, Przemysław WIELENTEJCZYK,
Maciej BŁASZCZYŃSKI, Filip PIJANOWSKI
Institute of Building Structures, Poznań University of Technology

The paper presents a renovation process of a historic postindustrial building situated on premises of Gazownia Poznańska. An unprepared team of designers made a lot of mistakes and negligences, which led to additional work, repairs including. The increased scope of work also led to a substantial increase in the cost of the carried out renovations. The modernisation process was realised with the use of modern technologies, some of which for the first time in Poznan.

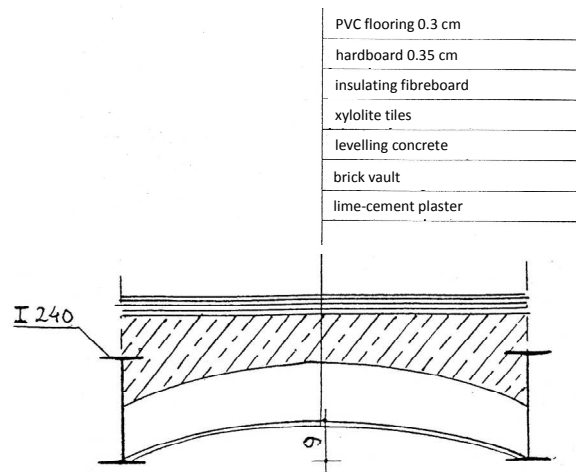
Fig. 7. A cross-section through the existing floor

Floors consist of brick vaults on beams made of I240 steel. The average beam spacing is 0.94 m. The ceramic arch was 12 cm thick, and their bending arrow amounted from 9 to 10 cm. The steel beams are supported on external longitudinal walls of the building and on a steel suspension placed at half-width. The span of the floors is about 9.68 m measured from wall to wall. Beams in both spans are assumed as freely supported. The central joist is produced with two I360. It is supported on indirect columns spaced 4.70m, and rests on the gable walls of the building. The cross section of the steel column is of a circular pipe shape, and consists of four identical profiles connected with rivets (fig. 8). The geometrical characteristics of the sections are taken from [10]. According to the tables presented in the book, profile No. 5 was used on the second floor, profile No. 7 ½ was used on the first floor, and on the ground floor and in the cellar – profile 12 ½. Brick arched and steel lintels were used and produced on the basis of 2 I200, with approximately 15 cm spacing. The wooden gable roof of the building was covered with roofing felt on roof sheathing. A longitudinal

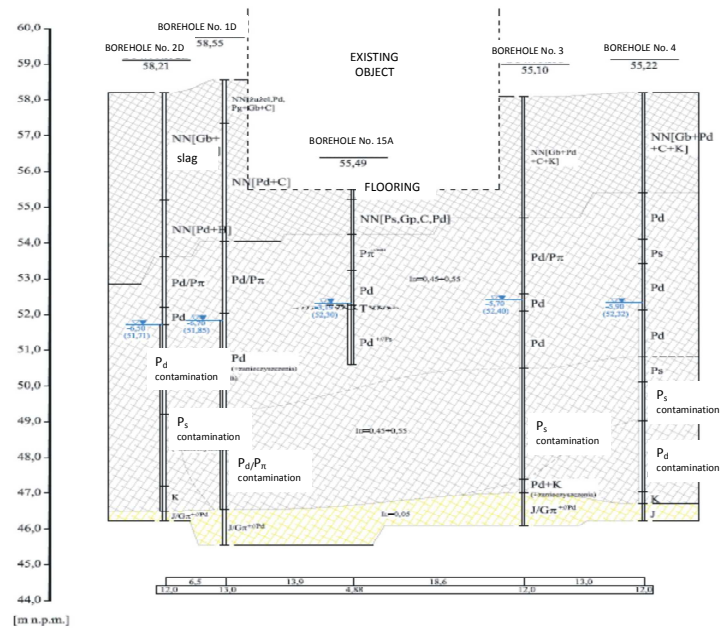
Fig. 9. Geotechnical cross-section under the existing Dressing Room and Bath (Szatnia-Łaźnia)

The analysis (fig. 9) allows statement that the geological structure in the area of Szatnia-Łaźnia (dressing room-bath) building is simple. Under a layer of

embankments useless for construction purposes, which are 5.0 m thick, there is a layer of alluvial sands (fine and medium sands with a layer of stones at the bottom). Below ordinate 46 ÷ 47 m above mean sea level, there is a continuous layer of Poznań Formation loams. Due to this, the geotechnical parameters should be evaluated as complex for the occurrence of a layer of embankments of various degree of compaction, from loose to compacted ($i_d = 0,35 \div 0,60$). Within the area of embankments, at the depth of 4 m below the ground level, there are large chunks of rubble and concrete, which posed a substantial hindrances during the geotechnical site tests. Additionally, former coal stores with deep technological rooms, which are the remaining of the former wagon discharger, were found in this area (fig.6). Also, the area was found to be polluted with specific substances (organoleptic test indicated the presence of oil and phenol) at the depth of 6,5 to 12,0 m. It was also found the maximum level of underground water reaches the building foundations, whereas its minimum level is about two meters lower. Additionally, it was found that the ground water did not reveal any leaching, acid, carbonate, magnesium or sulphate aggression to concrete, but it revealed medium ammonium aggression.

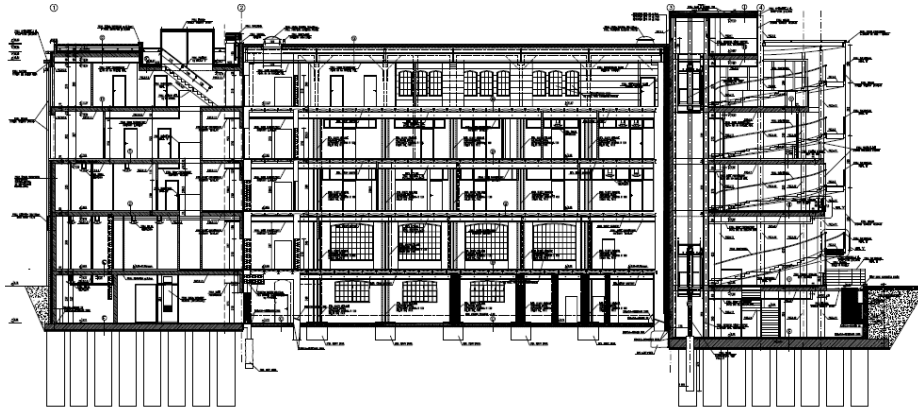
The carried out analysis of the load bearing capacity of the soil under the foundations of Dressing Room -Bath building, the exterior walls including, showed that it is fully or almost fully exploited. Thus, it was not possible to

build the newly designed parts of the building directly on the existing foundations, according to the performed technical design, without causing substantial damages to the existing building of the dressing room – bath. Because of the above, it was necessary to design the way in which loads exerted on the subsoil by the newly designed parts would be transmitted into its deeper layers, to prevent the cumulation of the values of stresses resulting from loads exerted by the existing building (Dressing room – Bath) and the newly designed parts from exceeding the load bearing capacity of the given subsoil layer. In order to ensure it, an indirect foundation was applied to the newly designed parts of the building which would base on jet grouted columns (*Solcrete T*), as the safest and the most efficient solution (fig. 13).

Fig. 13. Distribution of jet grouting piles under part A and B (cross section)

Due to the fact that the subsoil was polluted with oil and phenols at the depths ranging from 6.5m to 12.0 m, it was necessary to consider this fact while producing the *Solcrete* columns, which was realised by assuming the piles to be made of cement CEM I and by using three-stage technology to stiffen the contaminated subsoil.

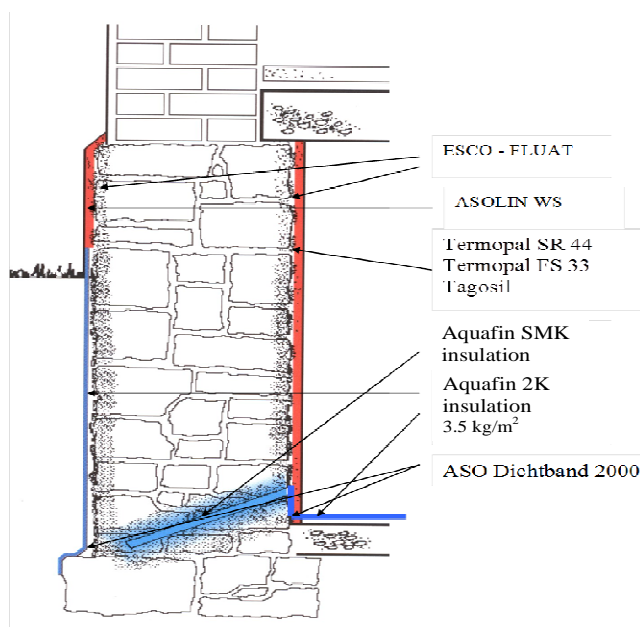
Fig. 14. Schematic waterproofing system in the existing part

In order to produce tight waterproofing barriers in the existing building, a technology applying horizontal injection siloxane was used and a system of internal and partly external polymer-cement coatings, which simultaneously produced a load bearing layer of the floor on the existing embankments. Before producing the internal coatings, the walls were injected and after the coatings were produced the walls were plastered with an intelligent renovation plaster. Outside, above the ground level, the walls were additionally hydrophobized (fig. 14).

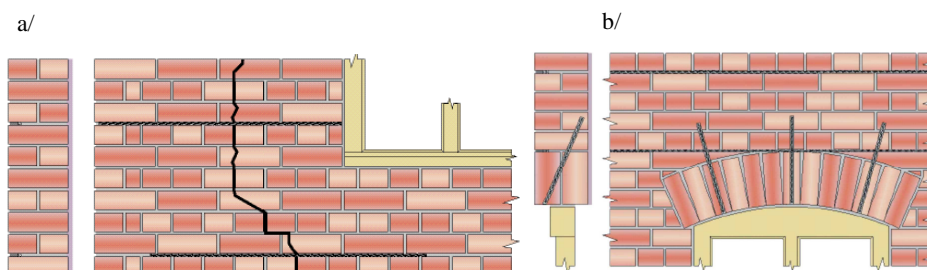
Fig. 15. Repair system applied to the exterior walls
a / walls themselves, b / lintels

Bearing in mind the historic value of the building elevations, the repairs of the cracks on the exterior structural walls were performed basing in the innovatory repairing system PCC connected to system HELIFIX. Connectors, anchors and reinforcing rods, which form the basis of the solutions, are produced from austenitic stainless steel using a unique spiral design Hi-Fin (fig. 15).

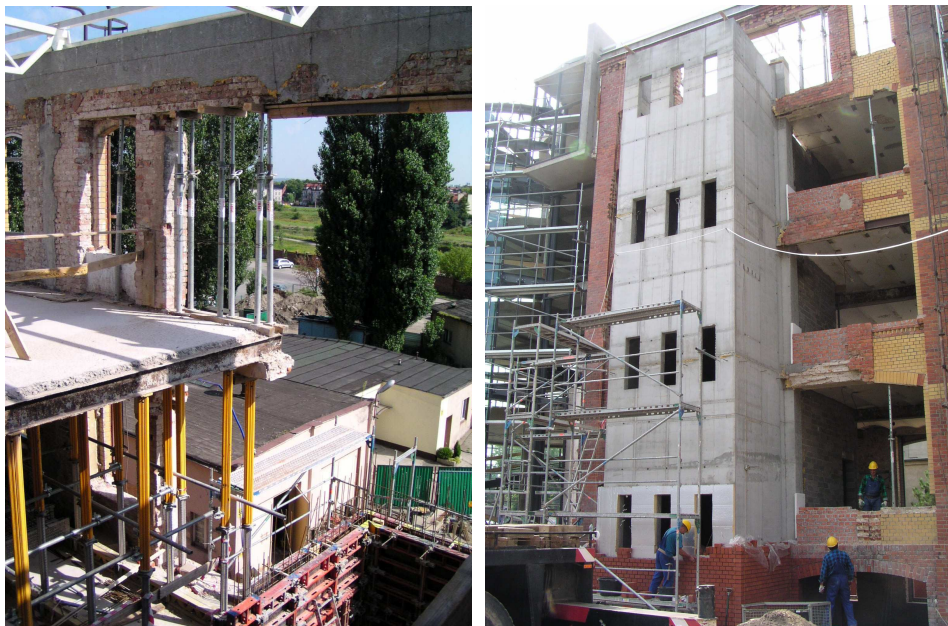
Due to the poor technical condition and safety risks of the back staircase (fig. 2), it had to be dismantled and reconstructed conforming to all the requirements of the building conservation officer (fig. 16, 17).

Fig. 16, 17. Restoration of the back staircase basing on SCC concrete

In order to connect it rigidly to the main building, self compacting concrete was used (for the first time in Poznań, or even maybe in Poland). It was

impossible to use a classical kind of concrete due to the poor technical condition of the existing building and the fact that various kinds of steel merged with each other (fig. 16, 17). Self compacting concrete provides tight filling of the boarding yet under its own weight, while maintaining high uniformity even if there is a dense reinforcement [11]. It is a unique product especially useful when vibrators cannot be applied, also in the case of erecting additions or expansion of existing facilities, particularly historic ones, and also when formed and reinforced steel merge with each other. On the basis of the formed superstructure, a three-layer wall was produced with an elevation layer made of specially selected face bricks.
