EXECUTIVE DISADVANTAGES IN THE LAYERED WALL OF THE FACADE

Elżbieta GROCHOWSKA¹, Antoni MATYSIAK²
University of Zielona Gora, Zielona Góra, Poland

Abstract

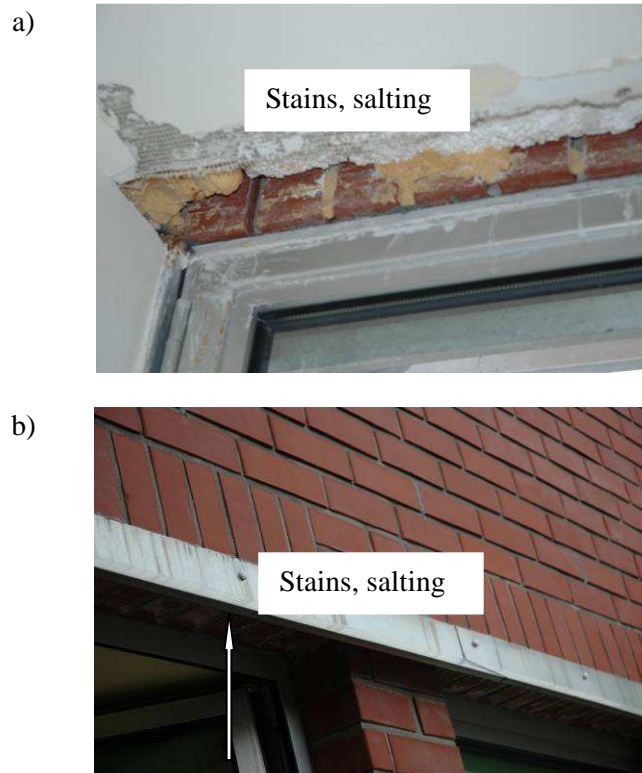
In accordance with the will of the architect (and with a design) windows were made in the construction of metal and mounted (in some walls) in the plane of the face of the external walls. Stains, resulting in the building on one of the windows, were shown in Figure 1 a.

Fig. 1. Setting of window in the three-layer wall; a) view the installed windows from the inside b) the method of attaching aluminium canopies above the windows

Between the window frame and bricks of the protective wall there is no gap comfortable for the setting of windows and then performing the required sealing. This solution is shown in Fig. 1a. It follows that the window frame was a lintel for wall part made above the window. Between flat (smooth) metal and rough, porous brick is no tightness, water penetrates easily. Such a phenomenon

has occurred in many places in the building. In addition, the wall of the facade one did not filled tightly, with a suitable mortar, the space between the clinker bricks, which is also the cause of the leakage.

Proper execution of the designed three-layer wall with windows, arranged in the face of the exterior wall, requires special attention. The user of the object decided on their own to protect the building against leaks and, above the windows, made canopies, of sheet metal, shown in Fig. 1 b. Canopies did not provide adequate protection against the penetration of water, leaks still occurred.

In this situation, this kind of solution (sealing with expansion tape) is no longer possible. The solution to this problem involves financial outlay. The sealing can now be done only on the inside of the building so as not to destroy the existing clinker facade and the vision of the architect, regarding the appearance of the building. This can be done as follows: around window frames one should create drills of respective depth (less than the thickness of the brick) and seal with proper preparations which are resistant to humidity, aging, and are flexible.

In order for building elements not to undergo further destruction, due to penetration of rainwater into the building, it should be, on the inside of the building around window frames, performed the appropriate sealing.

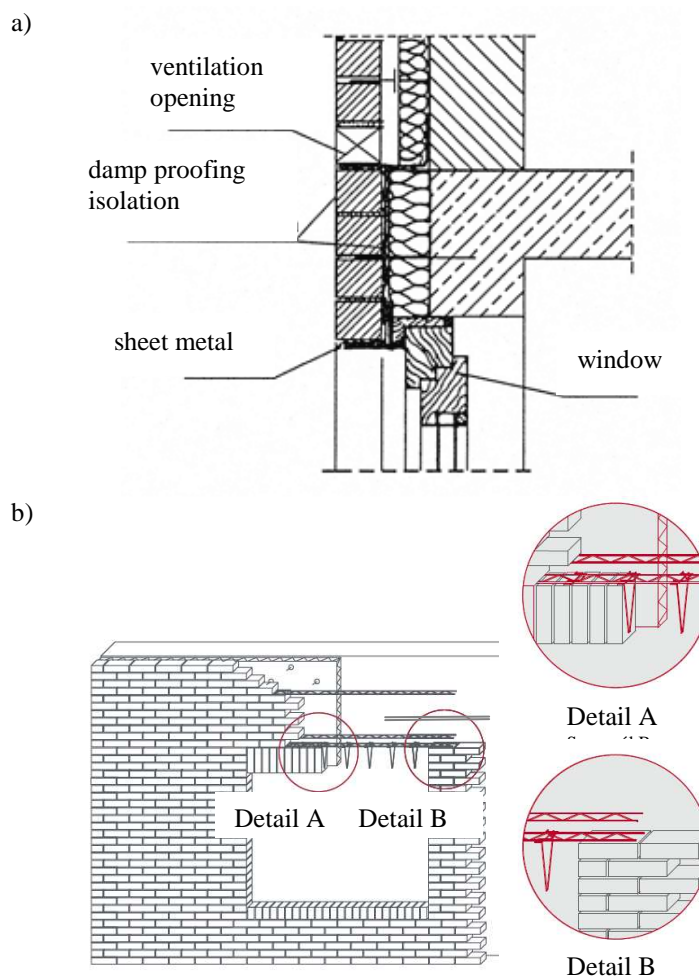
Correct performance of the lintel, embedding windows and sealing gaps (which should be left) between the window and the doorjamb without nib is shown in Fig. 2.

Fig. 2. a) Example of the gap sealing between the aluminium window and doorjamb in three-layer wall by [2]; b) the sample brick lintel in the three-layer wall by [3]
