RENOVATION AND RECONSTRUCTION OF A NEOCLASSICAL BUILDING ON THE EXAMPLE OF A PUBLIC CITY LIBRARY IN NOWA SÓL

Anna KUCHARCZYK¹

University of Zielona Gora, Zielona Góra, Poland

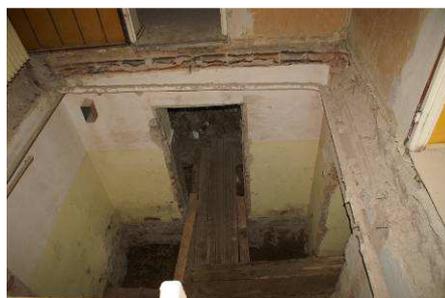
Fig. 3. Removing a part of the old ceiling. Source: MBP archives.

The existing floors were changed to ones of reinforced concrete, 12 cm in thickness, using C12/15 (B15) concrete reinforced with bars Ø8 of A-I steel, spaced 15 cm apart, welded to the middle of the beams, supported by IPE 200 and 180 steel beams for floors characterized by smaller spans.
