RECONSTRUCTION OF WAR DAMAGED BUILDINGS - A PROBLEM THAT STILL STANDS. THE CASE OF THE NATIONAL ECONOMY BANK IN WARSAW RESTORED DURING THE SECOND WORLD WAR

Sławomir ŁOTYSZ¹

Polish Academy of Sciences, Warszawa, Poland

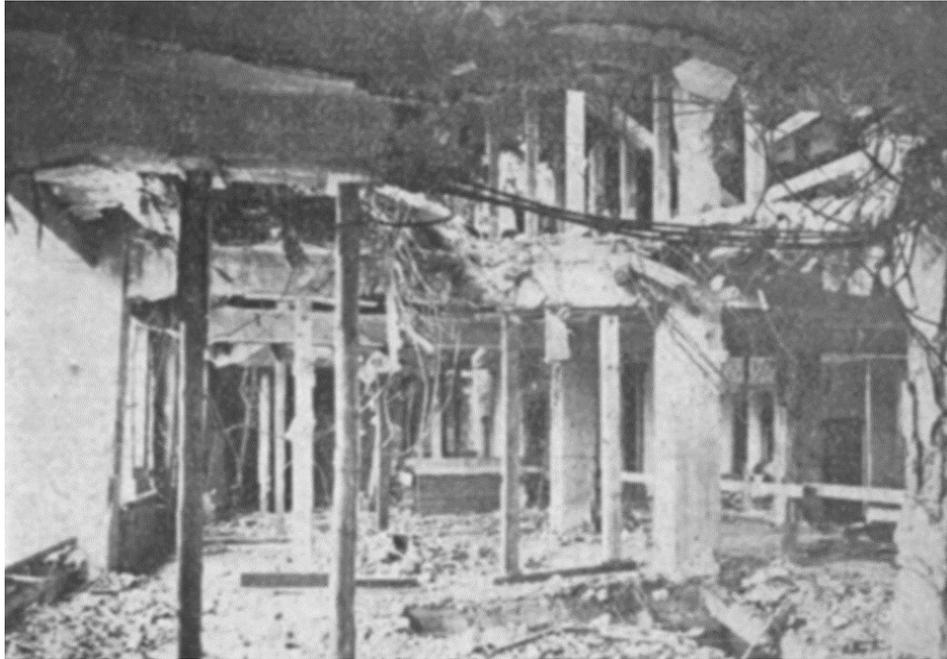
During the inspections of the premises, a reinforced concrete structure constituting 55% of the roof area was found to have been completely destroyed by artillery fire and aerial bombardment. Damage to beams, columns and slabs in

about 10% of the area were so great, that their repair turned out to be uneconomical. In the remaining part, in spite of the scratches and cracks, the structural elements were suitable for repair.

Fig. 4. Damage caused by the German bombing in September 1939. An entire span and part of the floor is missing [4]

It was also observed that the bomb damage had a specific character. The bombs first pierced the roofing slabs, travelling down through the floors and then exploding. At the points of detonation and in their immediate vicinity, the structure was completely collapsed, while elements located radially around the epicentre of the blast were damaged to a lesser extent. As a result of the blast, within the horizontal plane between the floor and ceiling of the level on which the explosions occurred, supporting columns were displaced, resulting in horizontal cracking at their bases and in their heads. The exploding bombs also caused vertical forces between the floors. These lifted the ceiling slabs, bending the main floor beams upwards and cracking them along their bottoms, which had been reinforced for normal operation under compression conditions. Flooring slabs that were lifted with the blast waves were detached from the beams and after the self-collapse of the main floor structure, the beams often remained raised up, their surfaces bulging out. Just how powerful the destructive forces affecting the

construction were, could be seen in the reinforced concrete bars exposed in the beams bent by the blast waves.

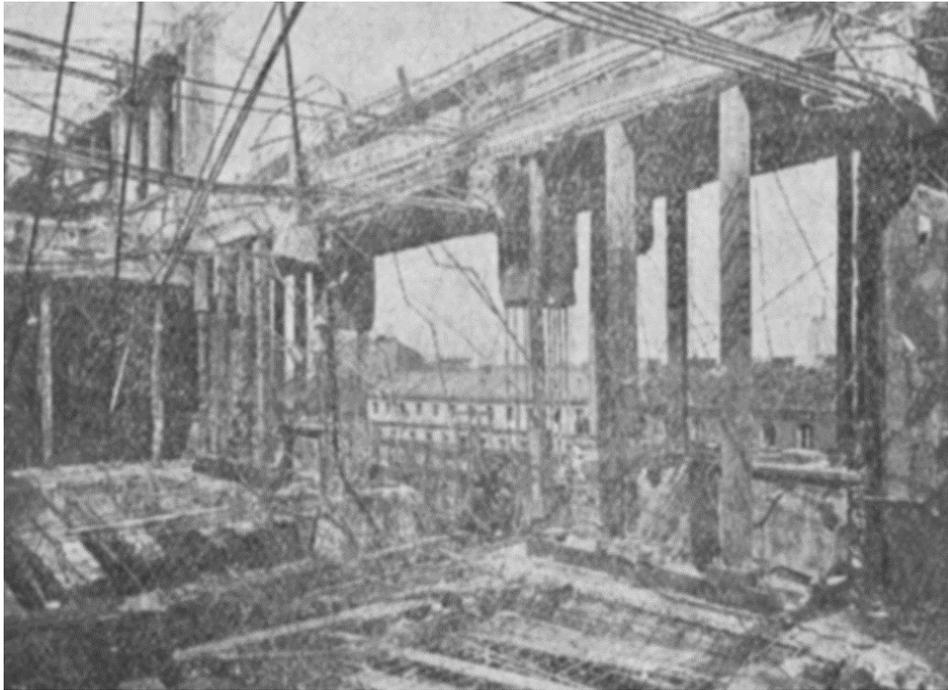
Fig. 5. Damage caused by the German bombing in September 1939. The damaged pillars being removed from the fifth floor [4]

Usually, the bombs would explode on the top two floors, and the stresses carried by the frame structure nodes to the lower floors were not that significant. As a result, the number of elements that needed to be exchanged or repaired decreased on subsequent floors, and the ground floor did not require any work.

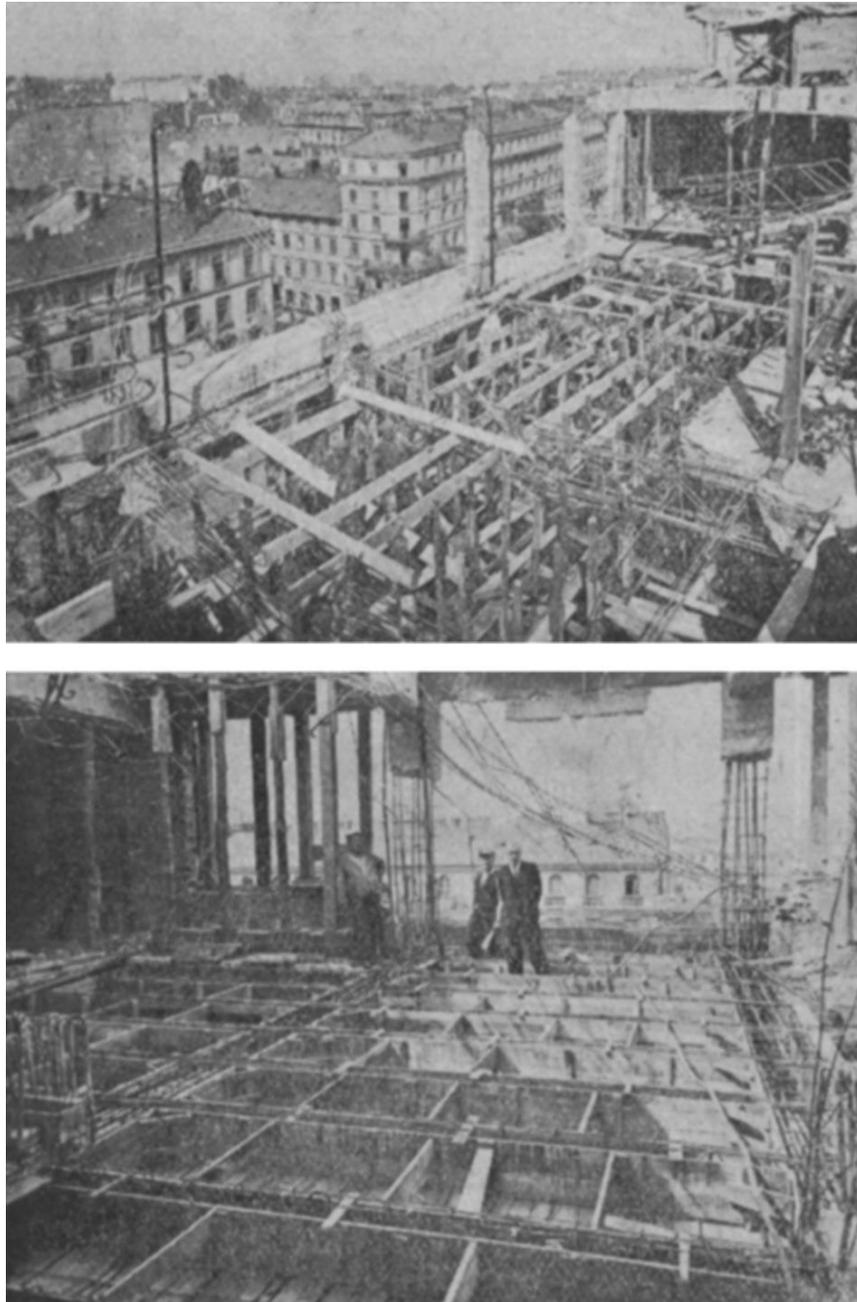
Fig. 6. Top: the roofing, which suffered the most during the bombing, has been entirely replaced. Bottom: the restoration of a less damaged slab on a lower floor [4]

Damaged reinforced concrete elements were removed by hand, using chisels and hammers. Broken rods, anchored at both ends in the old concrete, and those that were excessively elongated were first cut out, then extended by adding new inserts. Each insert overlapped the remaining rod by a length of approx. 40 diameters of replaced rod. Where two or more steel rods had to be repaired in beams and columns, the engineers tried to avoid doing this in one place, instead cutting out the damaged elements at different lengths. When merging old and new rods, which always means weakening an element's durability, the engineers always tried to choose a spot as close to the point where the lowest bending force was calculated as possible.

parts were limited to pumping cement grouting under pressure into the cracks, followed by finishing with cement mortar ” [4].

This method was used in the repair of main floor beams throughout the building and of the least damaged parts of the roof on the Nowy Świat street side. Cement grout was pumped under pressure with few or several atmospheres of pressure by means of a specially-constructed apparatus using compressed air from a cylinder. Cracks to be filled were sealed on the outside with plaster, and then a hole was drilled into them, in which the pipe feeding the grout was inserted. In the case of the largest cracks, the mixture pumped in over several tens of centimetres.
