ANALYSIS OF CHANGES TO STEEL FOOTBRIDGE GEOMETRY WITHIN 25 YEARS IN SERVICE

Jacek SZTUBECKI¹, Adam BUJARKIEWICZ¹, Justyna SOBCZAK-PIĄSTKA¹, Tomasz JANIĄK¹, Jarosław GAJEWSKI¹
University of Technology and Life Sciences in Bydgoszcz, Bydgoszcz, Poland

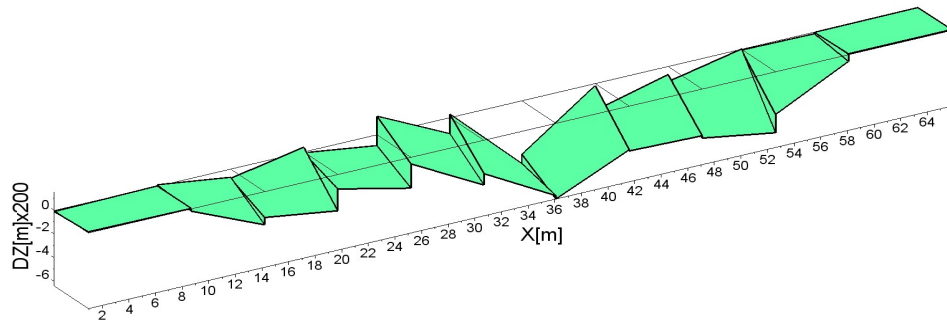
Fig. 2. Graphical representation of differences between the measured ordinates and the theoretical ordinates for measurement 2

Values of ordinate differences for measurement 2 showed that there are divergences relative to the geometry assumed to be theoretical. Therefore, bridge geometry was corrected after this measurement, and a third, control measurement was performed after the correction. Analysis of ordinate differences for measurement 3 shows significant improvement in bridge geometry after its correction. It is notable that the correction of geometry in points with significant divergence from the theoretical geometry negatively affected neighbouring points. However, values of these differences are visibly lower from those from before the correction.

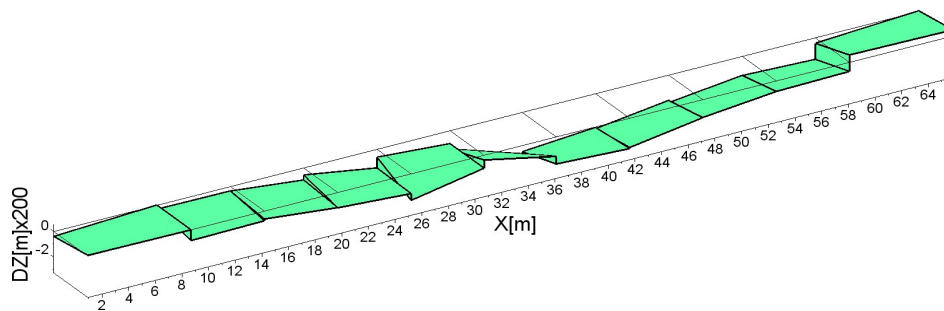
Fig. 4. Graphical representation of the difference between ordinates measured in measurement 3 and 4

Values of the differences obtained are nevertheless half as big again as those during the initial period of service (the years 1979-1992).

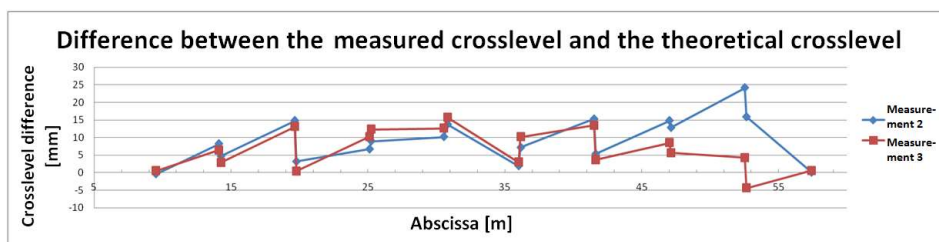
Fig. 6. Difference between the measured crosslevel and the theoretical crosslevel for measurements 2 and 3

Comparison of crosslevels resulting from measurement 2 (before the adjustment) and measurement 3 (after the adjustment) indicates that their change is significant only in the last three segments of the footbridge, at the abutment from the Jagiellońska street side (shown in Figure 6). Changes in crosslevel values along the remaining part of the main span were minor, with similar inclination tendencies being retained.

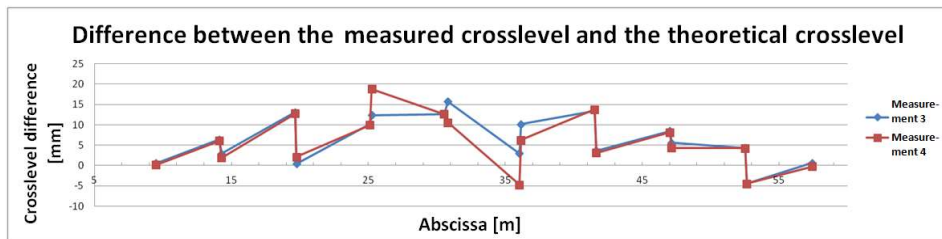
Fig. 7. Difference between the measured crosslevel and the theoretical crosslevel for measurements 3 and 4

On the other hand, the charts for crosslevels shown in Figure 7 show that, in the course of the last 23 years (from the adjustment of 1994 to the next measurements in 2017), significant crosslevel changes occurred only in the three middle segments of the footbridge, whereas other segments actually retained their transverse inclination. Of particular significance is the change in crosslevel on the border of segment 3 and 4 (abscissa of ca. 25 m). This might be evidence of loosened connection between these segments or even of its being damaged.

- ◆ Over the last 23 years in service, a significant change in crosslevels in the area of the middle three segments of the footbridge happened, *inter alia*. It can be assumed that, following the adjustment performed in 1994, cable stays on the right side of the footbridge were weighed down and the ones on the left side – relieved. Consequently, forces leading to inclination of the deck towards the left side began to act upon the deck structure. The twisting of segment 4 (within the range of abscissae of ca. 25 m to ca. 30 m) and huge change of the crosslevel on the boundary between segment 3 and 4 concluded from Figure 7 may be evidence of weakened segment 4 structure and weakening or even damaging of the connection between segments 3 and 4.

- ◆ Second adjustment of the pull of footbridge cable stays is recommended. While doing this, an approach to the design of this adjustment other than the one used in the years 1992-94 has to be implemented. The predicted effect of the adjustment should be achievement of correct geometry of the footbridge gradeline (as opposed to both of its edges) and equalisation of forces in cable stays. Such an adjustment will restore static operation of the footbridge as initially assumed in the design.
- ◆ A technical inspection of the footbridge should be conducted, and special regard should be paid to the structure of segment 4 and the connection between segment 3 and 4.
