## **TECHNICAL ASPECTS OF RENOVATION OF THE 16TH-CENTURY ROOF TRUSS**

Beata NOWOGOŃSKA<sup>1</sup>

University of Zielona Góra, Zielona Góra, Poland

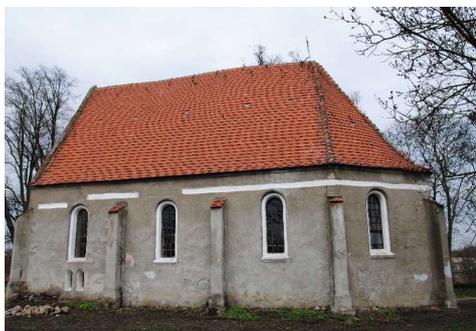
Photo 1. South view. Visible deflection of the ridge, roof slope deformation

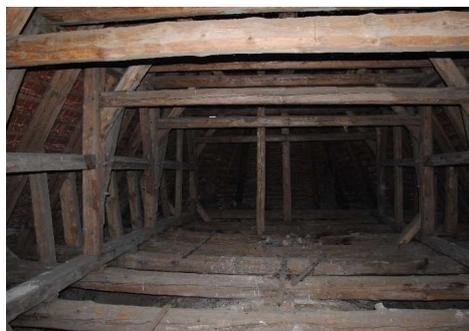
Photo 2. Truss structure with two supporting walls reinforced with dead bolts.

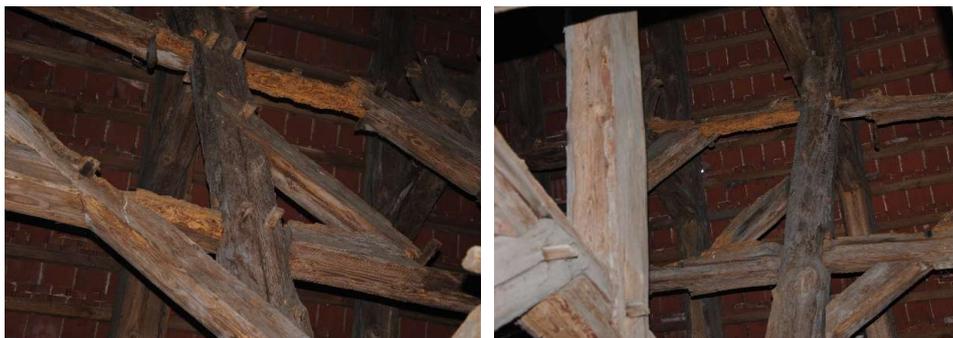
An assessment of the technical condition of the church roof truss was carried out. As a result of the research, it was found that the degree of wear of many elements is within 70% - 80%, and the supporting-dead bolt wall supporting the upper tab is worn 100%. It was found that some of the carpentry joints were split and displaced, numerous traces of secondary reinforcements and repairs are visible.

Photo 3, 4. Corroded supporting-dead bolt wall elements

It is planned to reconstruct the upper part of the roof truss structure, virtually 100% corroded, maintaining the same type of structure and shape. Replacement of elements includes a mullion-transom frame, which is located in the upper part of the roof, along with stiffening struts and rods on the upper level.

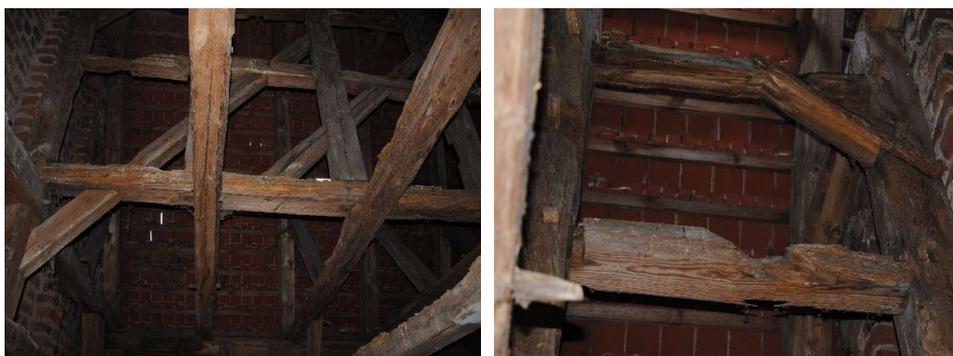
Photo 5. Bent collar beams and dead bolts

Photo 6. Split connections of support and transom wall elements

Measurements of deviations and displacements of the church roof truss structure were made. Deviations from the vertical columns of SL1 - SL7, SP1-SP7, S1, S2A, S3 were measured. Deviations from the vertical of the columns are in the range of 2.0 - 20cm. In addition, the rafter deflections are 20 cm in places, the deflections of the collar beams and dead bolts reach 25 cm.

Strengthening of damaged upper and lower purlins, collar beams, and dead bolts has been designed by using double-sided C30 wood seasonings with cross-sections supplementing the amount of hewn wood 6cm x 19cm (or 20cm). The beams will be joined together using M16 threaded rods, class 5.8. Between the purlin (beam, transom) on the non-corrosive section and the reinforcements, in the place of the bolted connection, double-sided stud plates should be used [5]. Corroded truss nodes in the support zone should be replaced. Before starting the work, it will be necessary to apply the concentration transferring the load from the reinforced truss to the outer wall of the church. The bracing will be in the form of struts located in the plane of the roof slope.

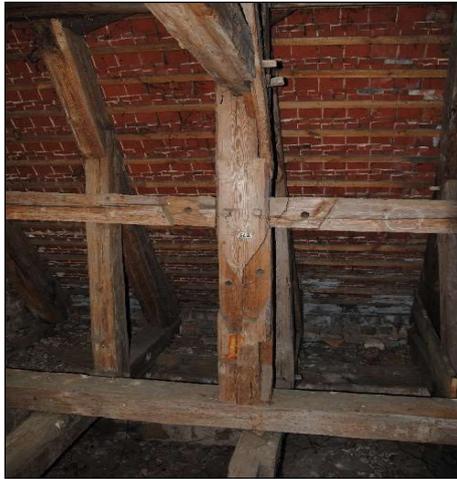
Photo 7. Places after removed struts.

Fill in the missing swords with 17 x 20cm wooden elements, and the missing S2B pole in the truss W6.1. A combination of elements for the overlay with narrowing was designed, adapting it to the existing cut-outs in the support and purlins [5]. Seasoned C30 grade wood, protected against biological corrosion and fire, by means of vacuum-pressure deep impregnation or hot-cold baths will be used for all newly introduced wooden elements.

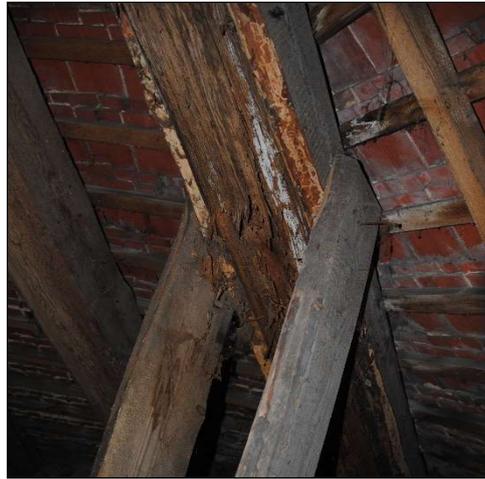
Photo 8. Corroded rafter secondary reinforced with counter battens

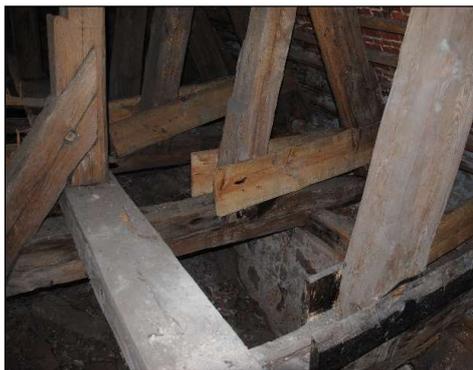
In the W2 and W3 trusses there are no braces, in the W4 and W5 trusses there are no single braces. In the W2a, W3, W3a, W4, W4a (L) trusses, the corroded ends of the truss beams are reinforced with wooden prints, the washers used between the lower purlin PD and the truss beam are used.

Photo 9. Corroded truss beam ends are reinforced with counter battens from boards

Then proceed to strengthen the corroded truss beams. Truss beams will be reinforced with additional beams located on the sides of the damaged element. The beams will be interconnected with M16 threaded rods, class 5.8, and between the girder beam on the non-corrosive section and the reinforcements in the place of the bolted connection, double-sided stud plates will be used [5].

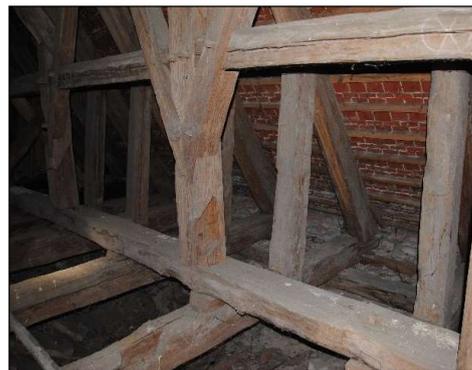
Photo 10. Wedges between the lower purlin and truss beams

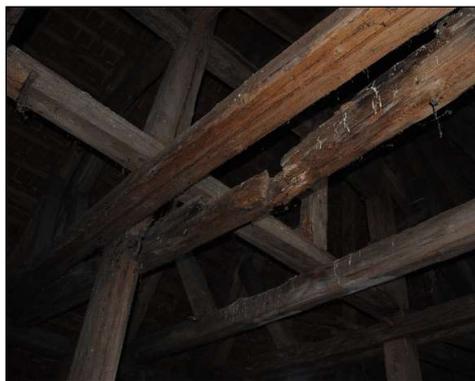
Photo 11. Place after the removed pole, biological corrosion of the collar beam

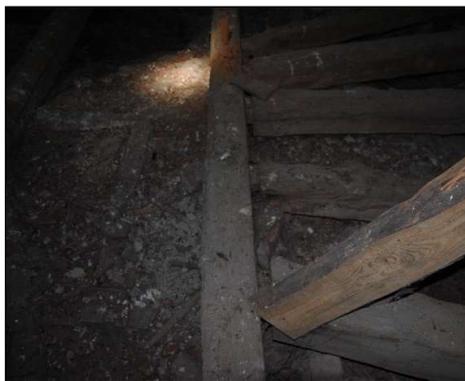
Photo 12. Split connections of truss beams above the presbytery
