**RESTORATION OF A BRIDGE STRUCTURE
ON THE EXAMPLE OF A BRICK RAILWAY VIADUCT
IN ZIELONA GÓRA**

A b s t r a c t

The article presents the successful restoration of a railway viaduct in Zielona Góra. The carried out reconstruction, in the scope of increasing the clearance gauge under the bridge, made it possible to increase operational safety while maintaining the existing structure of the object. The described case serves as an example of actions facilitating the further historic use of transportation infrastructure structures while limiting financial outlays for adapting them to current expectations.

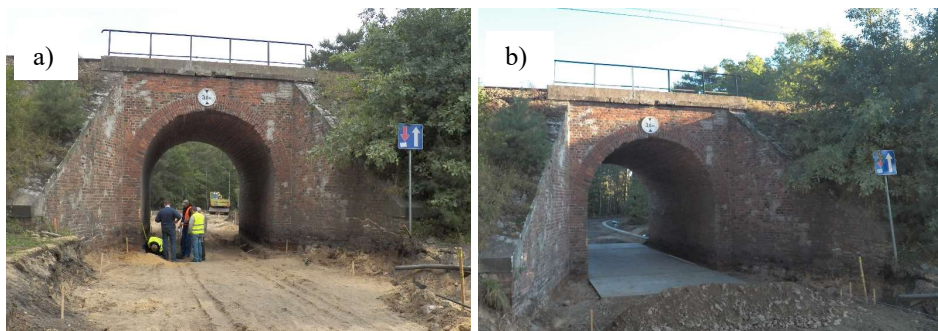
Fig. 4. View of carrying out works on the bridge structure: a) preparing the road bed, b) preparing the expansion slab under the viaduct

Additionally, in an effort to ensure an adequate expansion of the arch structure of the viaduct, a reinforced concrete slab, 0.25 m in thickness was designed under the structure of the road surface.

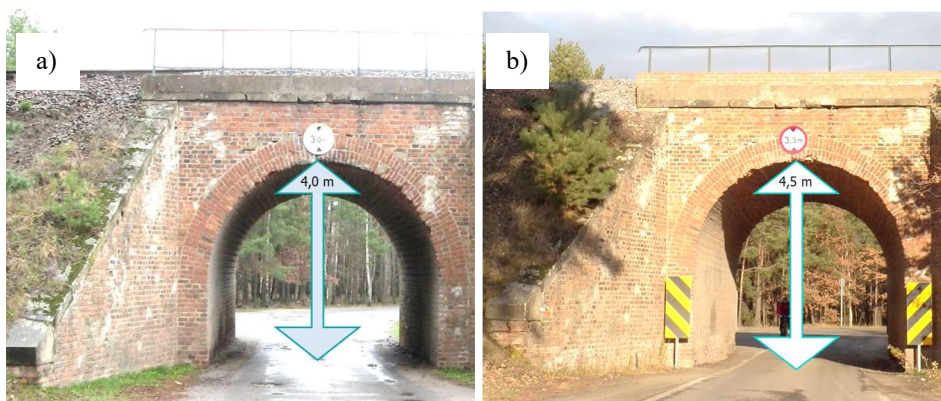
Fig. 5. View of railway viaduct in the course of Folszowa road in Zielona Góra: a) prior to reconstruction b) following reconstruction

Lowering the roadway of Foluszowa Street Under the railway viaduct made it possible to increase the vertical clearance from 3.00 m to 3.30 m. Thanks to this, the level of safety, along with the durability of the structure were increased. The presented realization serves to show that the proper preparation of an investment makes it possible to limit financial outlays for eliminating transportation barriers. As had already been mentioned in the introduction, existing engineering structures require reconstruction, mainly in light of continuously increasing transportation needs. Frequently, these structures are of a historic nature or are entered into the Register of Historic Monuments, which significantly limits the possibility of creating modern structures in their place. It is worth, for historic purposes as well as esthetic values, taking an interest to ensure a variety of bridge structures while maintaining their functional values, especially when this is economically validated.
