DIAGNOSIS OF THE TECHNICAL CONDITION OF HISTORIC TENEMENT HOUSES AS THE FIRST STAGE OF REVITALISATION OF THE CITY

Beata NOWOGOŃSKA¹
University of Zielona Gora, Zielona Góra, Poland

3. CASE STUDY - TENEMENT HOUSE 7 1 MAJA STREET

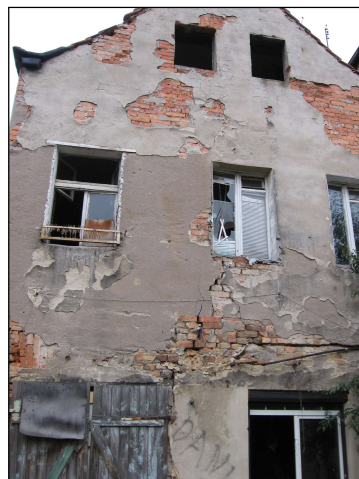
Fig. 3. South elevation. Numerous cracks and defects in the wall structure

The foundations have surface moisture from groundwater, the mortar is partly washed out, the brickwork loose in some places. The foundation under the southern wall (in part B) is in the worst technical condition. During the analysis of scratches and cracks in the outer wall, it was found that the reason for these deformations is the foundation settlement in the south-west corner, caused by soil

and water changes and technical wear of the foundation (loss of strength and rigidity of the strip foundation). There is no vertical or horizontal insulation.

Safe use and elimination of the causes of scratches and cracks can be ensured by a security system consisting in stopping the movement of foundations by exposing and strengthening the string foundation under the southern wall and in the southwest corner. Vertical and horizontal insulation should be made.

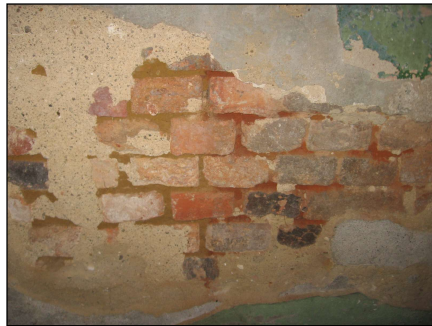
Fig. 4. Part of the western wall of the ground floor. Walls made of solid brick

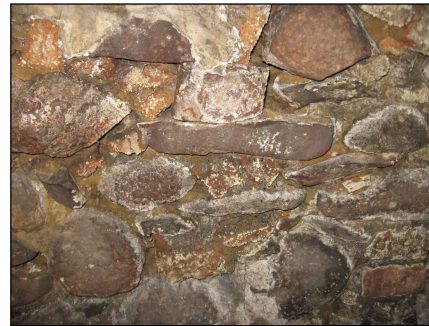
Fig. 5. Part of the stone wall of the basement. Wall salting and moisture

There are defects in the basement wall joints. The walls are very wet. From the inside, much efflorescence, severe salting and discolouration is visible.

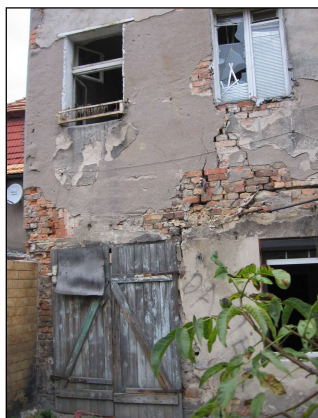
A diagonal structural crack is visible on the southern wall. The crack opening reaches up to 25 mm. The crack runs near the south-west corner, runs from the foundations to the upper floor level. The crack reaches throughout the entire thickness of the wall. It is also visible inside the building. In addition, a horizontal crack between the ceiling above the ground floor and the southern wall is visible from the inside. Cracks between the ceiling and the wall indicate that the wall is deflecting from the vertical towards the outside.

Fig. 6. Part of the southern elevation.
Crack near the south-west corner

The southern and northern walls should be connected with anchors with longitudinal walls, cracks up to 4 mm wide which appear in the gable walls and in the western wall should be sewn, larger ones should be rebuilt. All walls should be dried and desalted.

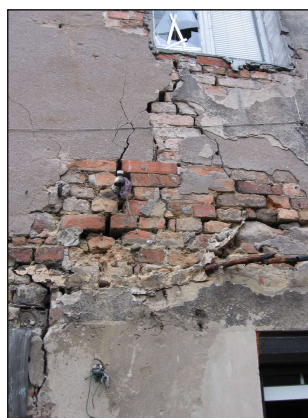
Fig. 7. Part of the southern elevation.
Loose brickwork, defects in the joint

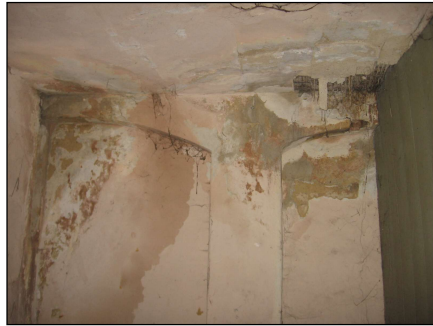
The southern wall of the ground floor is very wet, moisture reaches 1.2-1.3 m, the other walls of the ground floor - moderately wet. The eastern wall on the upper floor is very wet from above due to leakage of the valley between the eaves of buildings No. 5 and 7.

Fig. 8. Part of the eastern wall on the upper floor. Very damp wall and ceiling. Visible mould

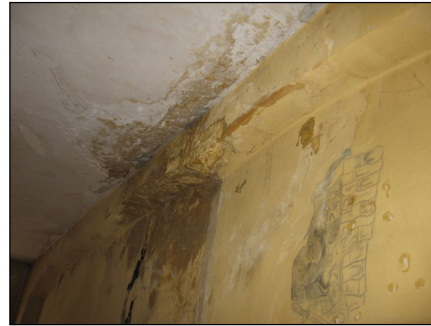
Fig. 9. Part of the eastern wall on the upper floor. Strong moisture of the wall and ceiling due to leakage of the valley

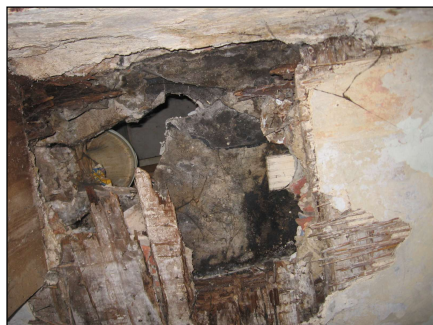
The ceiling above the upper floor is wooden, 16 x 22 cm ceiling beams spaced every 120-150 cm. In the ceiling above the upper floor, the ends of beams based on the eastern wall are very wet. In the central part of the building, in the ceiling above the ground floor and upper floor, beams are corroded as a result of leakage of the sewage system.

Taking into account the surveyed state of damage, it was found that the technical condition of wooden ceiling beams and other ceiling elements prevents the object from being operated in part B. Due to excessive deflection, significant biological corrosion of the ceiling beams (especially in the central part in the so-called wet rooms), and the high wear of the filling, it is suggested that ceilings should be replaced throughout the building.

Fig. 10. Section of the ceiling above the ground floor. Missing part of the ceiling, other beams corroded

The poor technical condition of wooden ceilings above the ground floor and upper floor, especially in the central part of the building, may threaten the safe operation of the building, and indicates the need to renovate the ceiling. In the central part, its immediate replacement is required, the remaining ceilings must be replaced during the planned renovation of the building. The vaults do not require reinforcement, they must be dried.

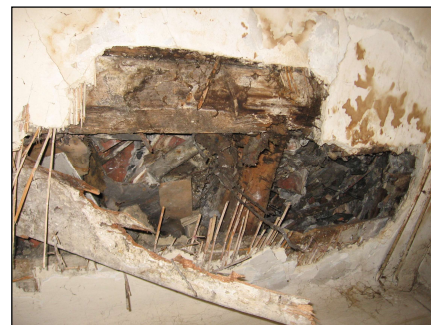
Fig. 11. Section of the ceiling above the ground floor. Moisture of ceiling beams, defects in the ceiling fillings

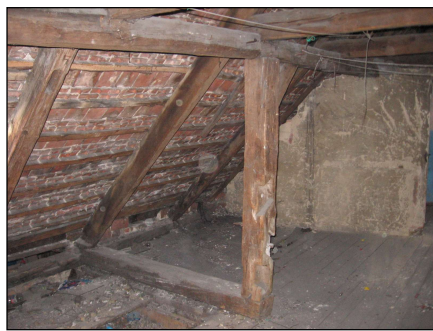
Fig. 12. Numerous defects in the construction of the truss. Purlins and rafters strongly bent

Numerous defects in the truss structure are also visible. Some of them are caused by the removal of some structural elements during numerous roof modernisations, others have undergone significant biological corrosion. The ends of truss beams, rafter heads and wall plates are in the worst condition. Large distances between the rafters caused bends or breaks of battens under the tiles. Knee walls approx. 30 cm high are very wet, wall plates corroded, locally, there are no wall plates, rafters are based directly on the wall.

The roof does not threaten the safety of use; however, elements of the roof truss do not meet the requirements of ultimate limit states, it is recommended to secure, replace and strengthen the elements.

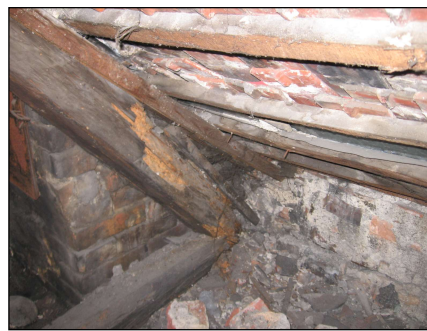
Fig. 13. Wet knee wall. The rafter ends are corroded, no wall plates, bent battens

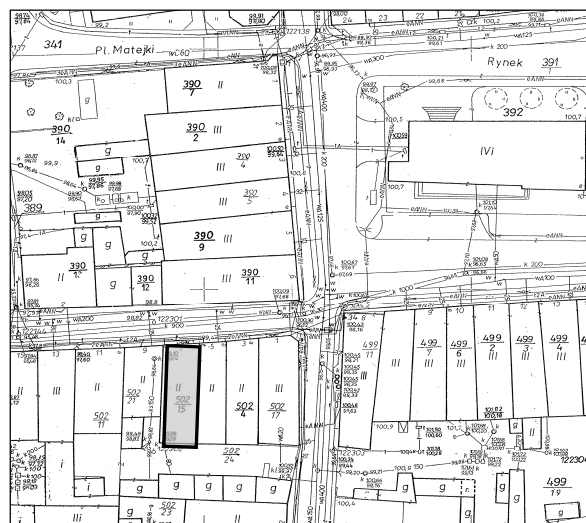
Fig. 14. Site plan

Alarming deformations of the building occur in its southern part. Structural scratches, numerous cracks are associated with foundation settlement in the southwest corner. This corner is not covered by high-density development (according to Fig. 14).

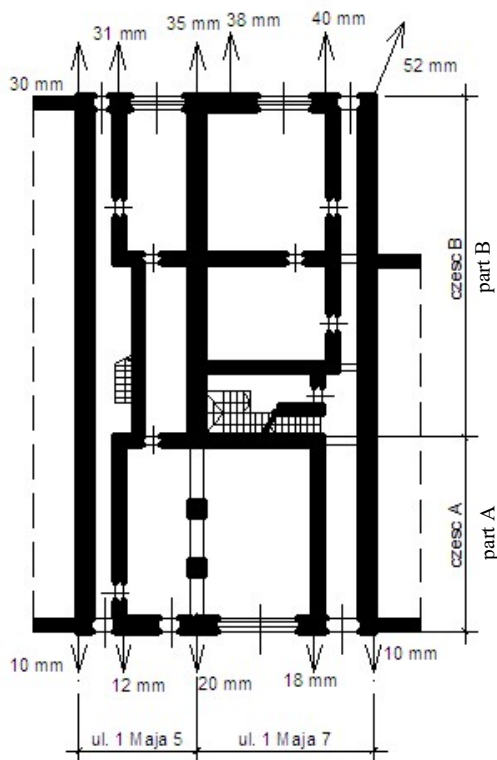
Fig. 15. The deviations from the vertical of the gable walls

The largest deviation values were recorded in the south-west corner of the southern wall amounting to 52 mm, other deviations are within 30-40 mm for the southern wall, 10-20 mm for the northern wall (Fig. 15). Deviations are directed outside the building.
