IDENTIFICATION OF THE CAUSE OF THE STEM NECK FRACTURE IN THE HIP JOINT ENDOPROSTHESIS

The aim of this paper is to evaluate the cause of the fracture of the Aura II stem neck, an element of the endoprosthesis implanted in a patient (male, 73), which occurred 6 years after the surgery.

The material under examination is the cemented Femoral Stem Aura II endoprosthesis (size 6 left, 5°42', 12-14 – material: Stainless Steel), reference number P0125006, batch number 0000372523, manufactured in October 2008, together with the Modular Head Component (28 mm, 12/14, Taper, Plus 3,5 mm, Neck, material: CoCr), reference number 53-131228, batch number 0000386265. The hospital

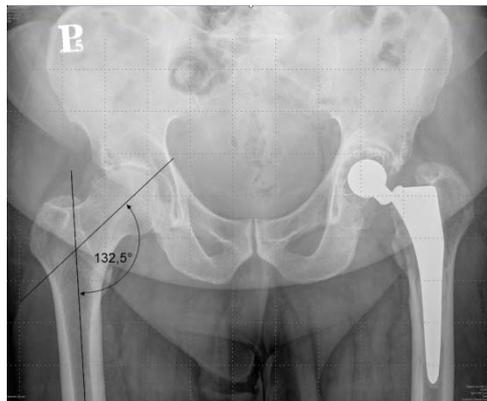
Fig.2. The X-ray image of the patient's hip zone at the Hospital Emergency Ward in 2014.

The analysed radiogram gives rise to certain doubts regarding the conditions of recreating the rotation axis of the implanted joint [19-21]. The rotation centre for the artificial joint is higher than the one for the natural joint. The tissue trauma could have caused a muscular contracture and some disturbances in the location of rotation centres for both joints. In the implant zone, there are no visible foci of osteolysis or loosening of the cement anchoring of the stem. The size of the stem is correct as, together with the cement, it fills the space between the inner walls of the cortical bone and the canal of the femoral bone. The location of the stem does not reveal any varus or valgus deformities. The anatomical angle between the head and the stem on the right is 132.5° , and the angle between the neck and the stem of the implanted Aura II stem is 137.5° . The size of the acetabulum is correct, too, without any evident signs of migration under the influence of locomotion stresses. The degree of the polyethylene acetabulum wear, measured using the distance of the dislocation between the centre of the endoprosthesis head and the centre of the acetabulum, is very small, below 0.1 mm. An external visual evaluation of the polished surface of the stem reveals extensive zones of corrosion in the medial and lateral bending of the stem, in the proximal section and in the conical part contacting the head (Fig.3). Observations of metal construction elements removed from patients do not show such advanced corrosion changes as the ones confirmed in the stem under examination. On the external surface of the head, there are numerous circumferential scratches that are in stark contrast with the smooth and polished head which remained in contact with body fluids and does not show any signs of corrosion (Fig.4). Moreover, there is a circumferential crack, perpendicular to the neck axis, which starts 3 mm from the edge of the fracture and the place where the fatigue fracture was initiated.

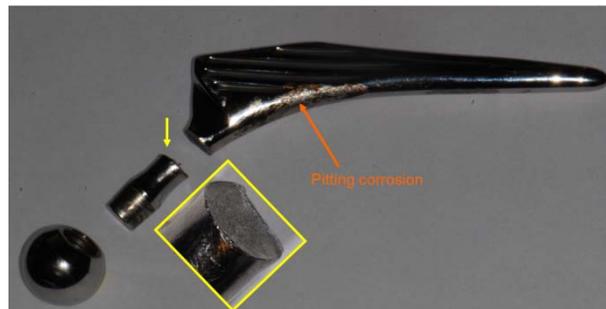
Fig.3. Fractured Aura II stem with the head removed from the patient's body.

What was the cause of the stem neck fracture? What additional circumstances brought about the notching effect and initiated the fracture? Direct observations indicate the presence of a defect in the stem neck (Figs 3, 4 and 7). The focus is visible in the fracture in both elements. On the external surface of the fractured neck, there is a deep scratch near the focus.

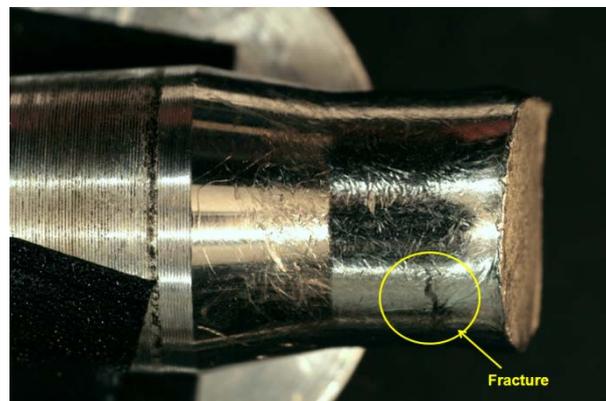
Fig.4. The surface layer of the fractured stem neck with numerous circumferential scratches and a crack in the close vicinity of the fracture initiation zone (focus).

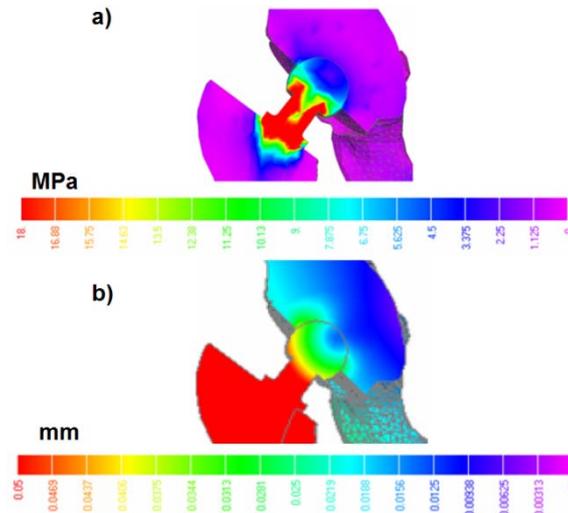
The analyses and numerical FEM analyses performed for the global model of bone structures and the endoprosthesis including the Aura II stem with the CoCr head, $\varnothing 28 \text{ mm}$, and the acetabulum, $\varnothing 28 \text{ mm} \times \varnothing 48 \text{ mm}$, indicate that the geometry of the stem secures the transfer of locomotion loads (Fig.6). The exemplary build-up of the stresses in the stem neck of the maximum value of 18 MPa makes 5% of the possible load of this construction element considering the properties of the M30NW steel [24-28]. Maximum resultant microdislocations, of 0.05 mm, do not cause destruction changes in the stem stabilisation zone. The fundamental goal of developing a load-bearing structure of the hip joint endoprosthesis is to ensure resistance to fatigue-induced destruction. The performance load on the endoprosthesis stem puts this construction element (replacing the lost function of the femoral neck) in the stress zone below the level of

fatigue, which is the equivalent of the gigacycle fatigue range [29, 30]. It may be said that the stress values that occur during locomotion could not have caused fatigue-induced destruction.

Fig.6. FEM calculations in the hip zone model with the Aura II prosthesis in the position of standing on two legs (vertical cross-section): a) map of reduced stresses, b) resultant dislocations.

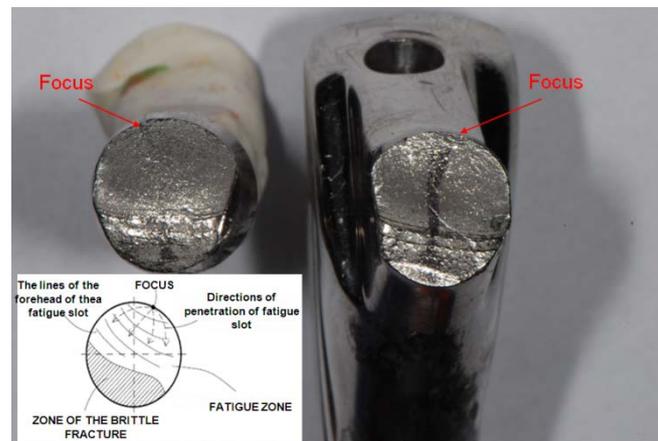
Fig.7. Surfaces of the stem neck fatigue fracture with the indication of the focus.

In the zone of the stem neck – the place of the technological defect – fatigue microcracks were initiated. Dislocation in the surface zone resulted in the creation of a slip plane and microcracks in the planes perpendicular to the load would develop into a macrocrack (Fig.7). The photograph shows the structures characteristic for a fatigue fracture: the focus, the focal zone, the fatigue zone, radial lines, the transition zone and the immediate fracture. The SEM analysis in the focus area may indicate that it was a defect which arose after forging, at the primary creation of the stem neck (Fig.8). It could be caused by microshrinkage that occurred in the manufacturing technology. There was a brittle fracture at the border of grains. The fracture was working and expanding in the physiological load conditions. The absence of stress relaxation at the top of the crack, because of the development of plastic deformations, caused further development of slip bands. The development of new slip bands resulted in further expansion of the crack and the rounding of its top.

Releasing the load caused a sharp top of the crack and, as a result, the expansion of the crack in the next load cycle. Because of the oxidation of the structures revealed in contact with systemic liquids, the process of corrosion developed more effectively. In the object under examination, the plastic deformation zones in the shape of stripes are located parallel to the direction of the crack development. Still, they were deformed even more by mutual dislocation of the fractured stem. The initiation of the neck crack at the visible forged layer of the material was stimulated by the stresses and corrosion caused by the entry of systemic fluids into the area of the microcrack development. The presence of the forged material layer resulted in the build-up of stresses and was the cause of the stem neck fracture (Fig.9). In forged elements, a microcrack may develop at the border between the stem and the reinforced layer. Without a doubt, the responsibility for this defect falls on the stem producer. For this kind of elements, an individual evaluation of the technological process in non-destructive tests should be carried out. Numerous areas affected by pitting corrosion on the external surface of the stem might indicate that the material used for its construction did not comply with the requirement of high resistance to corrosion declared by the steel producer.

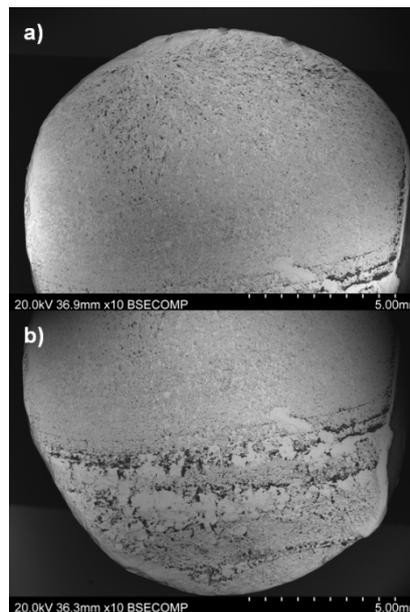
Fig.8. SEM images of the stem neck fatigue fracture in the ten-fold magnification: a) the area as seen from the focus, b) the fatigue zone and the immediate fracture zone.

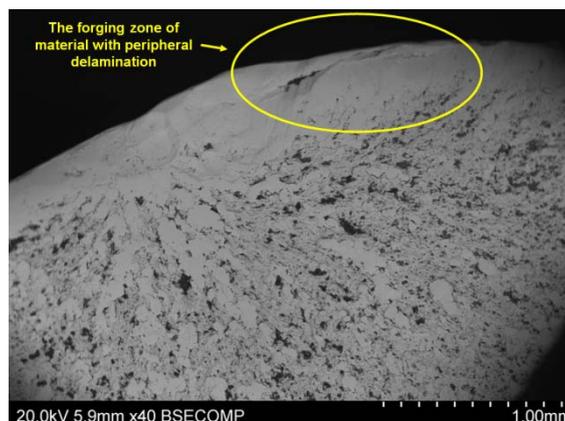
Fig.9. SEM images of the stem neck fatigue fracture with the location of the forging zone in the 40-fold magnification

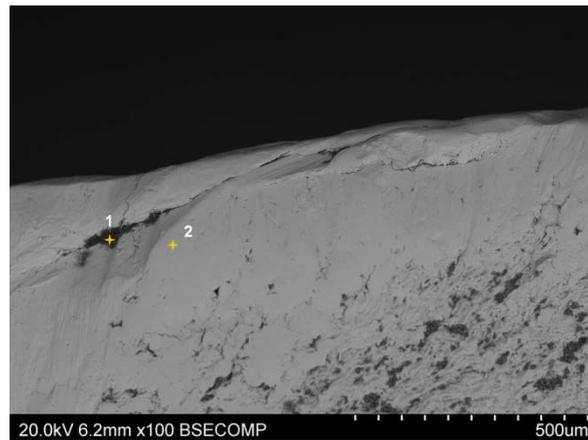
In order to confirm the time and cause of the crack development, a qualitative and quantitative analysis was performed in microareas (Figs 10 and 11). It was performed at point 1 – located in the delaminated space which developed as a result of forging (and, at the same time, the area that should be made of a solid material) and at point 2 – at the surface of the fracture (Tabs 3 and 4). At point 1, the levels of carbon, nitrogen and oxygen were significantly higher, while the levels of chromium and iron were lower than the ones reported by the material manufacturer. As compared to the percentage by weight of the M30NW austenitic steel, the following elements are present: aluminium, chromium, sulphur, potassium and calcium. Large contents of oxygen and carbon indicate the presence of oxides, respectively, that might have

caused the initial crack. At point 2, there are increased levels of carbon, nitrogen and oxygen, which are still lower than at point 1. The contents by weight of the elements that make austenitic steel, i.e., chromium, nickel, manganese and molybdenum, is approximately in line with the manufacturer's data. Both in point 1 and 2, there is aluminium and chromium in small amounts. Such elements as sulphur, chlorine, potassium and calcium, which do not occur in austenitic steel and are present in the delaminated space developed as a result of forging, prove the entry of systemic fluids and a defective technological process. The most probable process that led to the fatigue fracture of the neck of the Aura II stem under examination is the one related to material defects in the process of casting and forging (forging the material with delamination and the presence of brittle oxides and carbides), which caused a significant reduction in strength and resistance to corrosion.

Fig.10. A SEM image of the forging zone with the chemical composition analysis points marked.

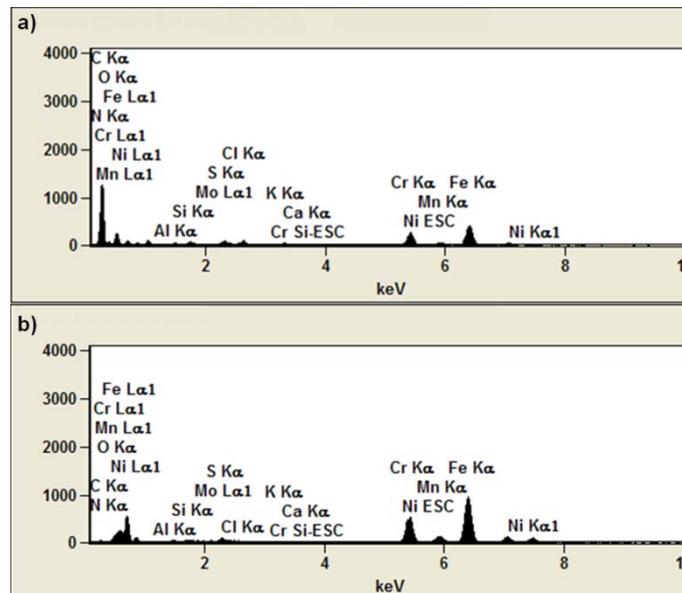
Fig.11. The chemical composition analysis in the stem neck: a) the forging zone - point 1, b) the brittle fracture zone – point 2.

In the light of the above, it must be stated that the fracture was caused by material and technological defects of the implanted stem and the entire responsibility for the event that occurred and the exposure of the patient's health and life to risk rests with the producer. In the information provided, the producer claims that the ratio of such events as fractures of cement stems of Aura II hip joint endoprostheses is 0.006%. This information, in the light of an unprecedented neck fracture, should be an indication for non-destructive tests of ready-made stems aiming to discover the material and technological defects that may arise in the process of casting and drop forging.
