AEROPHYTIC CYANOBACTERIA AS A FACTOR IN THE BIODEGRADATION OF TECHNICAL MATERIALS ON EXTERNAL BUILDING WALLS

Marlena PIONTEK¹, Hanna LECHÓW

University of Zielona Gora, Institute of Environmental Engineering, Poland

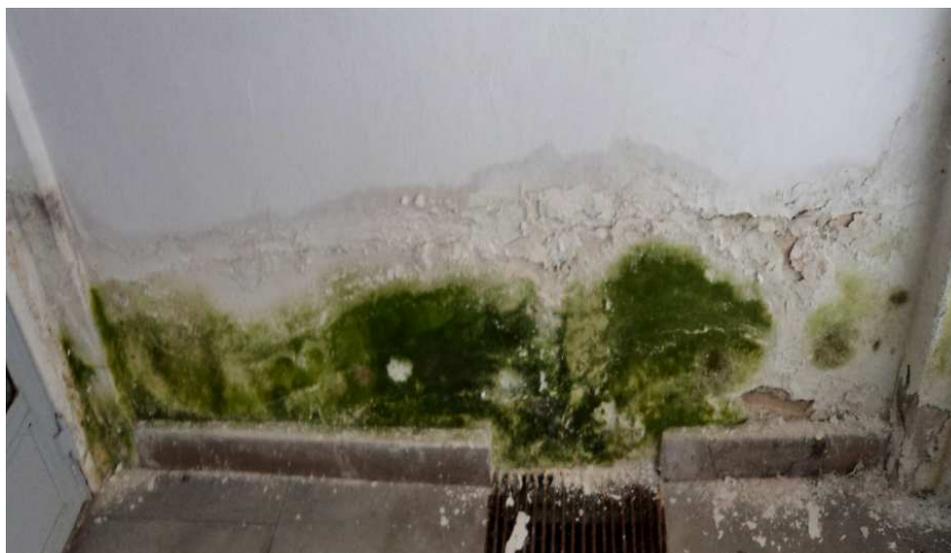
The external wall of the former UZ canteen was selected for research due to its perceptible biodegradation. On the wall there was visible discolouration and signs of structure degradation: cracking, scaling and crumbling of the technical material (Photo 1.). At present, the building is not used and it is ready for renovation. The wall selected for the study is located in a shaded canteen hall, exposed to moisture due to the leaking roof. The partition selected for research is built from solid bricks and covered with lime-cement plaster.

Photo 1. The external building wall with visible biocorrosion on the building of the former UZ canteen

The external building wall discussed in the paper provided conditions conducive to the colonization and growth of organisms causing biocorrosion. The degradation of technical material was very clear and it was characterized by surface discolouration and the destruction of the structure by numerous cracks and layer separation. During the research high moisture was detected in the areas with biological blooms. In the biofilm on the elevation aerophytic cyanobacteria were detected. Four species of cyanobacteria were identified. They all contributed to the creation of biological bloom on the wall and the initiation of biodeterioration processes of the technical materials.

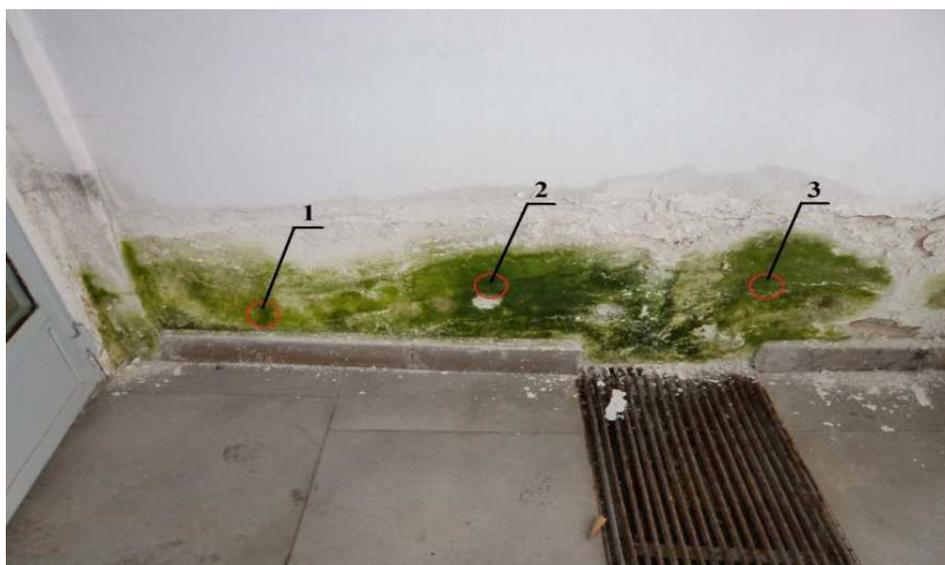
The material from the wall was sampled in April 2013. A fragment of biological material intended for laboratory growth and microscopic observations was taken off the wall with a sterilized scalpel. The samples were taken at three places of the bloom-covered wall (Photo 2).

Photo 2. The three sampling points (marked 1,2,3) on the biodeteriorated external building wall

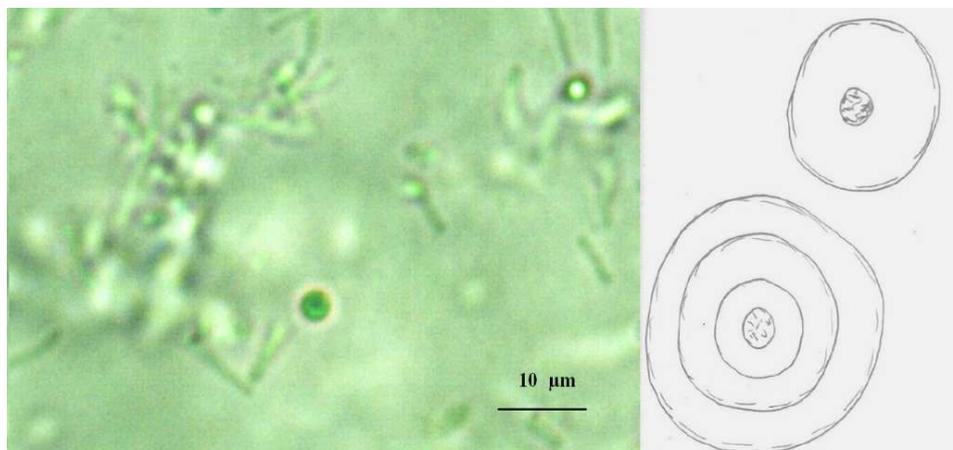
- *Gloeocapsa montana* Kützing (Photo 3) frequently occurs on moss, moist rocks and walls. Spherical or slightly elliptical cells, usually enclosed in broad, colourless, delicately concentric layered coatings [17].

Photo 3. *Gloeocapsa montana* Kützinger (on the left: microscopic image, on the right: sketch of view)

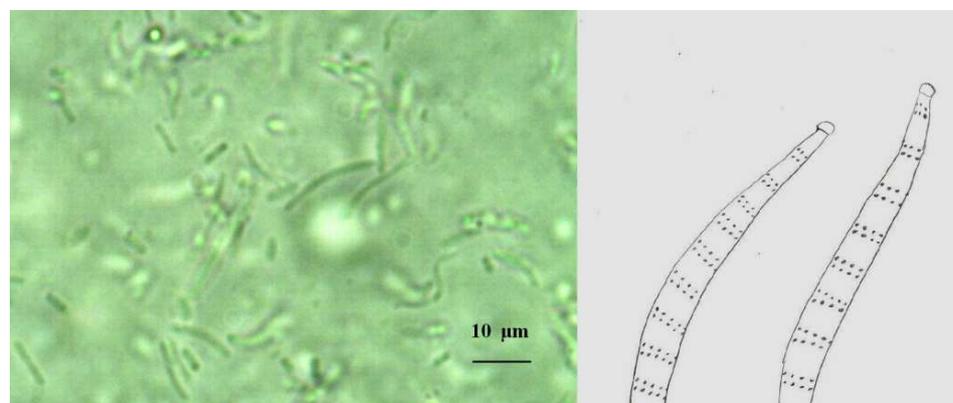
- *Phormidium calcareum* Kützinger (Photo 4) occurring on damp limestone. Layered, light blue and green, leathery thalli. The cell tip sharply conical, sometimes with capitate, nearly spherical formation on top [17].

Photo 4. *Phormidium calcareum* Kützinger (on the left: microscopic image, on the right: sketch of view)

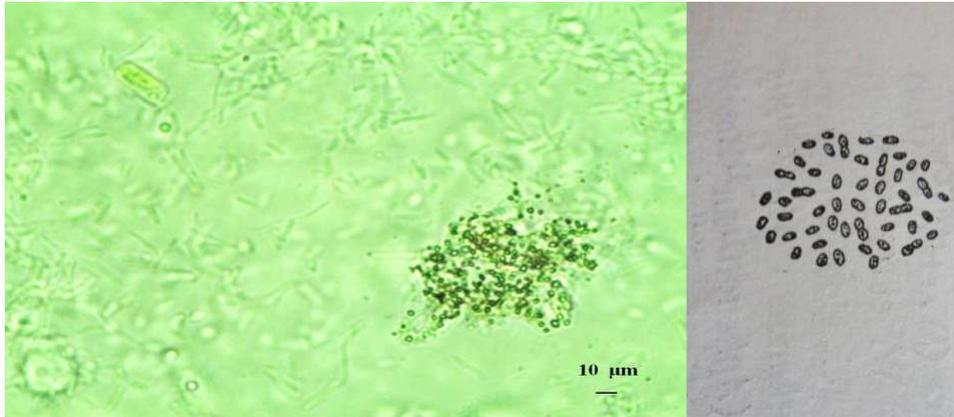
- *Aphanothece saxicola* Nägeli (Photo 5) occurs on moist rocks and walls. Microscopic spherical colonies blending into shapeless gelatinous thalli, pale blue and green, occasionally yellowish or violet in colour. Long, cylindrical cells, single or in pairs.

Photo 5. *Aphanothece saxicola* Nägeli (on the left: microscopic image, on the right: sketch of view)

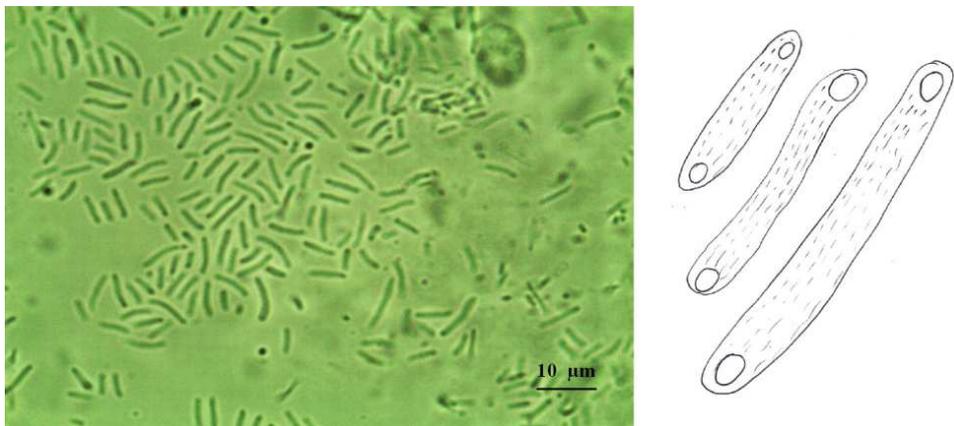
- *Gloeothece caldariorum* (P.Richter) Hollerbach (Photo 6) also occurs on moist rocks and walls. Broadly spread gelatin coatings consisting of single or double cells with a single glossy grain at either end [17].

Photo 6. *Gloeothece caldariorum* (Richter) Hollerbach (on the left: microscopic image, on the right: sketch of view)
