NOT IN-SERVICE RAILWAY ARCHED BRIDGES AND THEIR FUTURE

Artur JUSZCZYK¹, Marek DANKOWSKI², Adam WYSOKOWSKI³
University of Zielona Gora, Institute of Building Engineering, Poland

Keywords: bridge structure, viaduct, revitalisation of bridges

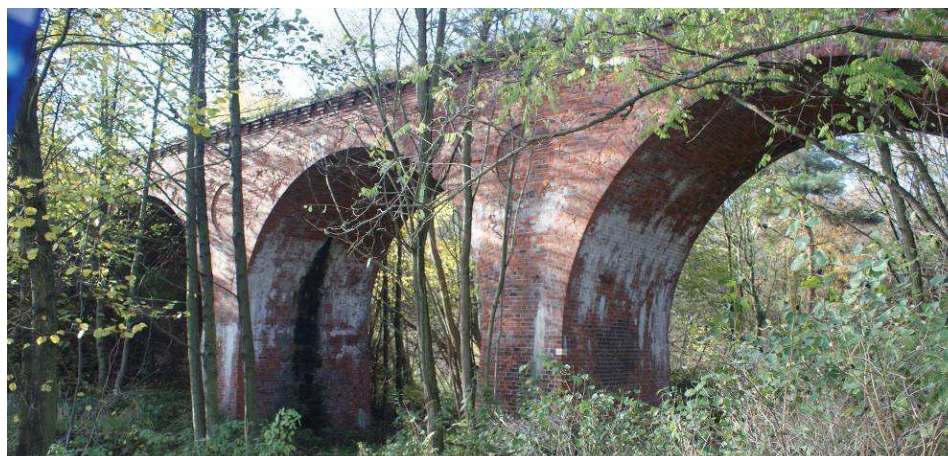
All arched bridges were made of full ceramic brick. The object marked with A is a viaduct, it composes of four arched spans up to approx. 8 m each (Fig. 2). Under the second span is a dirt road and under the third runs a small stream.

Fig. 2. General view of the bridge structure A

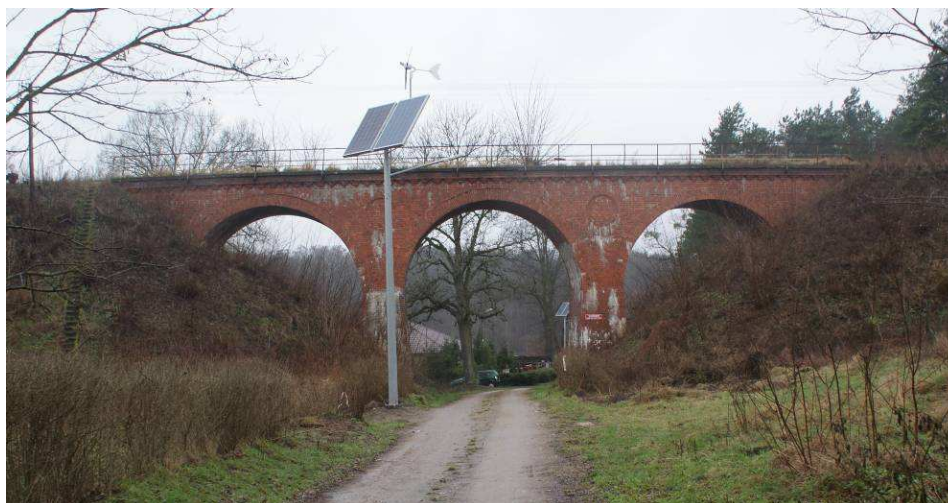
The object marked B consists of three arched spans (fig. 3), whose basic dimensions were shown on the side view and a cross-sectional span (Fig. 4). Under the middle arch runs a paved road.

Rys. 3. General view of the viaduct B

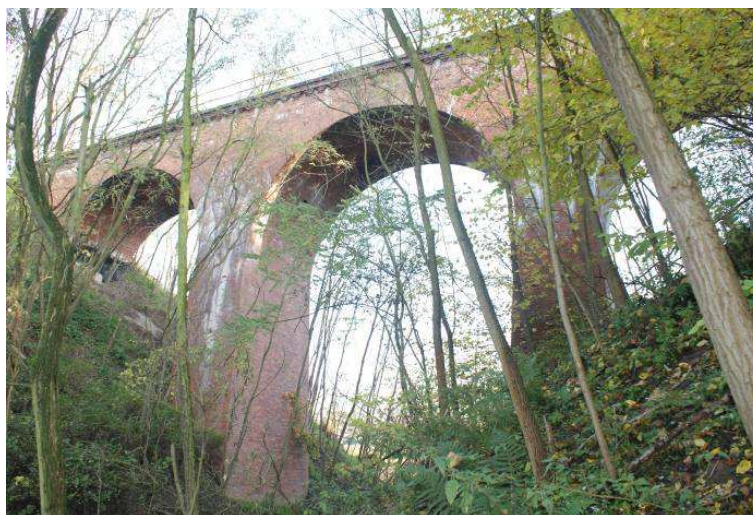
Object C, the highest of the described, is a bridge composed of three arched spans (Fig. 4). A few years ago, under the middle span flowed the small-sized watercourse - Oszczynica. Because on the west side one made the damming the stream, now the space between the pillars is completely filled with standing water. Due to the presence of water under the object and marshy areas on both sides of the bridge access is difficult.

Fig. 4. General view of the bridge C

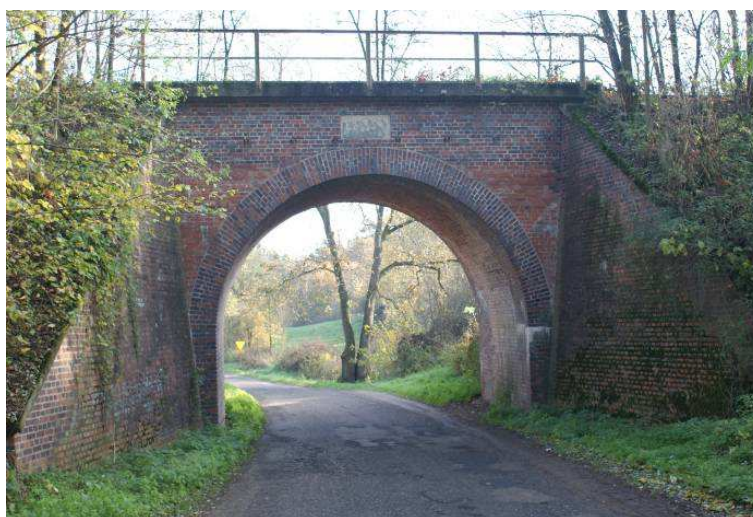
The object D is a one-span viaduct, the smallest of the described (Fig. 5). Under the object runs westwards the local paved road from the village of Nojewa to Kikowo. On both sides of the bridge, parallel to the road, on the length of more than 8 m, there are retaining walls restricting the ground scarps. In the early 60's building was undergoing a complete renovation during which fragments of vaultings, clinker bricks on the edges of the arches were renewed and one made a reinforced concrete bridging slab with a thickness of approx. 25 cm.

Fig. 5. General view of the bridge D

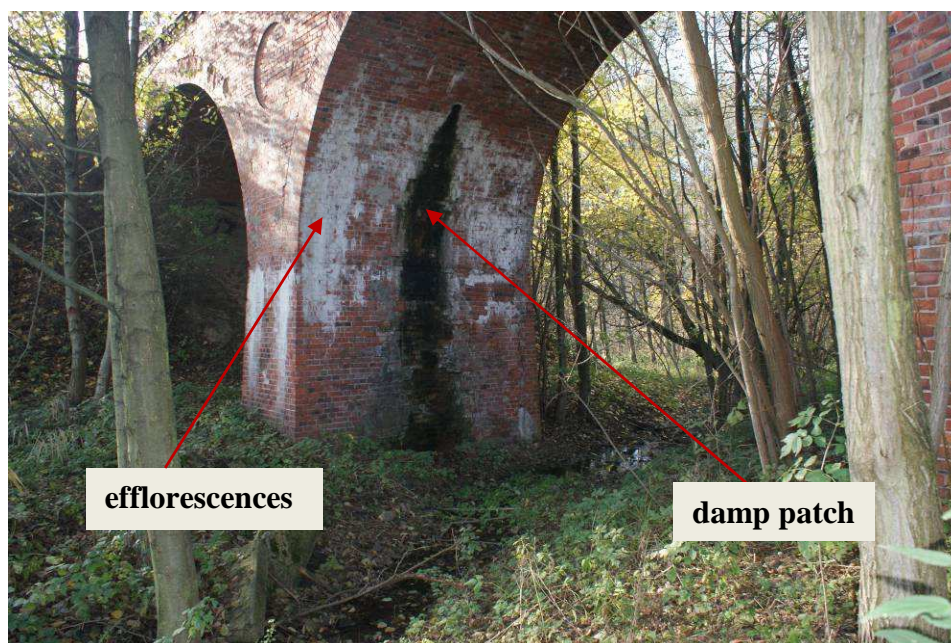
However, the described bridges and viaducts have visible and at the same time typical damages for unmaintained wall structures. The most obvious are, present in many places, white efflorescence on the surface of the walls. This applies particularly to the objects A and B. Efflorescence is always the result of water penetration, usually derived from the ground, adjoined to the structures. For these objects, most stains and associated efflorescence start at the top of the structure, often from the same crown (Fig. 6). Tracks are in fact covered with a thick layer of rich greenery-clad soil, which is rich reservoir of water. One can also notice a visible numerous defects on large surfaces, flaking and cracking of the outer layer of bricks. This phenomenon occurs especially in the upper part of the arches (key) and on the walls and pillars. The cause of the destruction of the bricks are frost damages and disintegrating action of crystalized salt. On one of the pillars of object B, on the west side, detachment was found from the outside section of the wall of a depth of two bricks (Fig. 7). The lack of proper protection of this section of the wall can cause landslide on the extending road there.

Fig. 6. View of the degradation of bridge object "A"

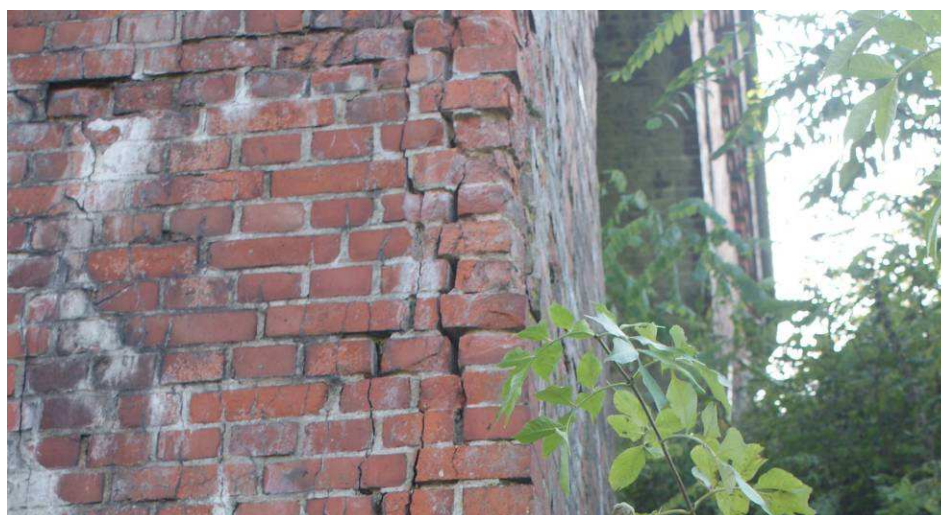
Fig. 7. View of viaduct pillar B. Visible cutting of the outer layer of bricks
