## ADAPTATION OF THE SOUTH-WEST WING OF COLLEGIUM CHEMICUM OF ADAM MICKIEWICZ UNIVERSITY IN POZNAŃ FOR STORAGE FACILITIES

### Abstract

The article refers to the problems of adaptation of Collegium Chemicum facilities belonging to Adam Mickiewicz University in Poznań to its storage needs. The subject building is situated in Grunwaldzka Street in Poznań. In the introduction part, the building and its structural solutions are described. The results of the materials research and the measurements of the used reinforcement have been presented. The structure diagnostic analyses were performed basing on measurements and research. The analysis allowed the determination of the limit loads. The results of the performed analysis of the current state turned out to be unsatisfactory, not only in terms of the planned storage load but also in terms of the current load state, as was shown by the construction analysis.

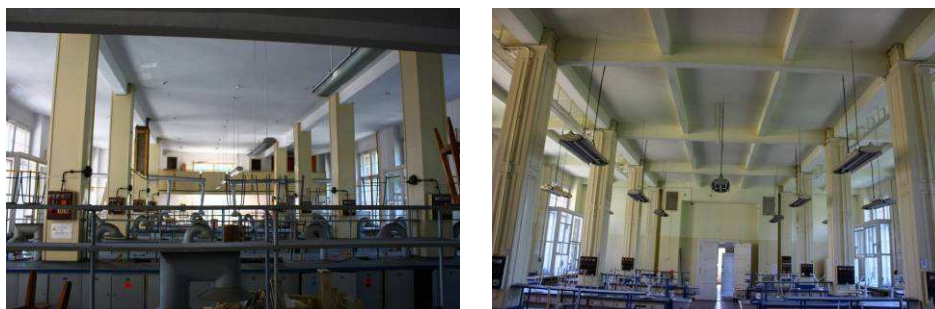
Fig. 4. The floor slab structures: over the ground floor (left) and over the 1st floor (right)

The structure of the first three floors, (basement including) consists of two eight-span, reinforced concrete frames of a longitudinal shape (Fig. 4). Monolithic ceiling beams are based on internal, reinforced concrete columns and external masonry gable walls. Monolithic, ribbed floor slabs are made of structural clay tiles. The structural thickness of floor slabs are: 0,21 m over the ground floor and 0,18 m over the basement and over the first floor. Precast concrete slabs of the basement and the ground floor are constructed as continuous, three-span slabs. The supports are provided by internal longitudinal main beams connected monolithically to the floor slab, as well as by external longitudinal masonry walls. Precast concrete slabs of the first floor rest on longitudinal beams and on internal steel beams between reinforced concrete beams.

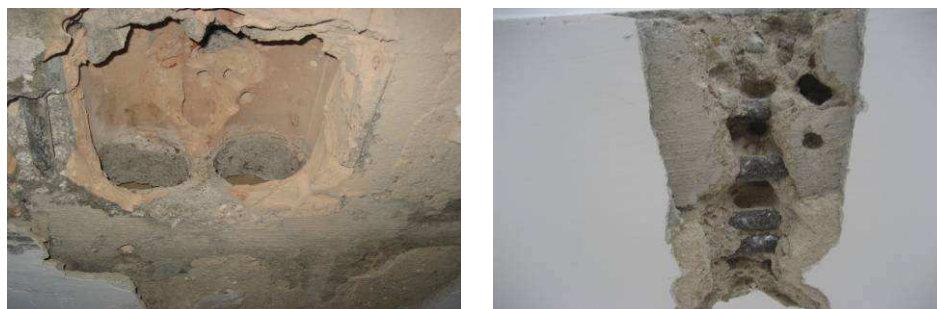
Fig. 6. Test openings in the ceiling above the basement: the floor slab (left) and the main beam (right)

In the absence of both the archival design documentation and the as-built documentation, for the full recognition of the structure, the structure inventory was performed as well as the measurements of the reinforcement [1]. In addition, test openings were performed to examine the reinforcement in the following structural bearing elements (Fig. 6): floor slabs, main beams and columns to the extent necessary for the verification of non-destructive inspection performed with the use of an electromagnetic locator for reinforcement detection HILTI - PS200 FERROSCAN. The performed test openings enabled the determination of the used types of breezeblocks and reinforcing steel.

The inventory of the location of the applied reinforcement in main beams and columns confirmed that smooth steel was used for all reinforcement components. The inspection of the location of reinforcement showed its significant diversity, and in the case of ceilings and main beams – even considerable randomness of the applied reinforcement both as to its quantity and the used rod diameters. The consequence of this discovery was significant extension of the research, in relation to the principles typically used in the engineering practice, which involved random controls of the number and the diameter of the used reinforcing bars.
