**METHODS OF TESTING AND ASSESSING  
THE TECHNICAL CONDITION OF CHOSEN BUILDING  
STRUCTURES LOCATED IN THE AREA  
OF THE AUSCHWITZ-BIRKENAU NATIONAL MUSEUM  
IN OŚWIĘCIM**

Stanisław KAŃKA<sup>1</sup>, Teresa STRYSZEWSKA<sup>2</sup>, Tomasz TRACZ<sup>3</sup>  
Cracow University of Technology, Faculty of Civil Engineering, Kraków, Poland  
Stanisław KARCZMARCZYK<sup>4</sup>, Roman PARUCH<sup>5</sup>  
Cracow University of Technology, Faculty of Achitecture, Kraków, Poland

The results presented in this article consider the means of assessing the technical condition of two selected buildings, i.e. prisoner barracks number 123 and 124, located at the Auschwitz-Birkenau State Museum in Oświęcim. The work was carried out within the framework of a research project involving the development of methods for preserving, securing and strengthening the structure of buildings, along with their substrate and finishes. The aim of the project was to gain a knowledge base reflecting the actual state of the existing facilities and, on that basis, develop preservation methods and ways to protect the existing facilities against further damage, while maintaining the current character.

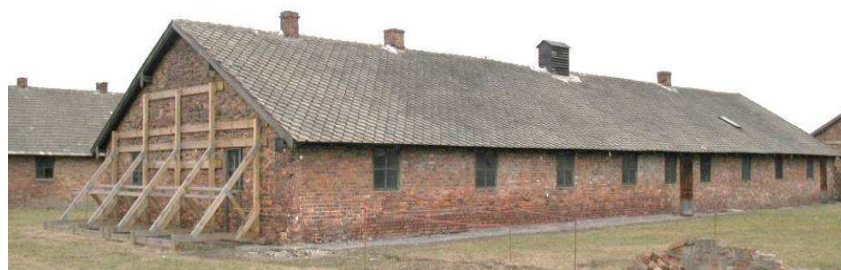
The accepted method of assessing the technical condition of buildings located in the area of the National Museum of Auschwitz-Birkenau in Oświęcim was presented on the basis of two prison barracks. Fig. 1 presents one of the analyzed prison barracks.

Fig 1. Prison barrack No. B-123

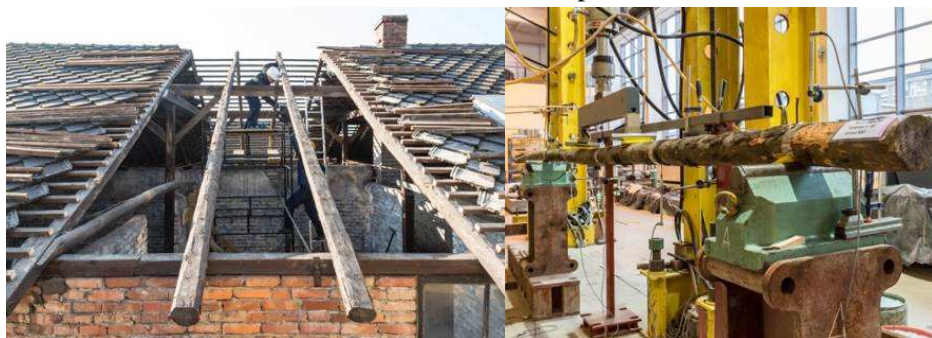
The analysis was carried out at a testing station equipped with an ISTS testing system (Fig. 4). The rafters were placed in a horizontal position by supporting them in the same areas as in the roof structure. Vertical force was applied by a traverse for a two-point bending scheme. The load stress was realized until a bend of  $L/150$ , i.e. 26.7 mm was reached, at a speed of 1 mm/min.

Fig. 3. Removal of rafters - barrack B-123

Fig. 4. Element at the testing station

The deviation of the analyzed rafters was registered at five measurement points using induction sensors. Two sensors were placed in the area of support, whereas the remaining three were installed under the rafter, spaced every 100 cm in the part between the supports. A series of measurements using a resistograph were also taken on the analyzed rafters.
