IMPACT OF BUILDING WALLS OF HISTORIC OBJECTS FROM HALF-TIMBERED WALL IN THEIR STATE OF THERMAL PROTECTION

Agnieszka SZYMANOWSKA-GWIŹDŹ¹, Tomasz STEIDL²
The Silesian University of Technology; Gliwice, Poland

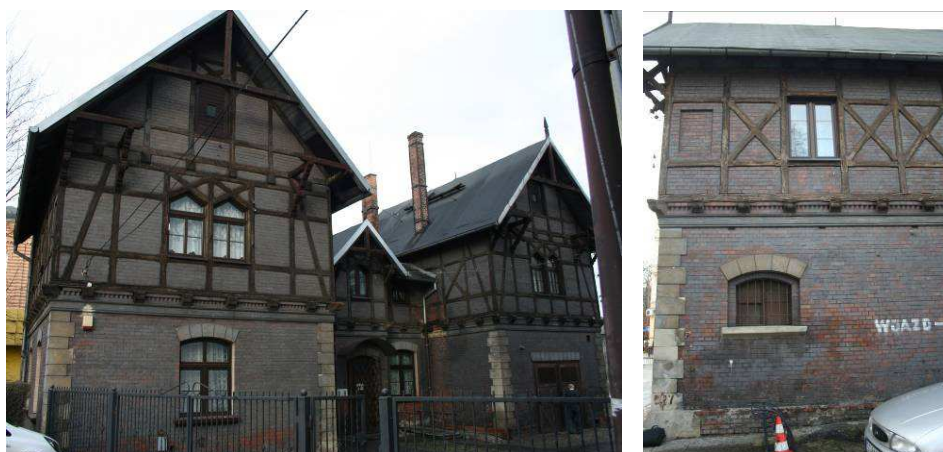
Fig. 3. Building of State Music School in Gliwice.

Gliwice's "pearl" of timbered houses is a building of the current State Music School, dating from the early twentieth century. The skeleton construction is found in the walls of the second floor, the ground floor is made entirely of a brick. Floor rooms are a library and music rooms for exercise.
