## **THE PROBLEM OF MOISTURE CONTENT IN HISTORICAL BUILDINGS BASED ON A CLASSICIST TENEMENT HOUSE AT 14A, ŚLĄSKA STREET IN GUBIN**

Bartosz MICHALAK<sup>1</sup>, Oliwia GRACZYK  
University of Zielona Góra, Poland

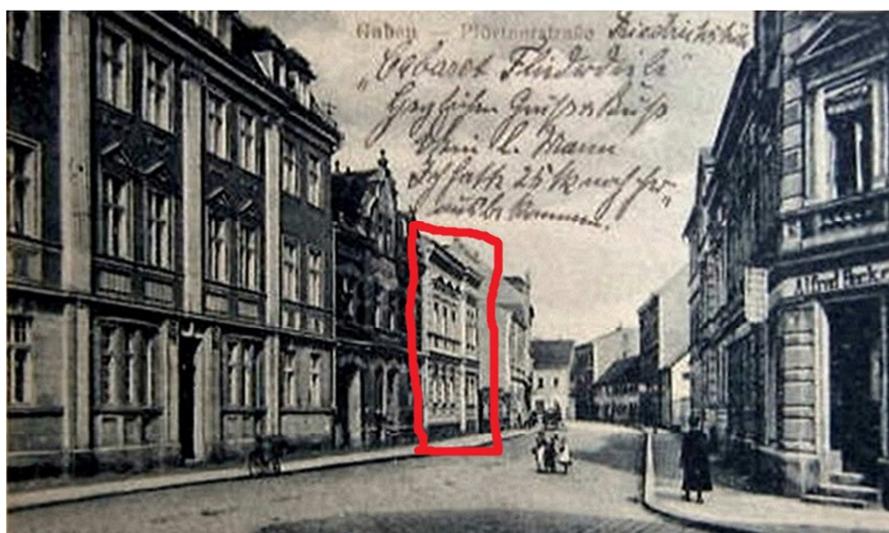
Fig. 1. View of Śląska Street (Pfortner Straße) at the beginning of the 20th century with tenement house numbered 14A marked in red (dolny-slask.org.pl, Ziemlicki, T.)

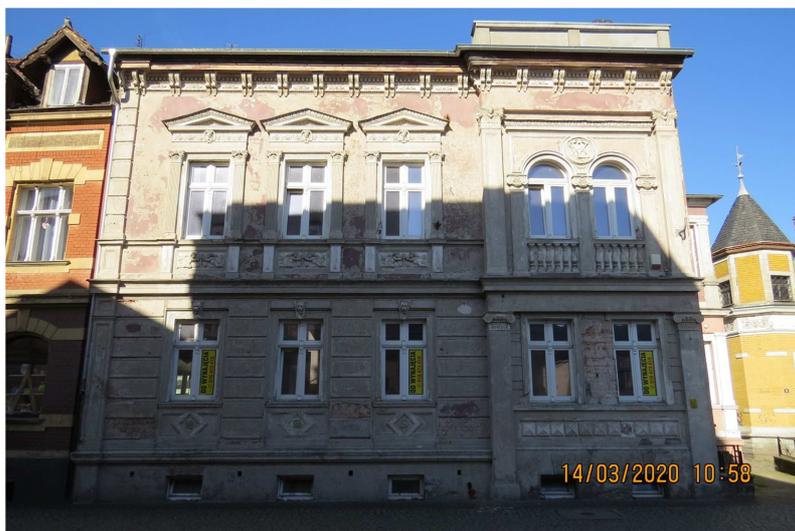
Fig. 2. Tenement house at 14A, Śląska Street – present view (author photo)

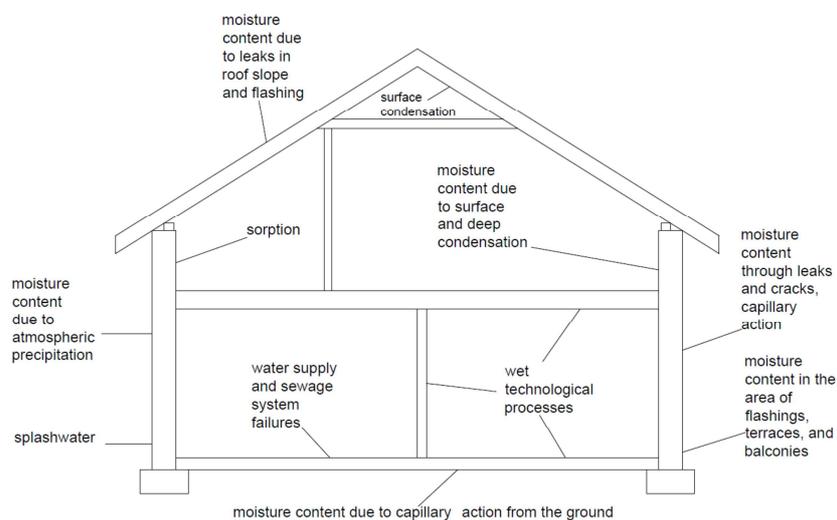
Fig. 3. Sources of building penetration by moisture

- Capillary action from the ground. Foundation and ground floor walls in any building are exposed to direct contact with moisture present in the ground, and with groundwater if it appears at shallow depth. This, however, does not mean that only a direct contact with humid environment constitutes a threat. Due to the phenomenon of capillary action, being the transport of water inside the pores in the building material and soaking of undamped areas, the exposure to moisture covers parts of the walls over a distance of several meters from the water source.

- Atmospheric precipitation. Atmospheric precipitation is the largest contributor to the quantity of water which causes most unwanted impact on the building. Precipitation water directly impacts each external surface of the building. The greatest danger is the threat to roof surfaces, which should remain waterproof and all rainwaters should be discharged from them into the rainwater drainage system through drainpipes. External walls are exposed to direct contact from rainwater, and indirect contact through increased quantities of water in the ground surrounding the building (capillary action), and due to so-called splashwater, i.e. water bouncing of the surface towards the lower parts of the walls.

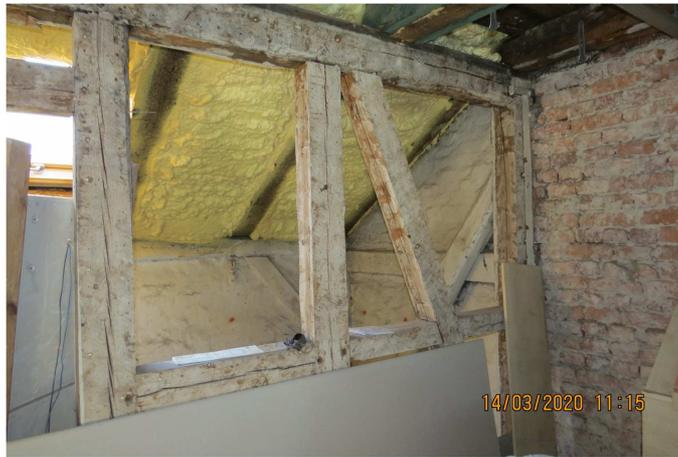
Fig. 4. Roof insulation with spray PUR foam and a fragment of Prussian wall structure (author photo)

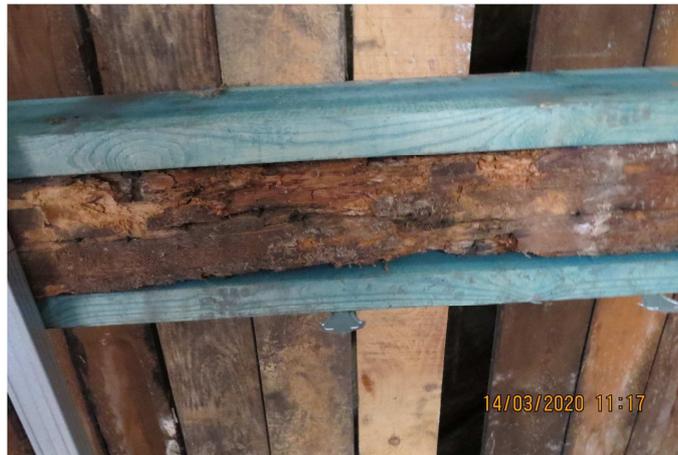
Fig. 5. Repaired wooden beam degraded by bio-corrosion (author photo)

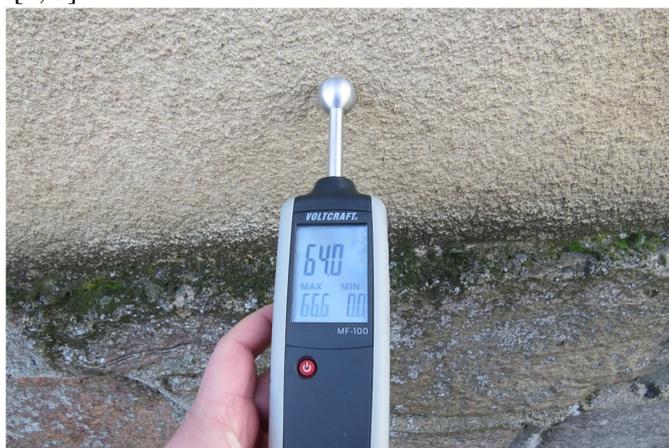
The measurements of wall moisture content were performed according to the dielectric method using a Voltcraft MF-100 moisture indicator. The dielectric method consists of measuring the electric capacity of the material at a moisture content change. Moisture content and material dielectric constant are interrelated [1, 5].

Fig. 6. Voltcraft MF-100 moisture indicator (author photo)

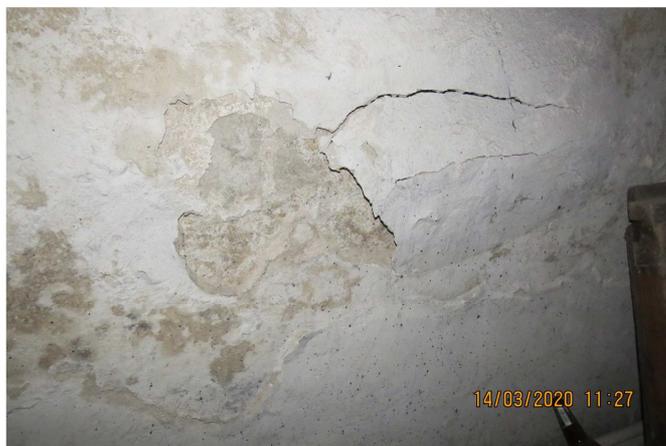
Measurements in the basement and up to the height of the building base clearly indicated highly humid or wet walls. The building areas located above this height were moderately humid or damp, and both the brick and wooden elements of the roofing in the attic were dry. The high level of moisture content in the walls caused apparent damage to partitions, such as mold, salinity, swelling, and debonding of plaster over surfaces larger than 0.5 m<sup>2</sup>.

Fig. 7. Debonding of plaster and wall salinity in the basement (author photo)

No foundation wall insulation was applied to the building. Recently, only vertical insulation on the north-western side has been performed. The lack of primary waterproof insulation, traces of salinity on the walls, degradation of partition surfaces, and the obtained measurements of moisture content explicitly indicate a significant presence of capillary action of groundwaters inside the porous ceramic material from which the building walls are

At present, the building is not in use and remains unheated, which additionally worsens its technical condition. The present condition of the structure, especially in the area of the ground floor, requires necessary repair works such as drying of the walls, application of new plaster coatings, and securing against the devastating influence of moisture (horizontal and vertical waterproof insulation) to avoid any future re-occurrence of the problem. Leaving the building without performing the necessary repairs will result in significant impairment of the thermal insulation properties of the partitions, reduction in mechanical resistance (e.g. to compression or damage resulting from regular freezing) of the ceramic brick and mortar used to erect the walls, and will lead to corrosion of the steel construction elements (Klein ceiling beams), destruction of plaster and elevations with valuable historical motifs. Excessive moisture content favors the development of bio-corrosion (moss, mold, lichens, pests), which, apart from degrading the building, has an adverse impact on the microclimate inside the spaces. The crystallization of mineral salts from groundwaters inside the pores of building materials is an uncommonly dangerous phenomenon for the technical condition of construction elements.

According to the authors, the suggested method for use in the described building could be the injection method. It is a relatively simple method to be implemented in this type of facilities and the cost is acceptable. Additionally, insulation of buildings should be considered. This can be done using eco-friendly, easily accessible placement of materials [4].

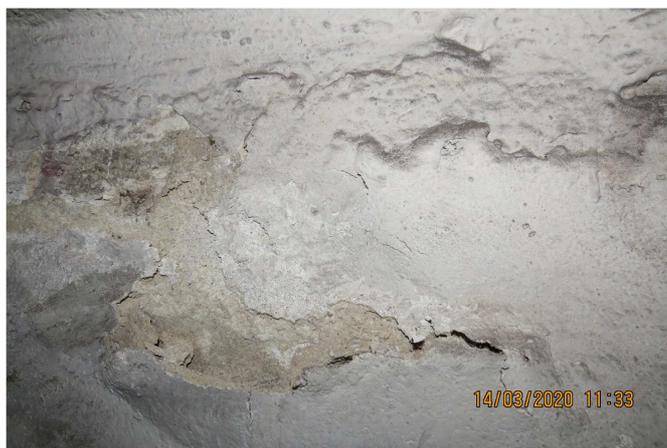
constructed [2]. Also, the bricks in the Klein ceilings above the basement show medium and high humidity.

Fig. 8. Damaged external surface of Klein ceiling in the basement (author photo)
