## EXPERIMENTAL TESTS OF THE VECTOR II SLAB IN FIELD CONDITIONS, SLAB AND STRIP MODEL

Vector II slab was tested on a natural scale (a slab with a dimension of  $6.30 \times 6.30$  m) and a strip 6.30 m long and 1.20 m wide. The Vector II slab is built by precast panel 60 cm wide, 4 cm thick and 14-20 cm thick concrete overtopping on the construction site. The main purpose of the slab tests on a natural scale was to observe the "faulting" effect and temporary deflections. During the tests, the displacements in the area of the panel joints in the middle of the slab span were recorded. The maximum difference in displacement between adjacent panels of the slab model was 0.16 mm, and the vertical displacement was 1.9 mm. The strip model had no cracks that could indicate a interface cracks between the precast element and the concrete overlay. After completion of the field tests, the load was left on the slab model to verify long-term effects.

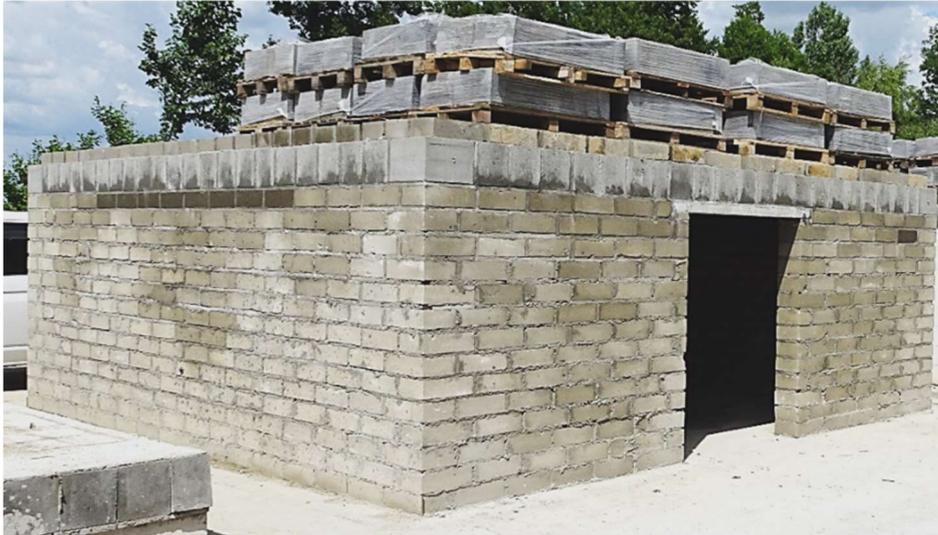
Fig. 2. General view of the model

The tests were carried out on a full-size model of the Vector II slab. The model was made on walls made of 240 mm concrete blocks. Precast ring beam elements are placed on the walls (Fig. 2). Two openings were made in the walls, covered with prestressed concrete system lintels SBN 7.2/12/180 and SBN 12/12/210. The dimensions of the model are  $6.30 \times 6.30$  m, and the total height is 2.24 m (Fig. 4). The slab was designed following the producer guidelines as Vector II 20/60 4.81, where the symbol defines the type and reinforcement of the precast element. The total thickness of the slab was 200 mm (160 mm of concrete overtopping). Both the precast element and the concrete topping were made of C20/25 class concrete. There are two distribution ribs, consisting of an upper and lower bar  $\phi 10$  mm (class C) and stirrups type S  $\phi 6$  mm (made of steel class A), spaced every 300 mm. The distribution ribs were placed on the precast plate (Fig. 3). In the axis of the lattice, support reinforcement was made of one  $\phi 10$  mm rebar ended with a straight hook in the ring beam.

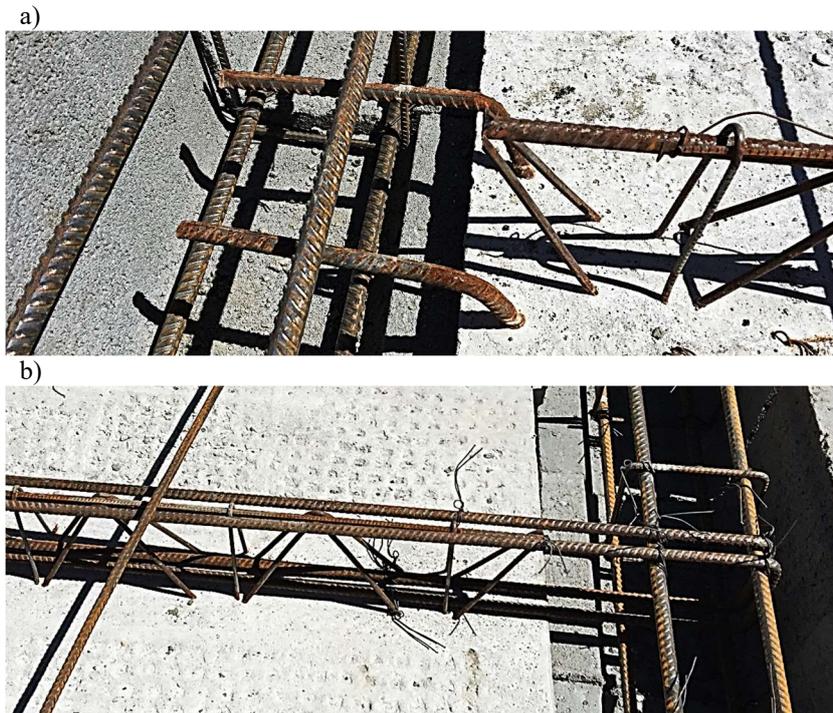
Fig. 6. Support reinforcement: a) rebars anchored from the top surface, b) U-type rebars

The same type of Vector II panels was used to make the strip model. The strip model is based on two edges (Fig. 5), achieving a one-way work, consistent with the producer design tables. The total length of the panel was 6.30 m and a width of 1.20 m - two Vector II panels. A 160 mm thick concrete overlay was made. Different support reinforcement was used, one of the supports had bars anchored from the top surface in the rim (Fig. 6a) with the upper bar ended with a hook in

the rim, and the other U-type bar (Fig. 6b) played onto the surface of the precast element. The panels did not rest on the ring beams but ended up touching them.

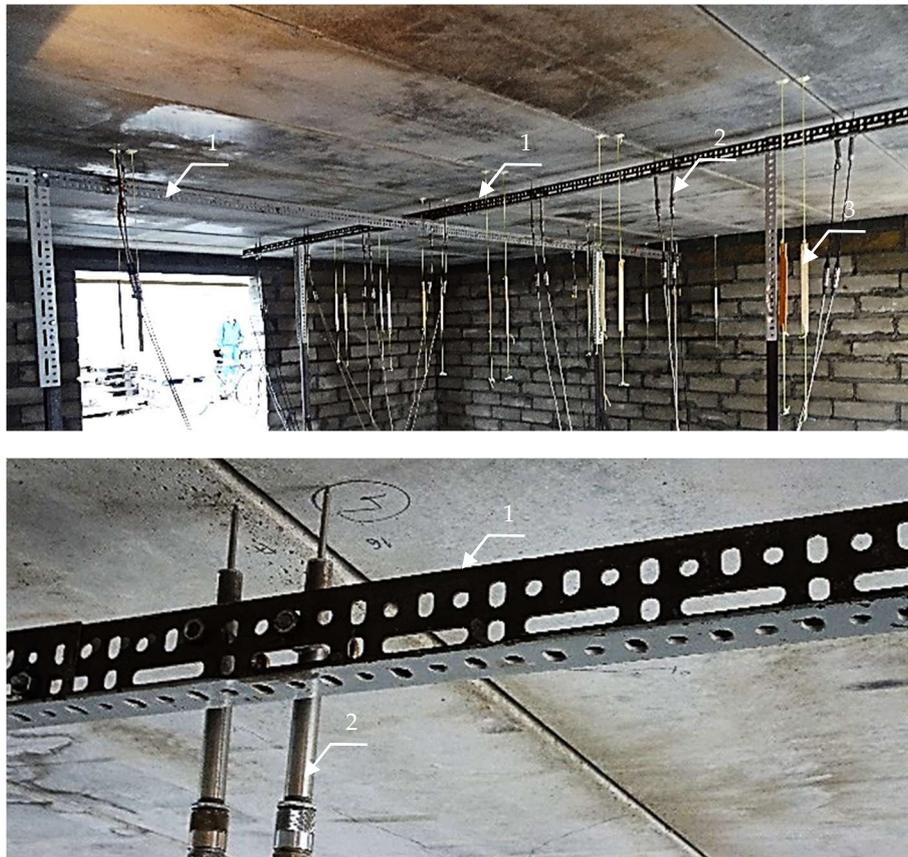
Fig. 7. Overall view of inductive sensors arrangement: 1- steel frame, 2- LVDT sensor, 3- geodetic marker

Short-term displacements were recorded using linear displacement transducers (LVDT) of the PJX-10 and PJX-20 type with the accuracy of indications equal to 0.002 mm. The sensors were attached to a steel frame support on a reinforced concrete slab (Fig. 7). Fig. 8 shows the arrangement of the sensors along the axis of the door openings and the joint of the middle panels. The sensors were placed approximately 25 mm from the panel joint; the distance between adjacent sensors was about 50 mm. In the strip model, displacements were measured in a geodetic manner in points located on the upper surface of the model (Fig. 5). The accuracy of the measurements was 0.5 mm.

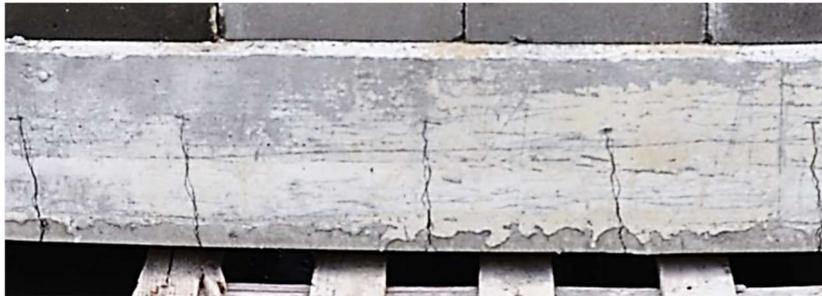
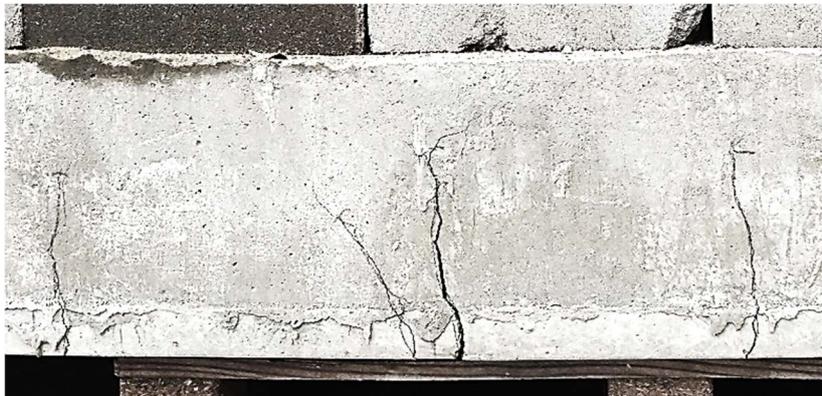
Fig.17. Cracks of the strip model: a) load  $17.3 \text{ kN/m}^2$ , b) crack in the middle of the span after failure, c) cracks near the support, d) view of cracks along the length of the slab after failure

The results are presented for the edge covering measurement points number 1-5. The difference in displacements between the edges was not more than 3 mm. The increase was proportional to the load, up to the value of 51 mm at 13.2 kN/m<sup>2</sup> (Fig. 16). After this step, the crack width exceeded 0.2 mm (Fig. 17a). The last complete reading was taken in scheme 7, where the displacement of 87 mm was recorded. The maximum load was over 18.5 kN/m<sup>2</sup>, and its distribution along the panel length was not even. There was a sharp increase in the crack opening in the middle of the panel span (Fig. 17b). With the load under the diagram 8, the maximum displacement of 122 mm was recorded. There were no cracks of the joint between the precast element and the concrete topping in the zone above the support - Fig. 17c. The image of the cracks on the side edge of the model after destruction is shown in Fig. 17d.

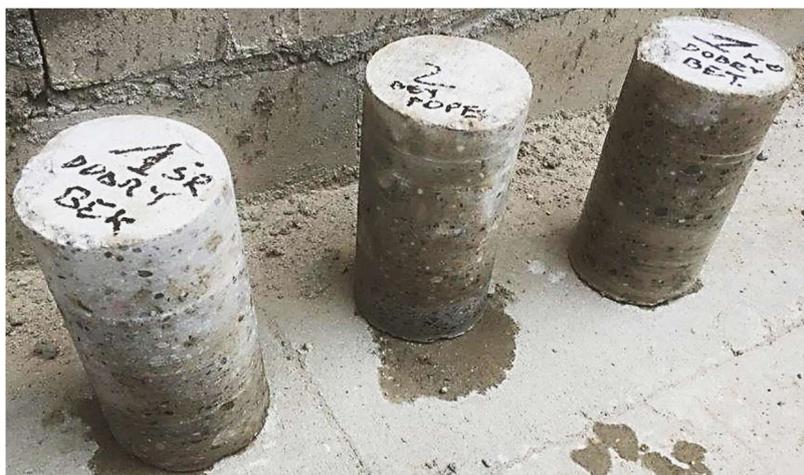
Fig. 19. Cores from the mid-span and support zones

After completion of the tests, five core samples were taken from the panels, which were used for the internal visual inspection of the joint between the precast element and the concrete topping and to determine the compressive strength of the overlay. Based on the performed visual inspection, no interface cracking was found at any point in the model (Fig. 19). Strength tests and then qualification carried out following PN-EN 13791: 2008 showed that the characteristic

compressive strength was  $f_{ck, is} = 29.5 \text{ N/mm}^2$ . On this basis, the concrete overlay can be classified to the strength class C30/37 (against the designed C20/25).
