COMPARISON OF LEAK DETECTION METHODS USED FOR TESTING LARGE AREA MEMBRANE ROOFS FOR DURABILITY ASSESSMENT PURPOSES

Barbara KSIT¹, Maria RATAJCZAK^{1*}, Agata ŻYLÍŃSKA¹
Poznań University of Technology, Faculty of Civil and Transport Engineering

This article presents different types of commercially available roof waterproofing membrane systems used on roofs with large surface area. It deals with the causes of deterioration of such membranes due to environmental factors and describes the tests used to detect leaks and determination of the severity of deterioration of polymeric membranes taking into account the properties declared by their manufactures. The last part of the article is a case study comparing a brand new membrane with a membrane after 27 years in service.

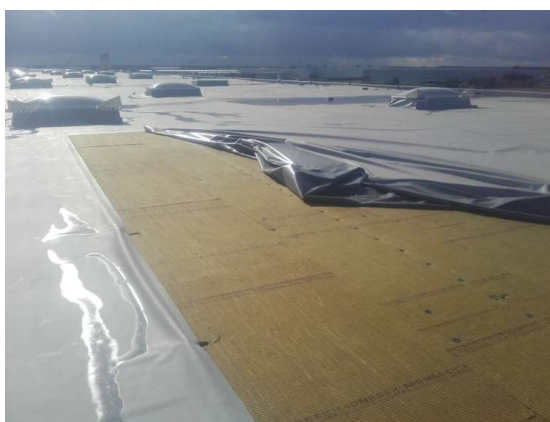
Fig. 1. Damage to roof sheathing caused by the action of wind [13]

The loads acting on a roof covering can be divided into mechanical and thermal loads of high or moderate severity. An example of mechanical loads is negative wind pressure (suction), a high impact load to which much attention is paid in the design of the roof covering system [10]. Negative wind pressure is the cause of damage to roof coverings during strong storms or hurricanes (Fig. 1) [22, 13].

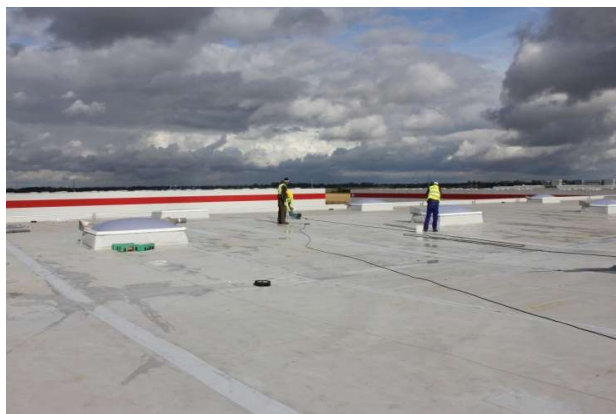
Fig. 2. Ponding water due to incorrect roof falls [Photo by Barbara Ksit]

Waterproofing membranes feature high permeability to water vapour. Due to the lack of ventilation of the roof, this feature is intended to ensure efficient evacuation of entrapped water vapour. The layers of the roofing system are laid one on top of the other without any ventilation gap in between. This being so, factors such as temperature changes can cause condensation of water vapour under the roof covering and the resulting moisture will affect mainly the remaining layers and the roof framing system. However, this is a rare cause of moisture problems. The most common problem is dampness and leaks at joints between membrane sections and between the membrane and roof details. The main property of roof membranes is the waterproofing performance and thus any leaks, other than caused by perforation should be attributed to long-term deterioration of the membrane. In any case, water vapour should not be pointed to as the cause of the moisture problem. That said, water vapour generally plays a major role in development of roof damage.

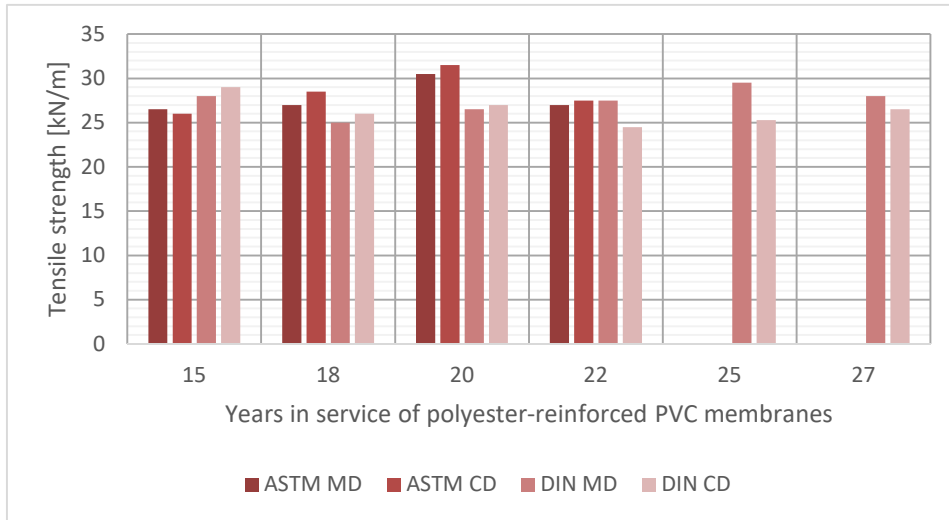
Fig. 3. Tensile strength of PVC membranes reinforced with S-type polyester (MD - machine direction, CD - cross-machine direction) [3]

The following graphs show the results of durability tests carried out on samples of PVC membranes taken from 15-27 year old roof coverings. The input data were obtained from a long-term durability report of PVC membranes [3]. These data include tensile strength and ultimate elongation of membranes reinforced with S-type polyester (Fig. 3, Fig. 4) and glass fibre mat (Fig. 5, Fig. 6). The analysed samples were obtained from several buildings located in North America (25 No.) and Europe (20 No.). Taking account of different locations, the procedures from

According to ASTM D4434 [2], the minimum required tensile strength is 35 kN/m and according to DIN 16726 [4] it is 16 kN/m. According to the DIN requirements, all the tested samples, both North American and European ones, met the requirements for brand new products, exceeding the minimum threshold by 60-75%. On the other hand, North American samples obtained 70-90% of this value, yet with the application of the 35 kN/m requirement. Changes in ultimate elongation due to long-term exposure in service are shown in Figure 4. The tested North American samples reached the minimum ultimate elongation of 15% as required by ASTM D4434 [2], and all samples reached the minimum value of 10 % as per DIN 16726 [4].

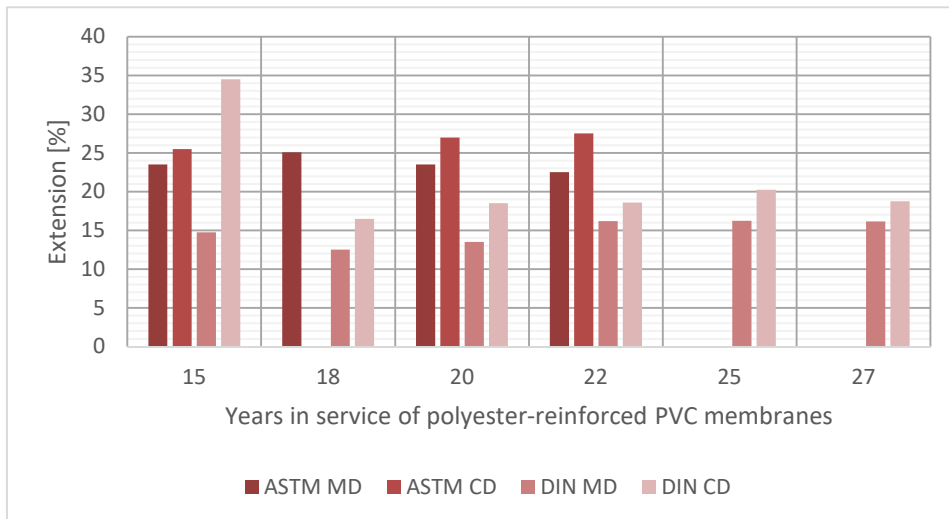
Fig. 4. Ultimate elongation of PVC membranes reinforced with S-type polyester (MD - machine direction, CD - cross-machine direction) [3]

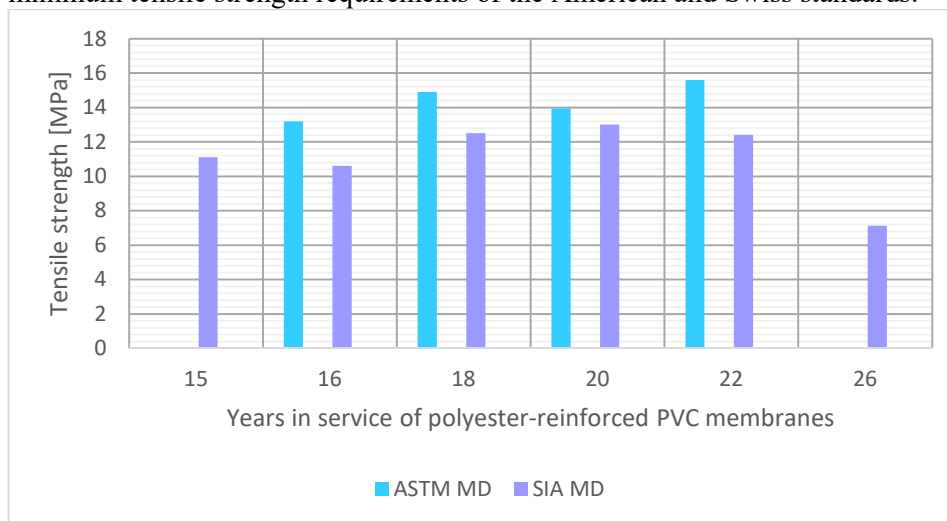
Fig. 5. Tensile strength of glass mat reinforced PVC membranes [G-type] (MD - machine direction) [3]

The values of tensile strength and ultimate elongation were compared also for PVC membranes reinforced with glass fibre mat (G-type) (Fig. 5, Fig. 6). During the tests carried out according to ASTM D4434 (North American samples) [2] and SIA V 280 (European samples) [18] it was observed that, strangely enough, the tensile strength tended to increase between 15 and ca. 22 years in service. In the case of these products it is important to note that the strength parameters are defined primarily by the properties of the polymer component. Therefore, in strength tests the thickness of the specimen is recorded and the strength value is given in MPa. As the plasticizer content decreases over time, the polymer loses its flexibility, which can lead to a higher tensile strength. The data obtained on membranes after 20 years in service do not provide sufficient basis to predict further progress of the described changes. All the tested samples satisfied the minimum tensile strength requirements of the American and Swiss standards.

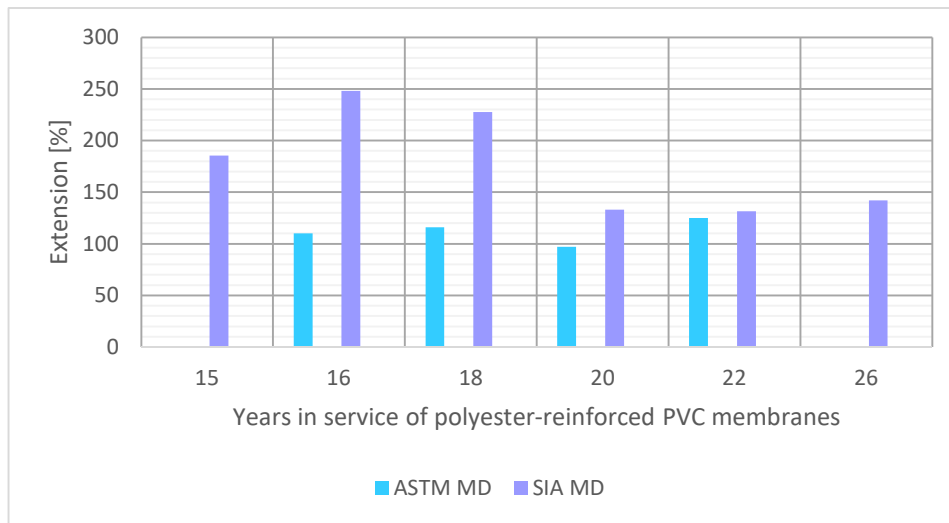
Fig. 6. Ultimate elongation of glass mat reinforced PVC membranes [G-type] (MD - machine direction) [3]

For brand new materials the minimum required elongation at break is 250% according to ASTM D4434 [2] and 150% according to SIA V 280 [18]. The tested samples, after 15-26 years in service, on average achieved about 61% and 84% of the values required by the US and Swiss standards respectively. It was determined that this deficiency has no significant effect on the further operation the roof coverings in question. The membrane was judged to still serve its purpose [3].

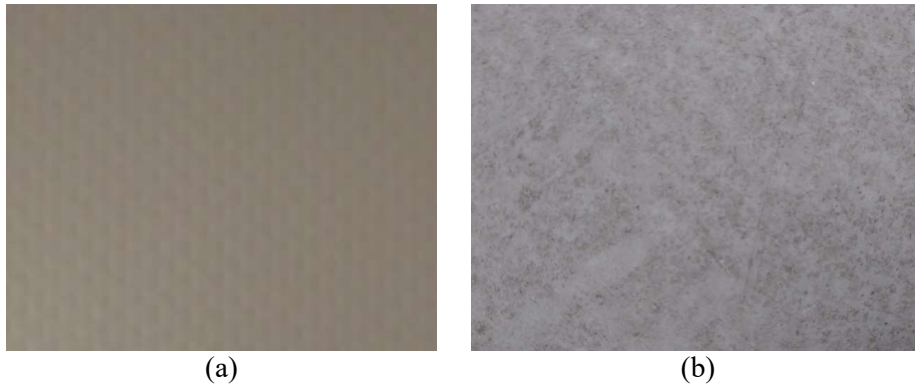
Fig. 7. Surfaces of PVC membranes: brand-new material (a) and sample of the material after 27 years in service (b) [Photo by Agata Żylińska]

examined for: visible defects [9], geometric characteristics (length, width, straightness, flatness) [8], effective thickness and weight per unit area [11]. During the visual evaluation (unaided eye) only natural build up of dirt was detected without any significant changes in the structure, cracking, damage or alligating indicating a considerable loss of plasticiser (Fig. 7).

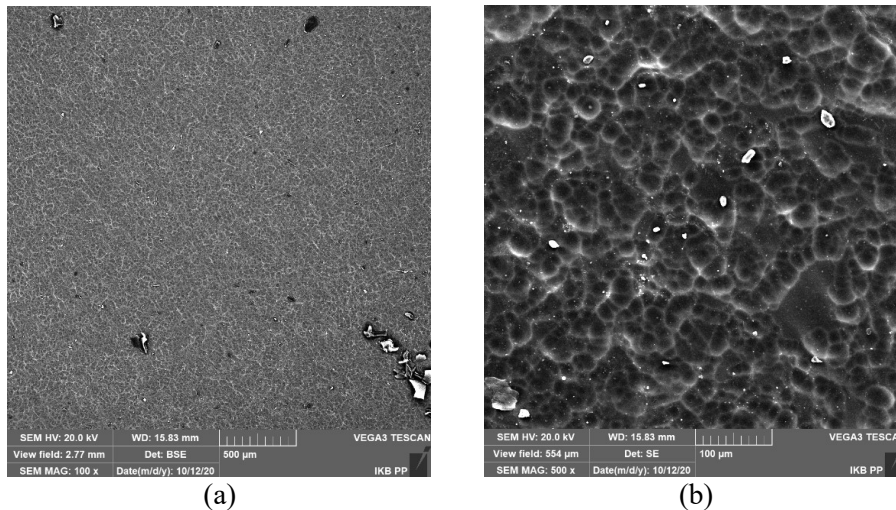
Fig. 8. SEM images of a new membrane, magnification: 100x (a) and 500x (b) [Photos by Maria Ratajczak]

The following figures compare SEM images of a new, control material (Fig. 8) and the tested piece of roofing membrane produced by the same manufacturer (Fig. 9). The SEM examination showed some degree of membrane deterioration.

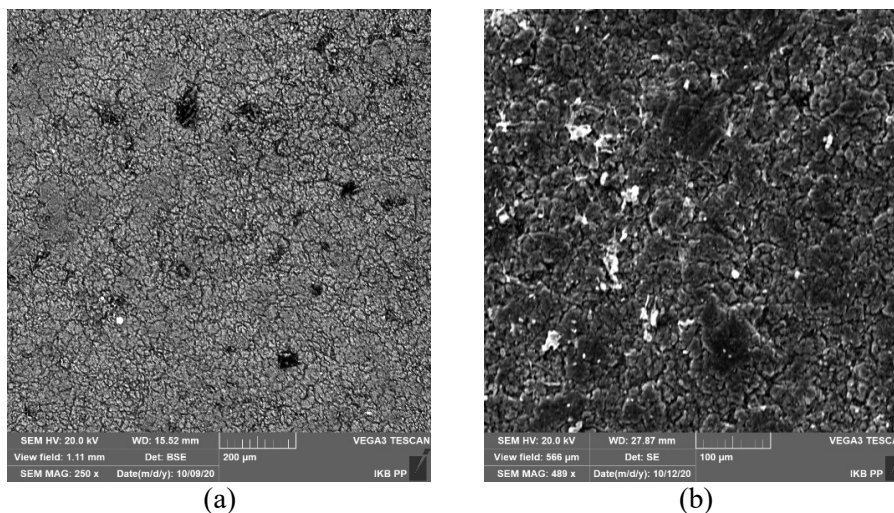
Fig. 9. SEM images of a membrane after 27 years in service, magnification: 250x (a) and 500x (b) [Photos by Maria Ratajczak]

Picture No. 9 shows characteristic alligatoring, an indication of a loss of plasticiser, which is particularly evident in Picture No. 10 taken at 2.0-k magnification.

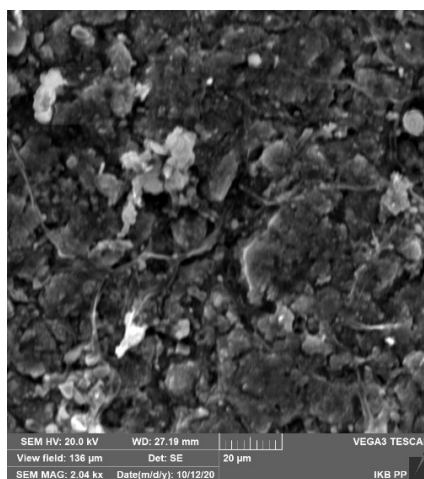
Fig. 10. SEM images of a membrane after 27 years in service, magnification: 2.0-k [Photo by Maria Ratajczak]

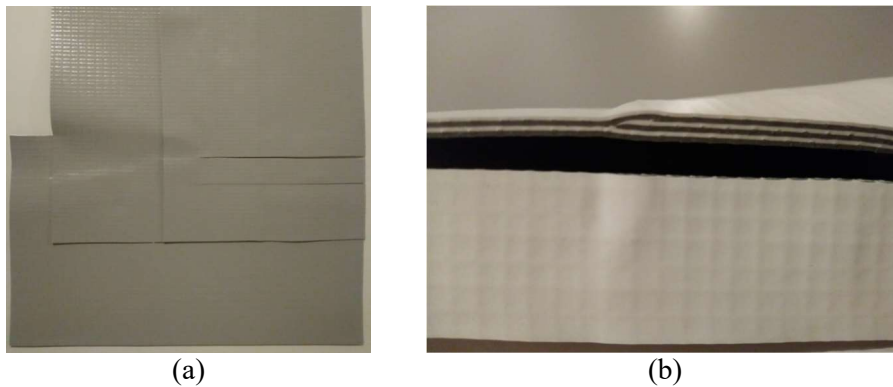
Fig. 11. Control T-type joint – view (a) and cross-section (b) [Photos by Agata Żylinska]

A control T-type joint was also checked, which is preferred over cross-joints in terms of long term integrity and strength. Before welding, the membrane pieces are bevelled to obtain a tight fitting and continuous joint. The sample passed the

macroscopic evaluation. No delamination or discontinuities were found within the seam (Fig.11). Microscopic examination of the joint confirmed good quality of workmanship and uniform structure of the entire joint (Fig.12).

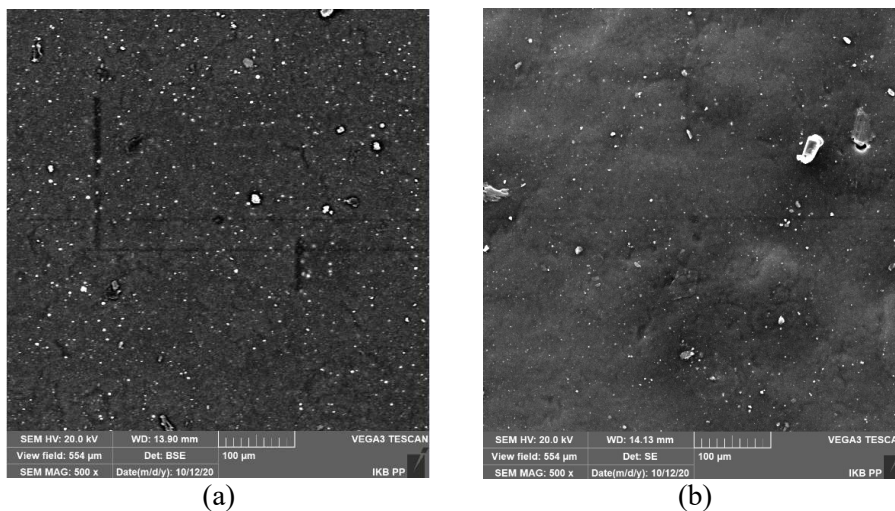
Fig. 12. SEM image of a T-type joint of a brand new roofing membrane [Photos by Maria Ratajczak]
