**RECONSTRUCTION OF THE RAILWAY STATION
BUILDING IN ŚWIEBODZICE AS THE AVANT-GARDE
OF THE MODERN RENOVATION.
ARCHITECTURE OF THE BUILDING SPACE IN THE
CONTEXT OF THE CREDIBILITY FEELING SPACE**

Faculty of Architecture, Silesian University of Technology,
Gliwice, Poland

Abstract

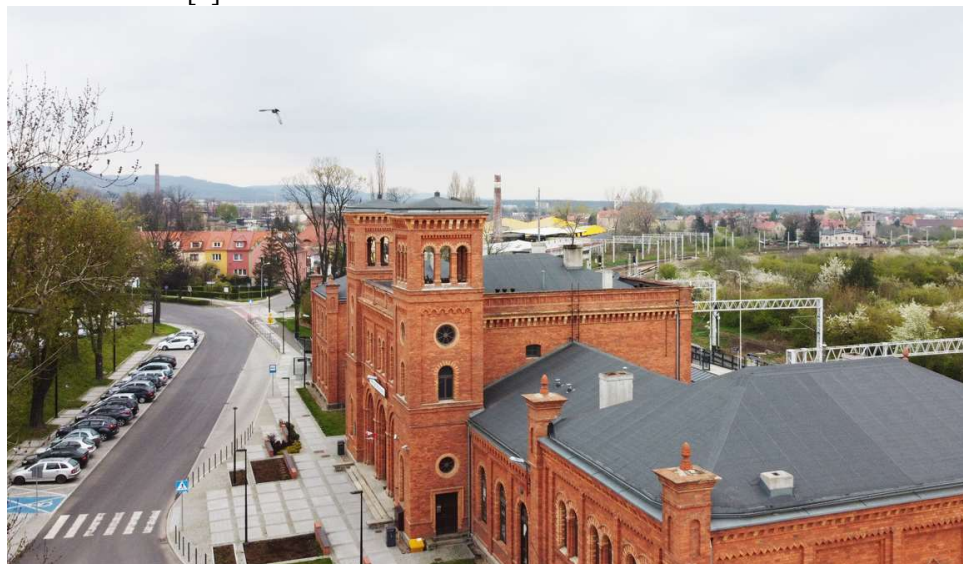
Fig. 1. Bird's eye view after renovation and modernization, [photo credit: author, 2021]

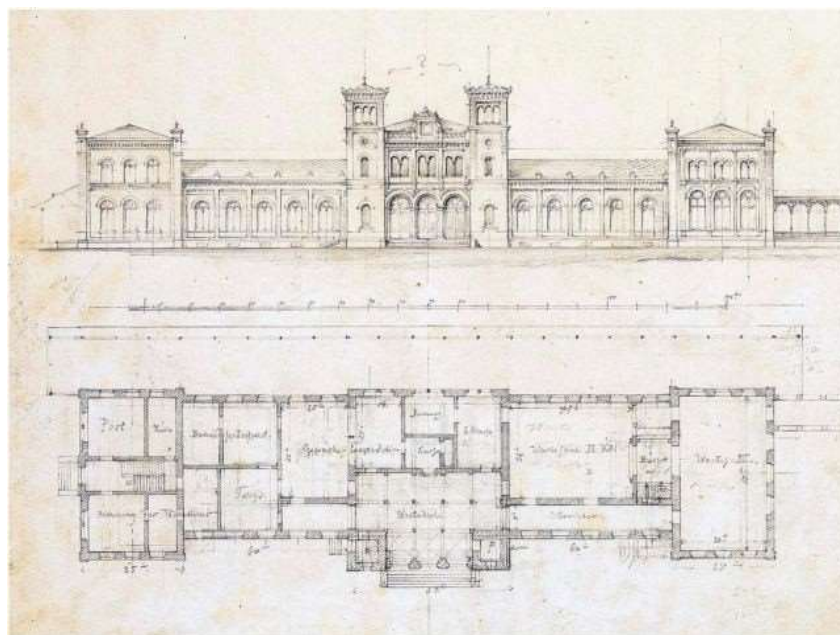
Fig. 2. South-west elevation and ground floor plan, drawings Carl Lüdecke, 1868, [10]

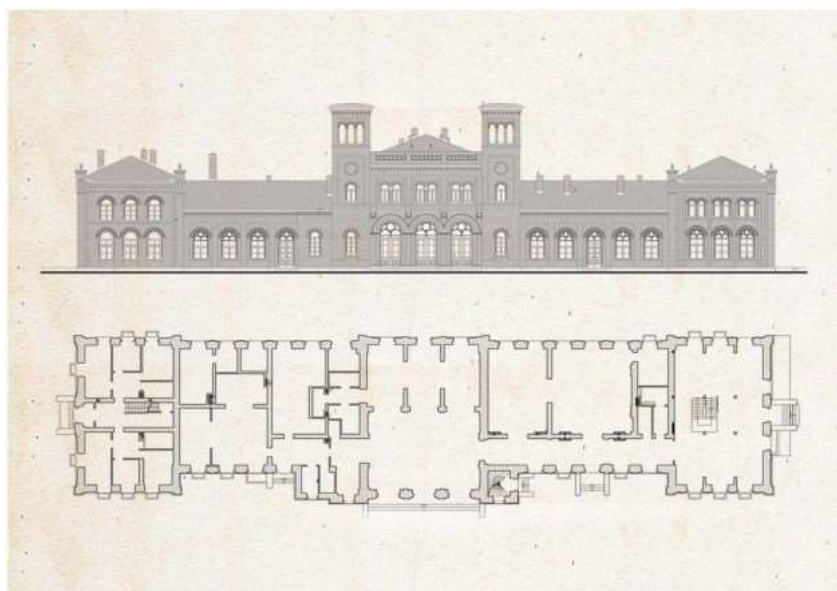
Fig. 3. South-west elevation and ground floor plan, drawings DOMUS, author, 2011, [9]

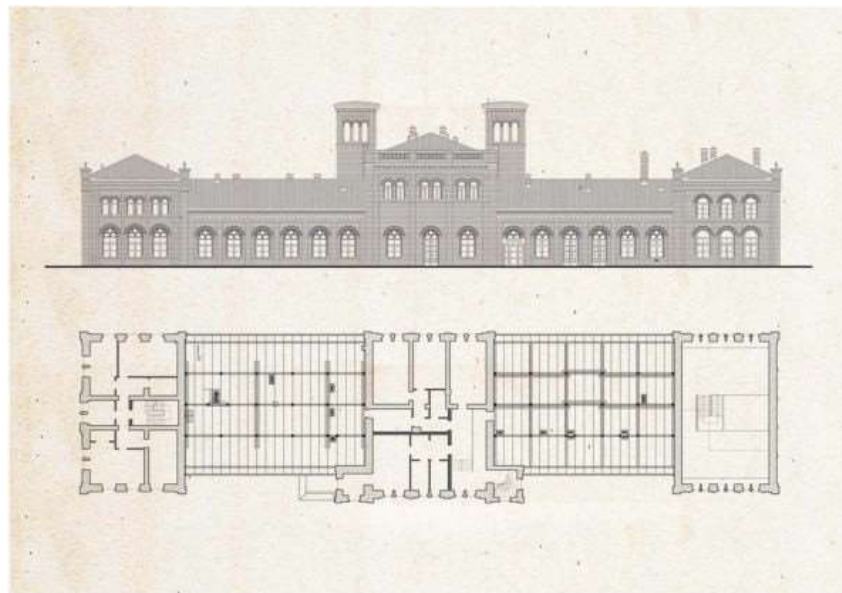
Fig. 5. North-east elevation and first floor plan, drawing DOMUS, author, 2011, [9]

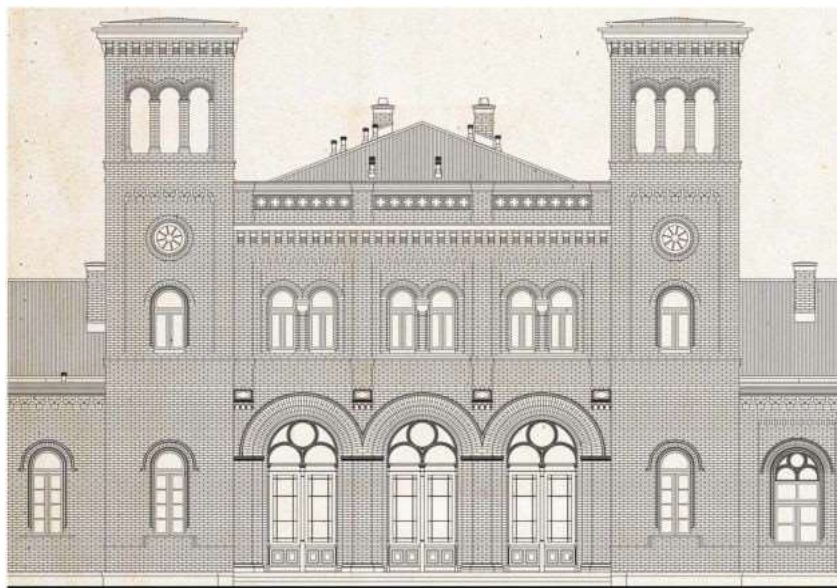
Fig. 6. South-west elevation, main entrance, drawing DOMUS, author, 2011, [9]

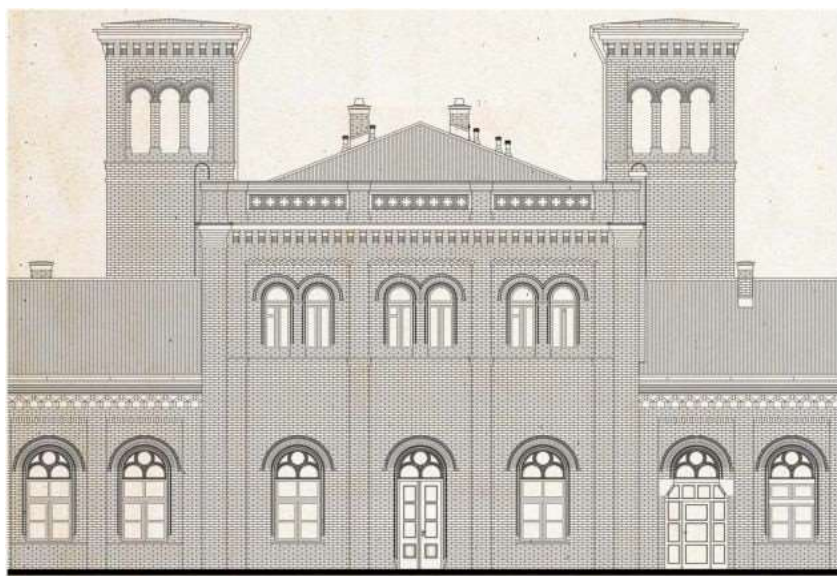
Fig. 7. North-east elevation, platform entrance, drawing DOMUS, author, 2011, [9]

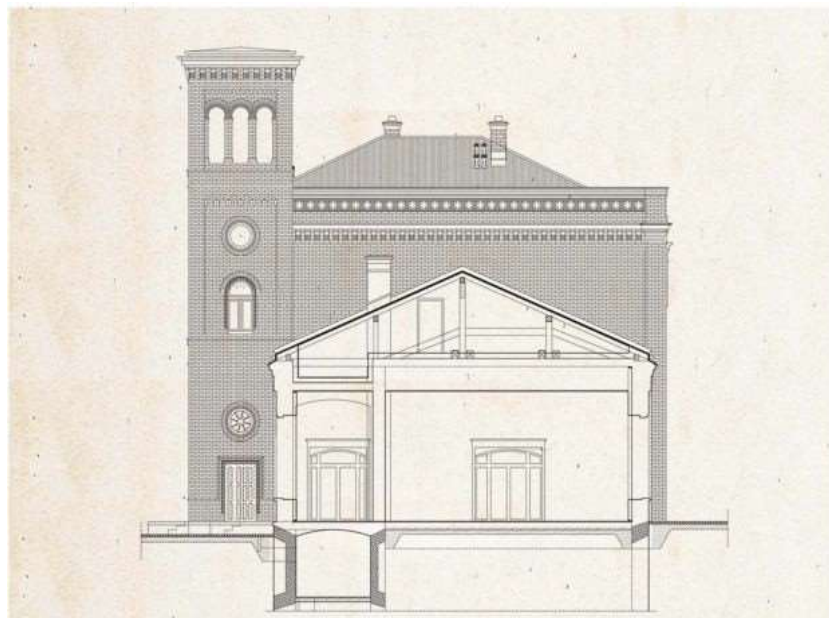
Fig. 8. Cross-section through the service areas, drawing DOMUS, author, 2011, [9]

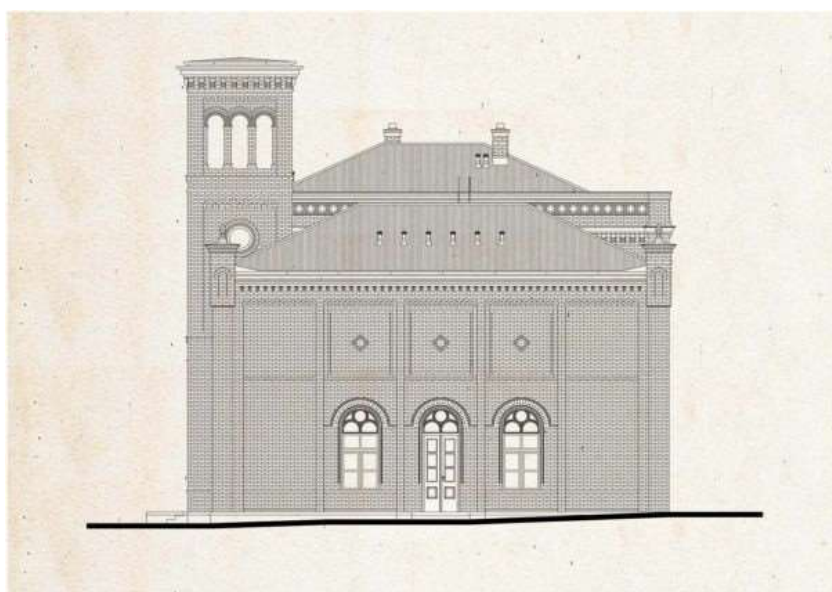
Fig. 9. South-eastern elevation, drawing DOMUS, author, 2011, [9]

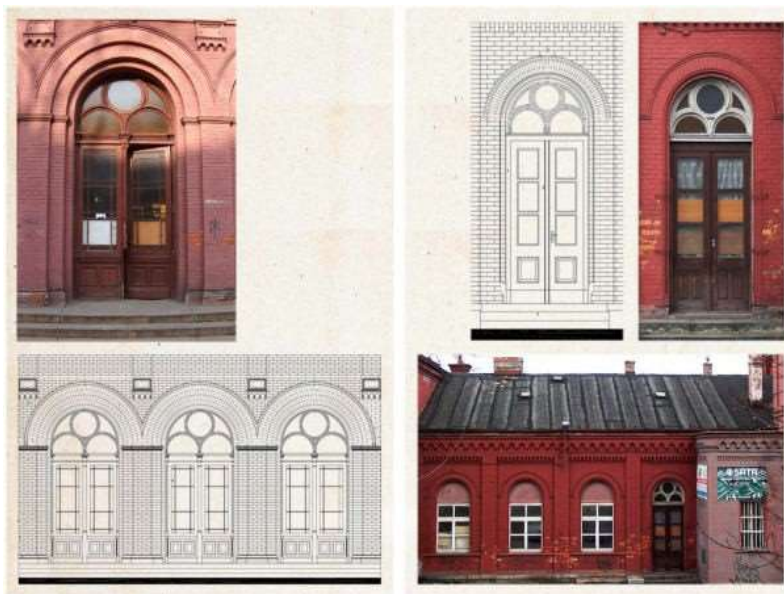
Fig. 12. Details of windows and doors inventory, photos and drawings credit: DOMUS,
author, 2011, [9]

The façades of the building are made of red face brick, which has been painted with acrylic paint. Due to improper use of the building i.e., leading to dampness in the building, the façade was degraded, the paint peeled off and bricks fell off. The scope of the damage is shown in the pictures (Figs.12,13).

- Cleaning (grinding) old, damaged paint coatings from the surface of a brick facade.
- Drying and insulation of the wall with the method of hydrophobic blockades.
- Reconstruction of brick threads in places being rebuilt and supplementing or replacing bricks in the places of any defects and gaps in the facade.
- Repair of damaged architectural details.
- Replacing the joints in the wall.
- Hydrophobic impregnation of the brick façade [9].
- The facade before renovation is shown in Figs.11,12. The façades after cleaning and renovation are presented in Figs.13,14.

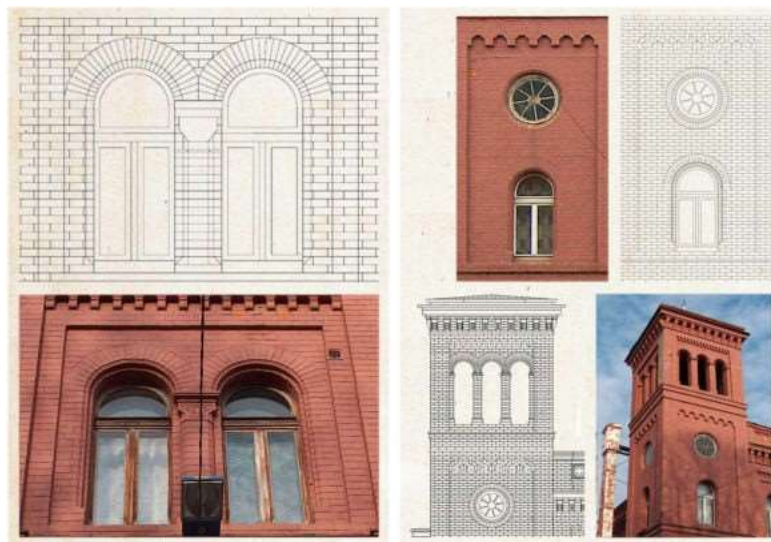
Fig. 13. Details of windows and inventory, photos and drawings credit: DOMUS,
author, 2011, [9]

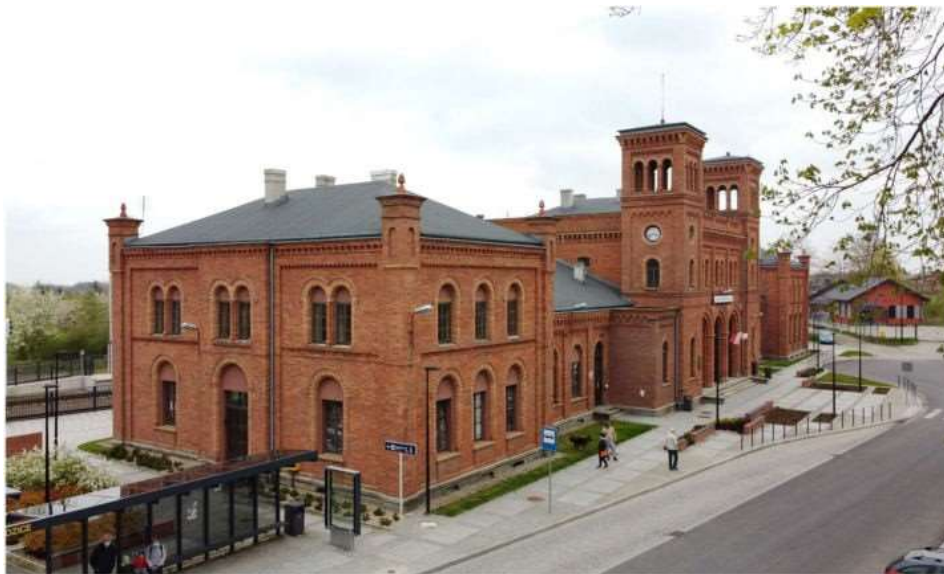
Fig. 14. Bird's eye view after renovation and modernization, photo credit: author, 2021

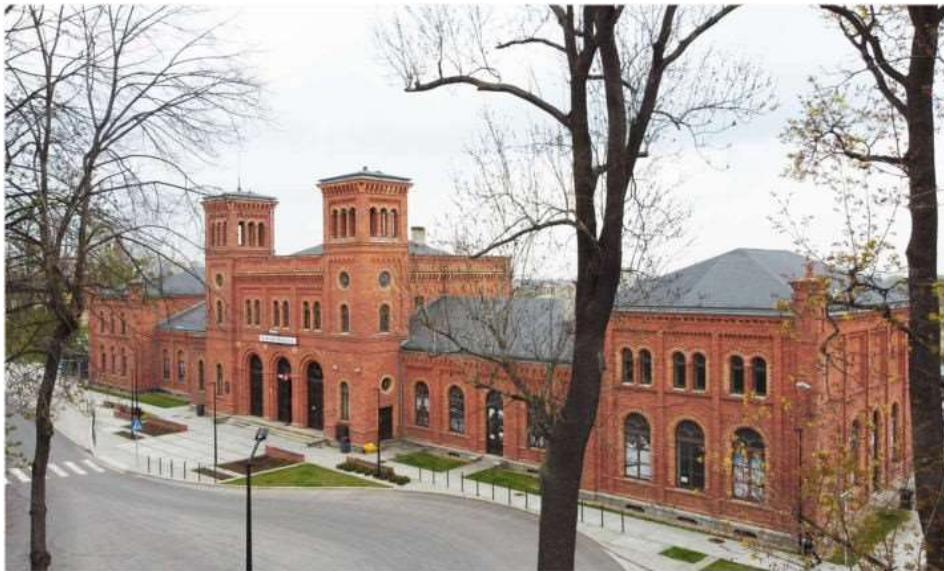
Fig. 15. Bird's eye view after renovation and modernization, photo credit: author, 2021
