## RENOVATION OF LARGE-PANEL BUILDINGS IN CONTEXT OF URBAN RENEWAL

Wiesław LIGEŻA<sup>1</sup>

The Bronisław Markiewicz State Higher School of Technology  
and Economics in Jarosław, Technical Engineering Institute, Poland

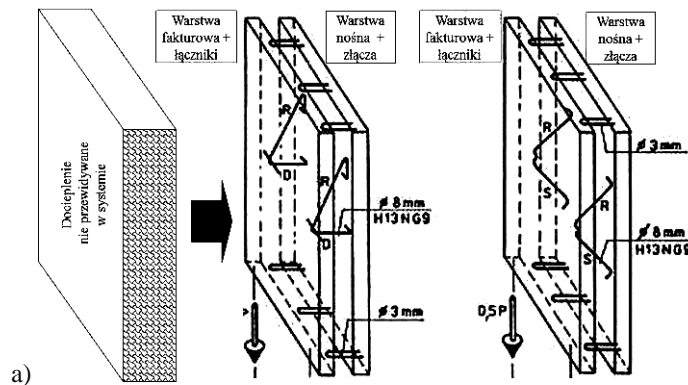
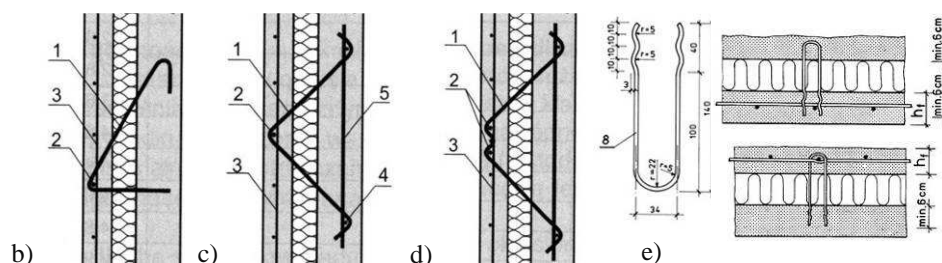
Fig. 4. Connection between load-bearing and texture layer in ZWS and ZWO type walls: a) model for joining with flexible connectors (hangers + pins), b) hanger with tensiled inclined arm, c) "one-humped" hanger, d) "two-humped" hanger, e) pins; 1 - hanger, 2 - element anchoring the hanger in the texture layer, 3 - reinforcing mesh for texture layer, 4), 5) - bar anchoring the hanger in the load-bearing layer
