ANALYSIS OF THE IMPACT OF MOISTURE AND BIODETERIORATION ON THE ASSESSMENT OF THE TECHNICAL CONDITION OF HISTORICAL BUILDINGS

This paper deals with issues related to the diagnosis of dampness and mycological tests in historic buildings. The selection of appropriate diagnostic procedures in the case of historic buildings undergoing modernisation, revitalisation or renovation is an important element of properly conducted works aimed at the preservation of cultural heritage. The article presents the issues of biodeterioration, and the scope of procedures for carrying out expert assessments of historic buildings, with emphasis on the issue of mycological testing. In conclusion, the article states that due to dynamic degradation processes caused by biological corrosion, mycological examinations of buildings containing wooden structures should be obligatory in the building law. It was pointed out that economics repeatedly determines the depth of research and thus the reliability of the analysis results obtained.

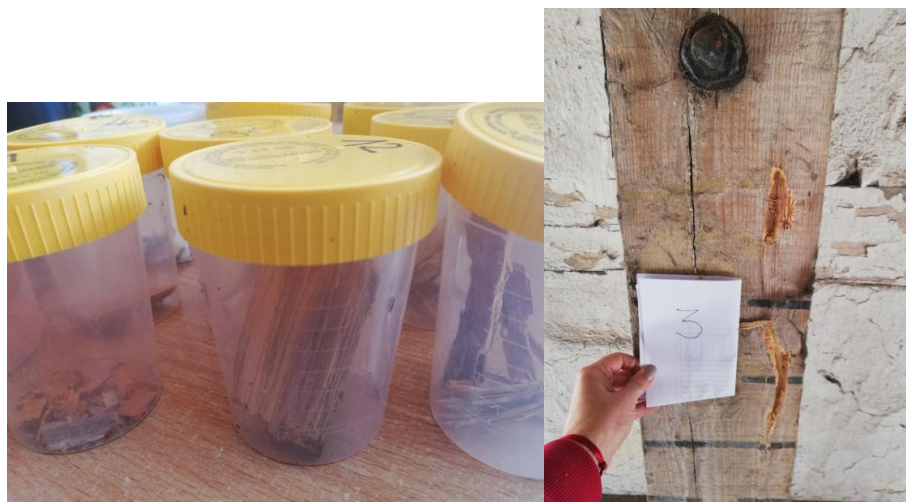
Fig.7. Containers with material collected for laboratory tests, documentation of representative sites author archive

On the day of the site visit, twelve samples were taken for microbiological testing under relative aseptic conditions from internal structural elements (floor beams, slabs, stringers, swords) and external structural elements (foundations and columns). The floor plans and Table 3 indicate the locations of the tests carried out (fig. 8).
