RENOVATION AND MODERNISATION OF A POSTINDUSTRIAL FACILITY IN POZNAŃ

Tomasz BŁASZCZYŃSKI*, Przemysław WIELENTEJCZYK,
Maciej BŁASZCZYŃSKI, Filip PIJANOWSKI
Institute of Building Structures, Poznań University of Technology

The paper presents a renovation process of a historic postindustrial building situated on premises of Gazownia Poznańska. An unprepared team of designers made a lot of mistakes and negligences, which led to additional work, repairs including. The increased scope of work also led to a substantial increase in the cost of the carried out renovations. The modernisation process was realised with the use of modern technologies, some of which for the first time in Poznan.

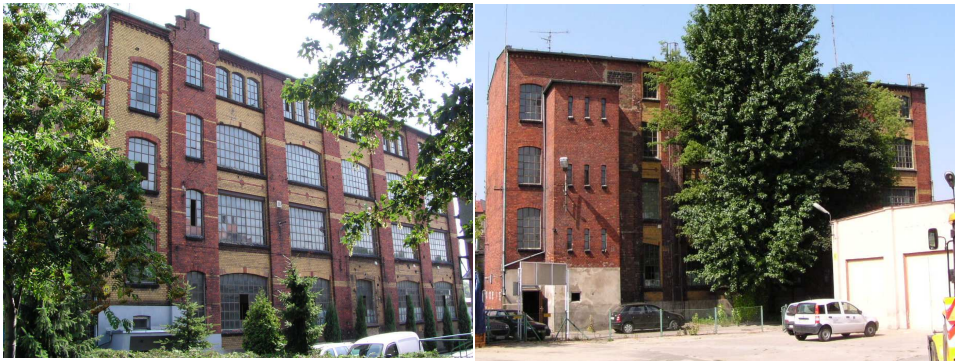
Fig. 1, 2. Dressing room - Bath house before modernisation, the front and back views

Due to the poor technical condition and safety risks of the back staircase (fig. 2), it had to be dismantled and reconstructed conforming to all the requirements of the building conservation officer (fig. 16, 17).

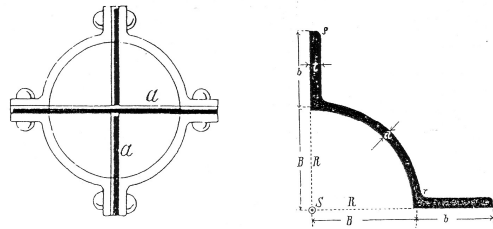
structure was applied in the building, i.e. the floors were supported on load bearing exterior walls and also on the internal column-beam system.

Fig. 8. A cross section of the column supporting the main joist
