RENOVATION AND RECONSTRUCTION OF A NEOCLASSICAL BUILDING ON THE EXAMPLE OF A PUBLIC CITY LIBRARY IN NOWA SÓL

Anna KUCHARCZYK¹

University of Zielona Gora, Zielona Góra, Poland

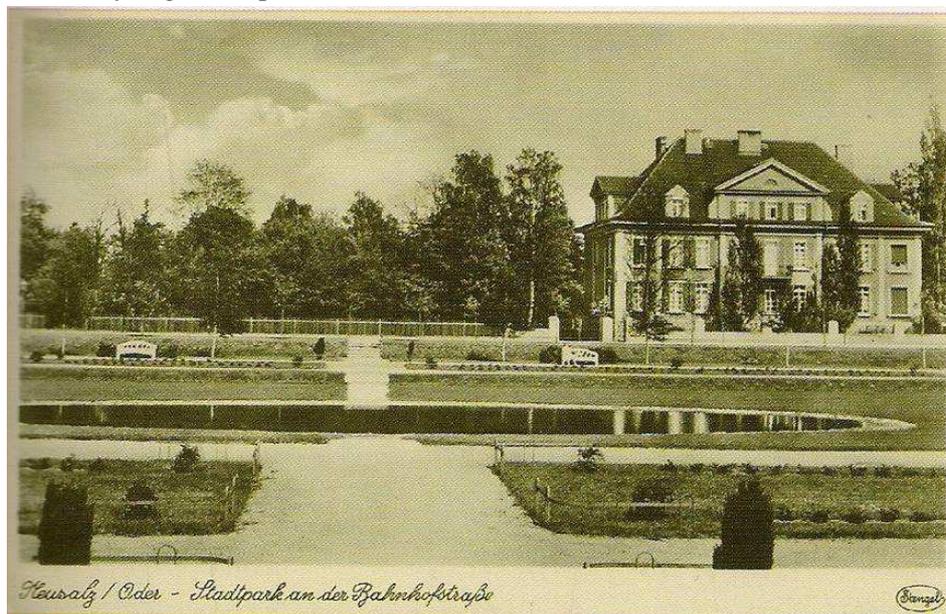
Fig. 1. View of the building from the direction of the city park.
Postcard from the 30's of the XX century. Source: Collection of the City
Museum in Nowa Sól.

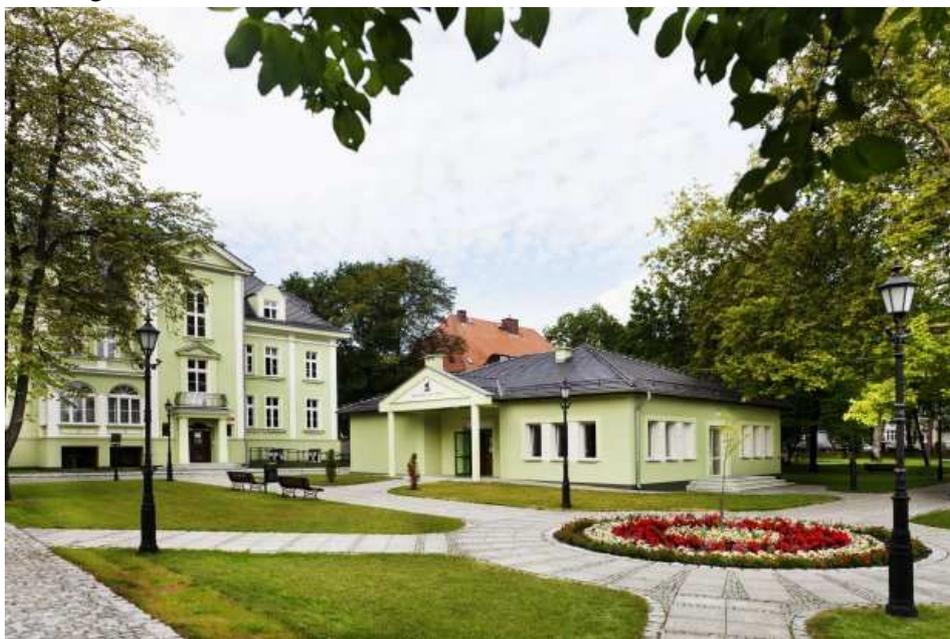
Fig. 6. New headquarters of the City Public Library. Source: Materials of the Marshal Office in Zielona Góra

The new MBP headquarters on Bankowa Street fulfill all qualities, esthetic as well as functional. The building, which had been falling into ruins during the time it functioned as doctors' clinics, was given a "second life". The elevation of the building was beautifully restored providing access to the handicapped and inside rooms were adapted to serve library functions. The library is equipped with modern electronic devices, which facilitate providing fast service to readers, ongoing registration of volumes and using electronic library cards. Halls for organizing book readings, meetings with authors and other cultural events are present in the building. The entire building is surrounded by a green park referred to as the Art Garden, where one can find, among others, a fountain, pergola, mini amphitheater, area for playing chess in the open air and parking places. As a result of such activities, a representative building which has been the home of the MBP since 2011 was created. The previous headquarters had been located in a building near the corner of Parafialna and Szkolna Streets. Despite applying modern devices and technologies, the MBP building has maintained its historic nature.
