ANALYSIS OF CHANGES TO STEEL FOOTBRIDGE GEOMETRY WITHIN 25 YEARS IN SERVICE

Jacek SZTUBECKI¹, Adam BUJARKIEWICZ¹, Justyna SOBCZAK-PIĄSTKA¹, Tomasz JANIĄK¹, Jarosław GAJEWSKI¹
University of Technology and Life Sciences in Bydgoszcz, Bydgoszcz, Poland

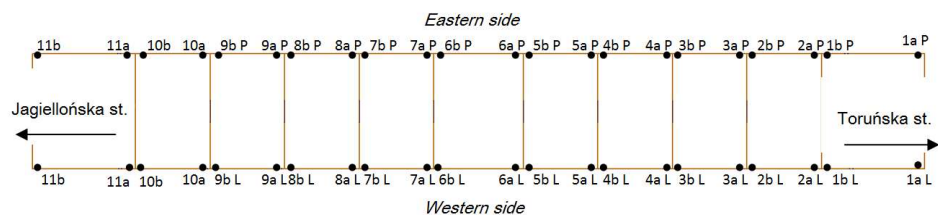
Fig. 1. Plan of control point arrangement

Between 1992-1994, the footbridge was being renovated and adjusted to improve its geometry. The 2017 measurements were performed with reference to technical documentations received from the Municipal Road and Public Transport Administration in Bydgoszcz (in the same points). According to the documents, control points were placed at the outer edges of footbridge spans, above stay cable fixing points (Fig. 1). Points on the left lane of the footbridge were labelled with the letter L, those on the right lane – with the letter P.

Each point was referred to the benchmark located in the vicinity of point 11bP on a support on the Eastern side. Elevation of the benchmark was assumed to be 37.2800 m.

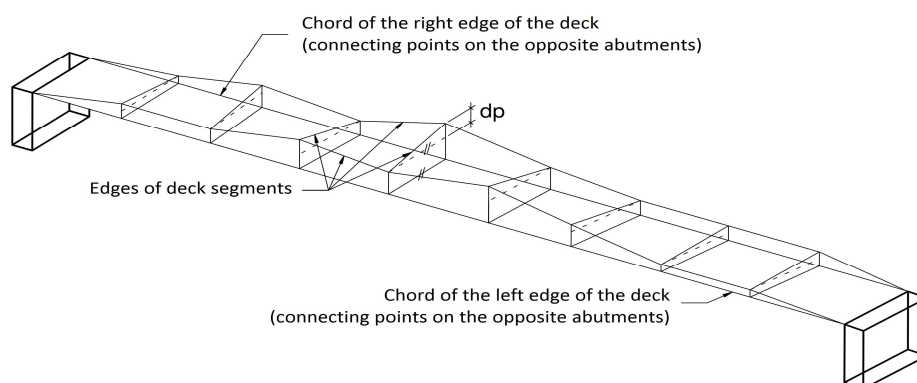
Fig. 5. View of the footbridge with the dp quantity shown

While analysing the geometry of the footbridge, one can observe that there is a difference between ordinates measured in points lying in cross sections on its

opposite sides, i.e. the so-called crosslevel. In order to analyse this geometrical anomaly of the footbridge, the difference between the crosslevel calculated on the basis of measured ordinates and the one calculated on the basis of theoretical ordinates was determined. This quantity was shown in Figure 5 and marked with the symbol dp .

On the other hand, the charts for crosslevels shown in Figure 7 show that, in the course of the last 23 years (from the adjustment of 1994 to the next measurements in 2017), significant crosslevel changes occurred only in the three middle segments of the footbridge, whereas other segments actually retained their transverse inclination. Of particular significance is the change in crosslevel on the border of segment 3 and 4 (abscissa of ca. 25 m). This might be evidence of loosened connection between these segments or even of its being damaged.

- ◆ Second adjustment of the pull of footbridge cable stays is recommended. While doing this, an approach to the design of this adjustment other than the one used in the years 1992-94 has to be implemented. The predicted effect of the adjustment should be achievement of correct geometry of the footbridge gradeline (as opposed to both of its edges) and equalisation of forces in cable stays. Such an adjustment will restore static operation of the footbridge as initially assumed in the design.
- ◆ A technical inspection of the footbridge should be conducted, and special regard should be paid to the structure of segment 4 and the connection between segment 3 and 4.
