## **TECHNICAL ASPECTS OF RENOVATION OF THE 16TH-CENTURY ROOF TRUSS**

Beata NOWOGOŃSKA<sup>1</sup>

University of Zielona Góra, Zielona Góra, Poland

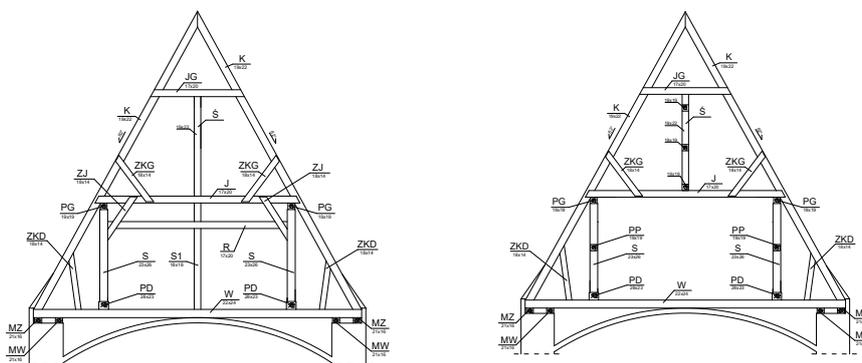
Fig. 1. Truss cross-section - full truss W1 Fig. 2. Truss cross-section - empty truss W1a

Truss structure is of collar beams with two supporting walls reinforced with transoms. Full trusses are additionally reinforced with a spreader beam. Between the full trusses in the longitudinal direction braces stiffening the structure. The cannula is additionally supported with braces.

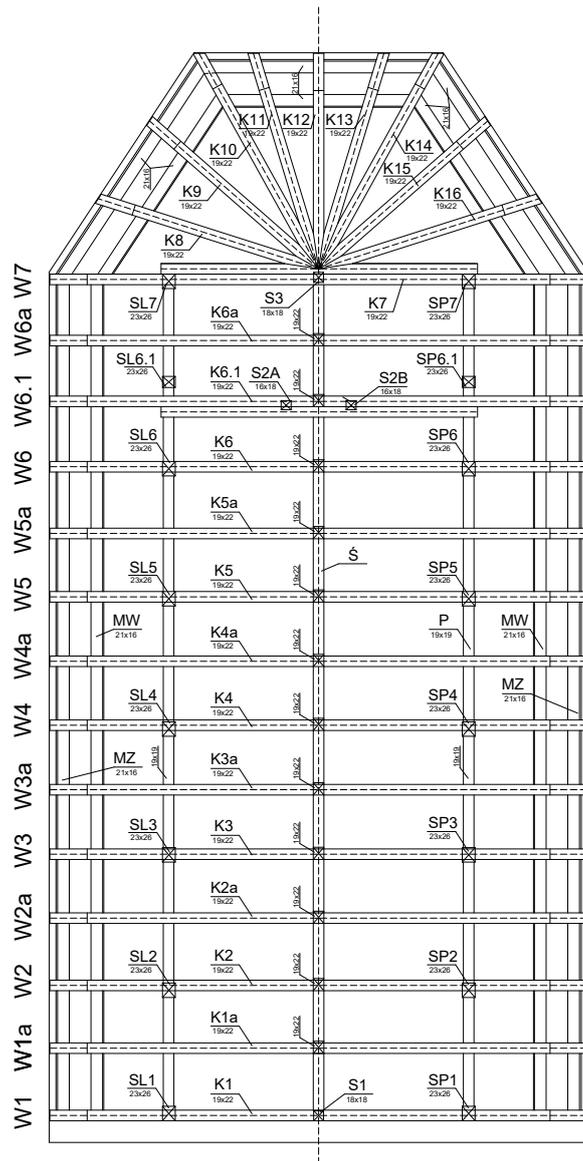
Fig. 3. Roof truss projection

In the upper part of the roof, a wooden mullion-transom frame is supported on the yards, additionally stiffened with braces running in one direction. The frame supports the tabs on the upper level. The truss is based on truss beams laid on two platforms.
