IDENTIFICATION OF THE CAUSE OF THE STEM NECK FRACTURE IN THE HIP JOINT ENDOPROSTHESIS

The aim of this paper is to evaluate the cause of the fracture of the Aura II stem neck, an element of the endoprosthesis implanted in a patient (male, 73), which occurred 6 years after the surgery.

The material under examination is the cemented Femoral Stem Aura II endoprosthesis (size 6 left, 5°42', 12-14 – material: Stainless Steel), reference number P0125006, batch number 0000372523, manufactured in October 2008, together with the Modular Head Component (28 mm, 12/14, Taper, Plus 3,5 mm, Neck, material: CoCr), reference number 53-131228, batch number 0000386265. The hospital

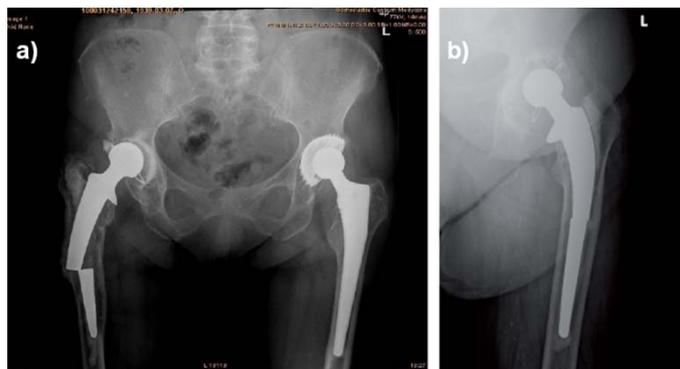
Fig.1. Endoprosthesis stem fractures: a) with the shaft of the femoral bone (the material of the Faculty and Clinic of Orthopaedics and Musculoskeletal System Traumatology at the Silesian Medical University in Katowice), b) isolated distal part of the Weller endoprosthesis stem [11].
