RATIONAL MANAGEMENT OF WATER RESOURCES IN THE BASIN OF A BIG RIVER IS NOT EASY

Urszula KOŁODZIEJCZYK
University of Zielona Góra

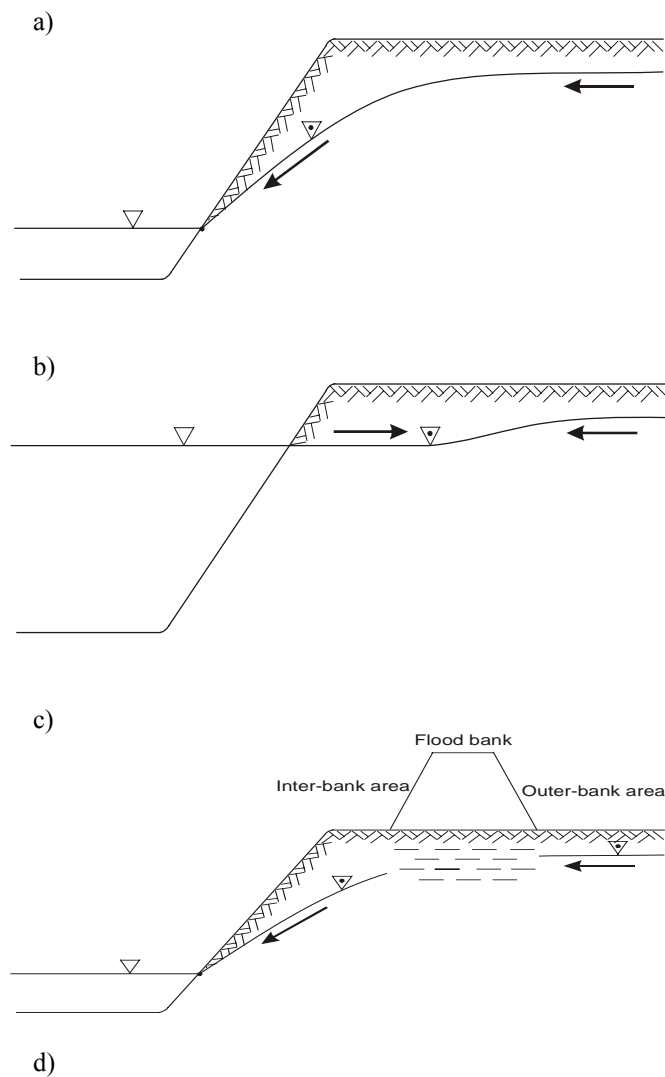
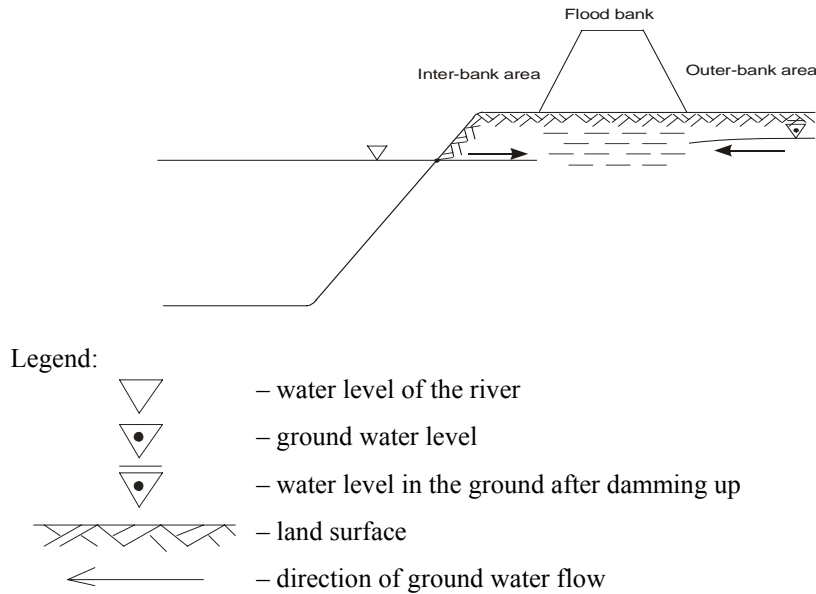
Fig.1. Diagram processes taking place in a river valley: a - at lower water levels the river drains the soil, b - under flooding conditions ground water is dammed up in the valley, c - at lower water levels drainage takes place, d - under flooding conditions in the inter-bank area the ground water level of the area before the bank is dammed up

From the middle of the Holocene epoch., higher and higher flood waves occurred in individual sections of the river valleys of the East Mid-European Lowland. The first flood banks, which were built, with time proved to be too low. They had to be heightened, and also their bases had to be widened. As a rule this was done in the conditions of an impending threat of flooding, and the material for building the flood bank was collected from the area before the bank, and not from the inter-bank area (fig. 1).

Thus the possibility of the occurrence of paludification and swamping increased which was due not only to infiltration of water from the inter-bank area through the flood bank to the area before the bank, but also to damming up of the ground water in the area before the bank. Neither was a proper technique of building up the flood banks always used due to the hurry and urgency of the situation. As a result, it turned out that raising up, widening and lengthening of the flood banks could not secure safety in particular sections of a valley. Successive floods followed, when the bulk of the flowing water destroyed the flood banks, or overflowed their crown if it could not be held in the inter-bank area.
