## VALUE OF ANTIQUITY IN THE RESTORATION PROCESS OF THE ART NOUVEAU VILLA DUELFER IN BARLINEK

Halina RUTYNA<sup>1</sup>

### Abstract

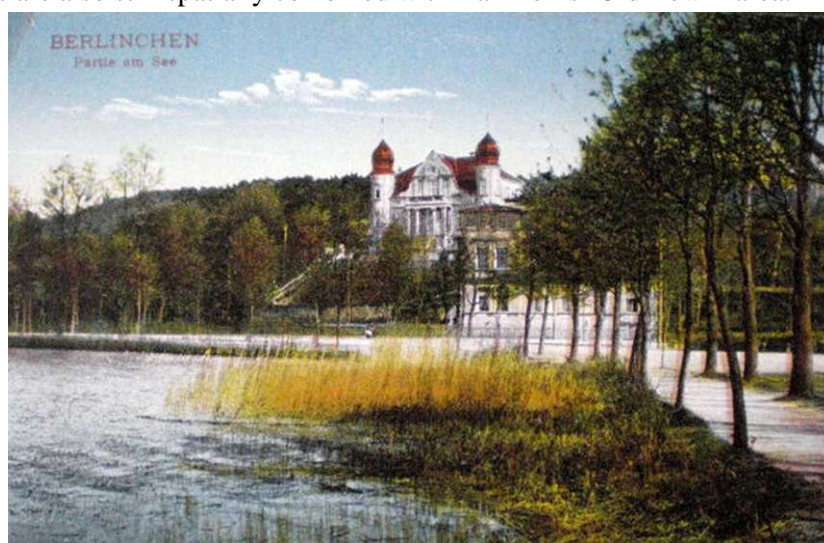
Fig. 1. Pre-war postcard of Berlinchen, showing the excellent location of the Villa Duelfer against the forest and lake. Source: Private collection

three sides is a forest (Fig. 1). Looking at the location and urban composition of the area, the villa's grounds blend into the green, tourist part of the place, which is slightly spatially separated from the centre in such a way that the two zones are axially linked by the clear, simple passage of Strzelecka street. The green areas are also still spatially combined with Barlinek's 'Old Town' area.

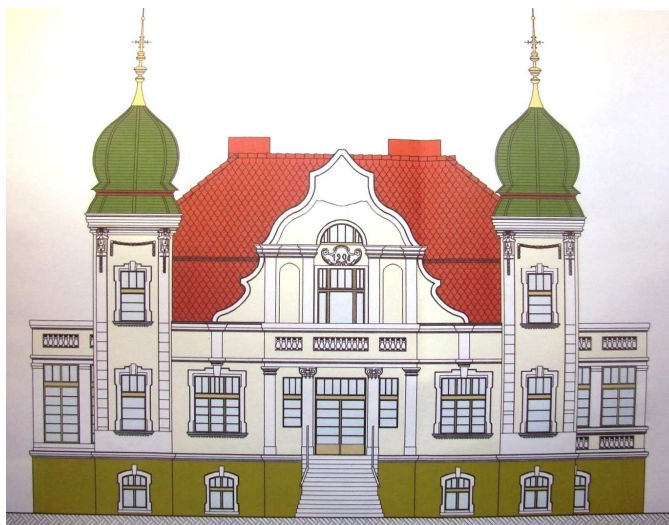
Fig. 2. Front elevation of the villa, by Halina Rutyna, 2008

Villa Duelfer is a compact, two-storey block sited on a high pedestal and covered with a large hipped roof. Its corners are included in the semi-circular towers and covered with onion-type domes. There is a large number of architectural detail on its front elevation, which is crowned by a large tympanum with a soft silhouette, divided by cornices and pilasters and decorated with soft Art Nouveau decorations of male and female figures, with the architect’s initials at the top. The towers are decorated with garlands, and the windows are included within in a broad band of wooden ears of varying degrees of detail. The axis of symmetry of the building’s main part is disturbed by the veranda, located on a side elevation and blending in to windows on the other side.

Whilst maintaining the conservation documentation for the 100-year-old Villa Duelfer, I decided to cultivate the values of antiquity, which I began at the planning stage of the villa's renovation (Fig. 2). The theorist, A. Riegl, maintained that the root of scientific conservation lies in the reasoning that every human action is directed by specific values. From the perspective of the 19th-century knowledge of culture, one could attempt to extract the leading values by analysing different kinds of motivation associated with conservation activities. The diversity of active entities leads, primarily, to the differences in perception of relics of the past and the different value judgements made about these relics.
