ROMANTIC JOSEPH LENNÉ LANDSCAPE PARK IN ZATONIE NEAR ZIELONA GÓRA AS A RELIC OF GARDEN ART - MODERN-DAY TRANSFORMATIONS AND THREATS

Agnieszka KOCHAŃSKA¹
University of Zielona Gora, Zielona Góra, Poland

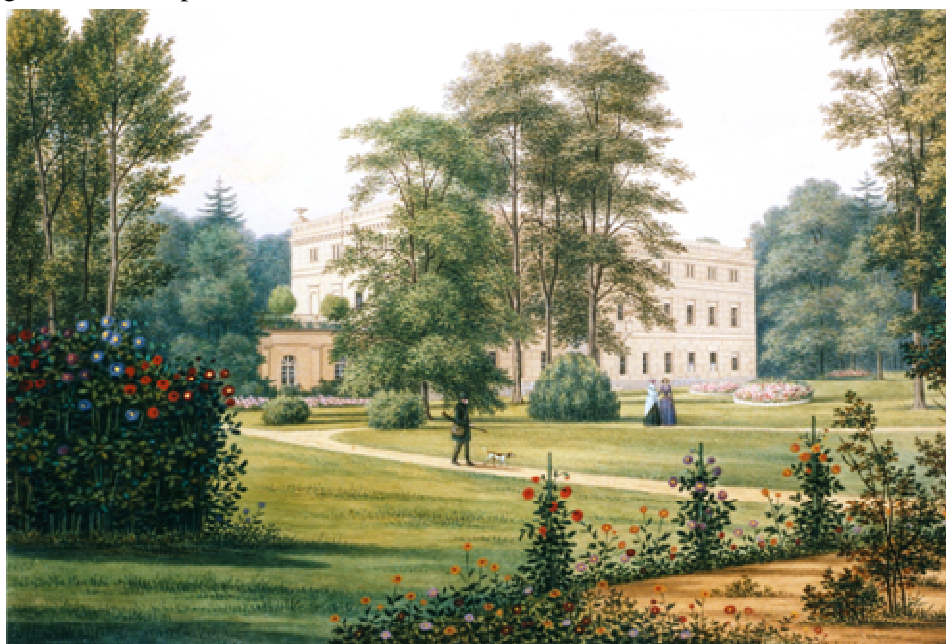
Fig. 1. Gouache by C. Bovet from 1843 showing the northern fragment of the park after reconstruction

A colorful gouache from 1843 provides very exact documentation of the area of the park on the north side of the palace. Far-reaching lawns extended out from the building. The abundant flowerbeds of flowering plants found here were surrounded by decorative white edges. Flowerbeds containing shrubs were different in character and placed freely on the lawns. Attention ought to be drawn to the picturesque group of lindens, partially covering the elevation of the palace. It was meant to give a feeling of obliqueness and, at the same, define the viewing axis in the direction of the hill with a rose gazebo. One of the mentioned lindens was still growing here in the 80's of the XX century. White wooden English style benches were placed at the beginning of the main viewing axes. Individual coniferous trees and poplars can be found in the tree massifs surrounding the area. Freely placed paths can be seen running between the groups of plants.

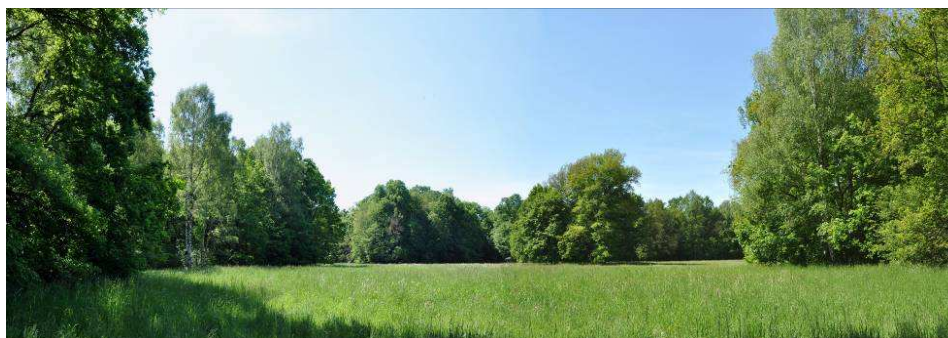
Fig. 2. Joanna's Meadow. View of a group of trees forming a coulisse for the viewing axes - existing state.
